FAILURE ANALYSIS OF A FEMORAL HIP STEM MADE OF STAINLESS STEEL AFTER SHORT TIME OF EXPOSURE

Żaneta Anna MIERZEJEWSKA*, Zbigniew OKSIUTA*

*Faculty of Mechanical Engineering, Division of Materials and Biomedical Engineering, Białystok University of Technology,
ul. Wiejska 45c, 15-351 Białystok, Poland

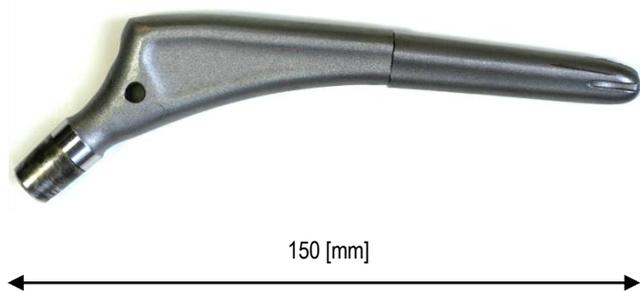
General image of the fractured stem is shown in Fig. 1. After revision, two parts of the fractured stems were prepared to further analysis. A small piece of material was cut from the stem and prepared for metallographic observations according to ASTM E1306-11 standard. The chemical composition of the stainless steel was examined by means of a spark emission spectroscopy (Thermo ARL Quantis, Switzerland). Microstructure observations after etching by means of the Vilella's echant (picric acid 1 g; HCl 5 ml; ethanol 100 ml) were carried out by an optical microscope (OM) a Nikon Eclipse LV1000. The fracture surfaces of stem were examined by means of Scanning Electron Microscopy (SEM) Hitachi S-3000N, equipped with Energy Dispersive Spectroscopy (EDS). Hardness measurements were performed using Vickers universal indenter with a load of 5 kg. Grain size and hardness measurements were performed according to ASTM standards E112 and E384, accordingly.

Fig. 1. General view of the fractured stainless steel stem

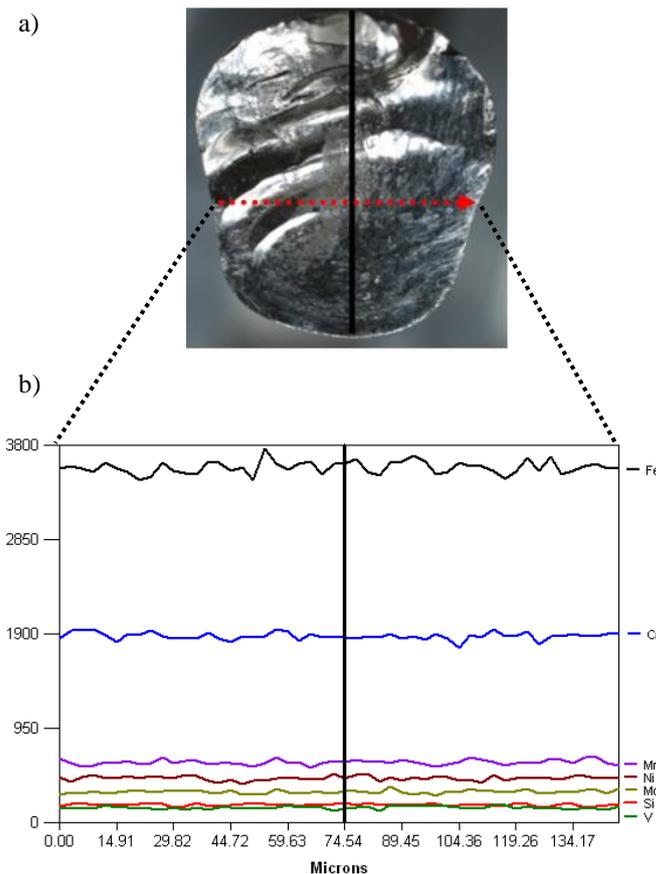
SEM-EDS linear analysis was also performed to observe changes in the concentrations of main alloying elements along a cross-section of the stem as it is presented in Fig. 2a. The results presented in Fig. 2b confirmed a homogeneous distribution of alloying elements in the steel matrix.

Fig. 2. SEM-EDS linear analysis of the elements concentration on the surface of the stem – (a) macroscopic view (b) – elements distribution

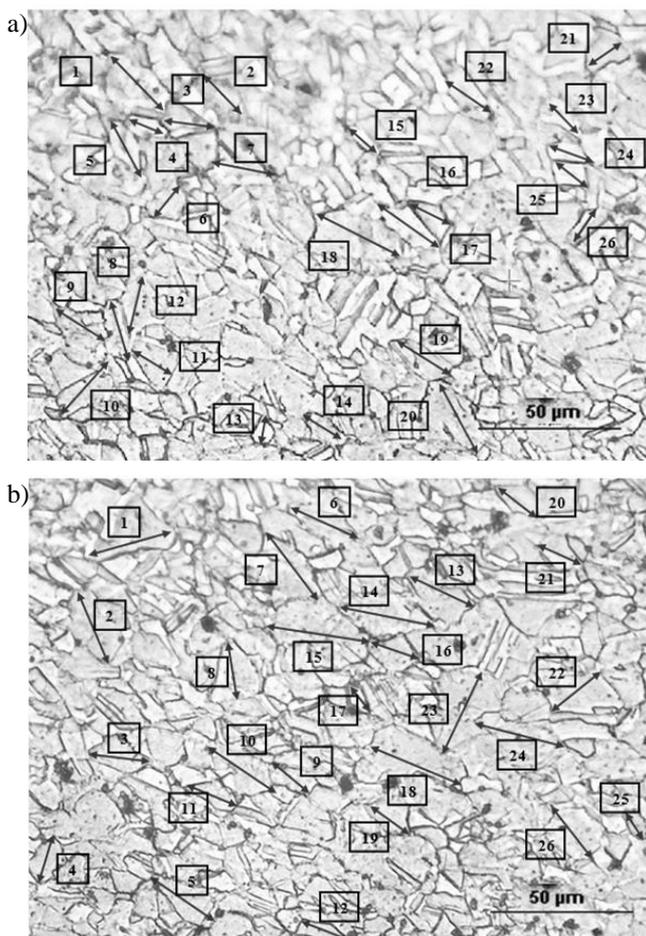
OM image of the etched microstructure of the tested sample, presented in Fig. 3 showed equiaxed austenitic grains and twins characteristic for forged and annealed austenitic stainless steels. Note, that no delta ferrite was observed.

In general, the microstructure is quite homogeneous, with an average grain size of $36 \pm 3 \mu\text{m}$ (no 7 according to ASTM). However, larger grains near the surface of the stem were also observed (which may cause an origin of a fatigue crack initiation of the steel (Fig. 3b). This inhomogeneity of the grain size is difficult to explain, however, this may be related to hardness results presented in the section 3.3 (Fig. 6).

Fig. 3. Typical OM microstructure of the femoral stem;
(a) taken from inside of the stem
(b) taken from an edge of the stem

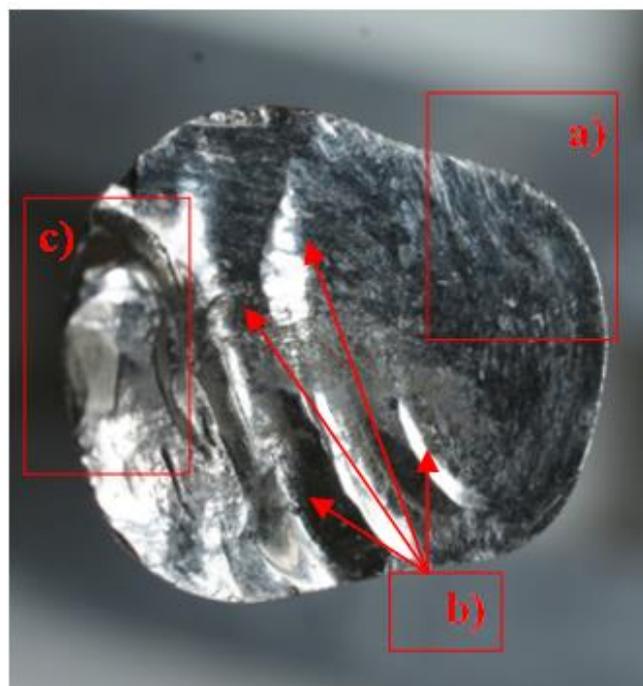
Fig. 4 shows a general view of the fractured surface of the tested material. The image shows a several distinctive features typical for fatigue fracture: an origin where a crack can be initiated (zone a), fatigue striations (zone b), and a final fracture area (zone c). The fatigue fracture probably was initiated close to the lateral edge of the material, and further propagated until a cross section of the stem was no longer strong enough to bearing the applied load and it finally broke. The fatigue zone is unique to fatigue fractures because it is the region where the crack grows from the origin to the final fracture zone. It should be pointed out that the geometry of the fractured stem did not reveal any changes. No bending of stems was observed. Also, no traces of corrosion were discovered.

Fig. 4. Fatigue surface with fracture view showing the zones:
a) an origin, b) progression lines
c) and a final fracture zone

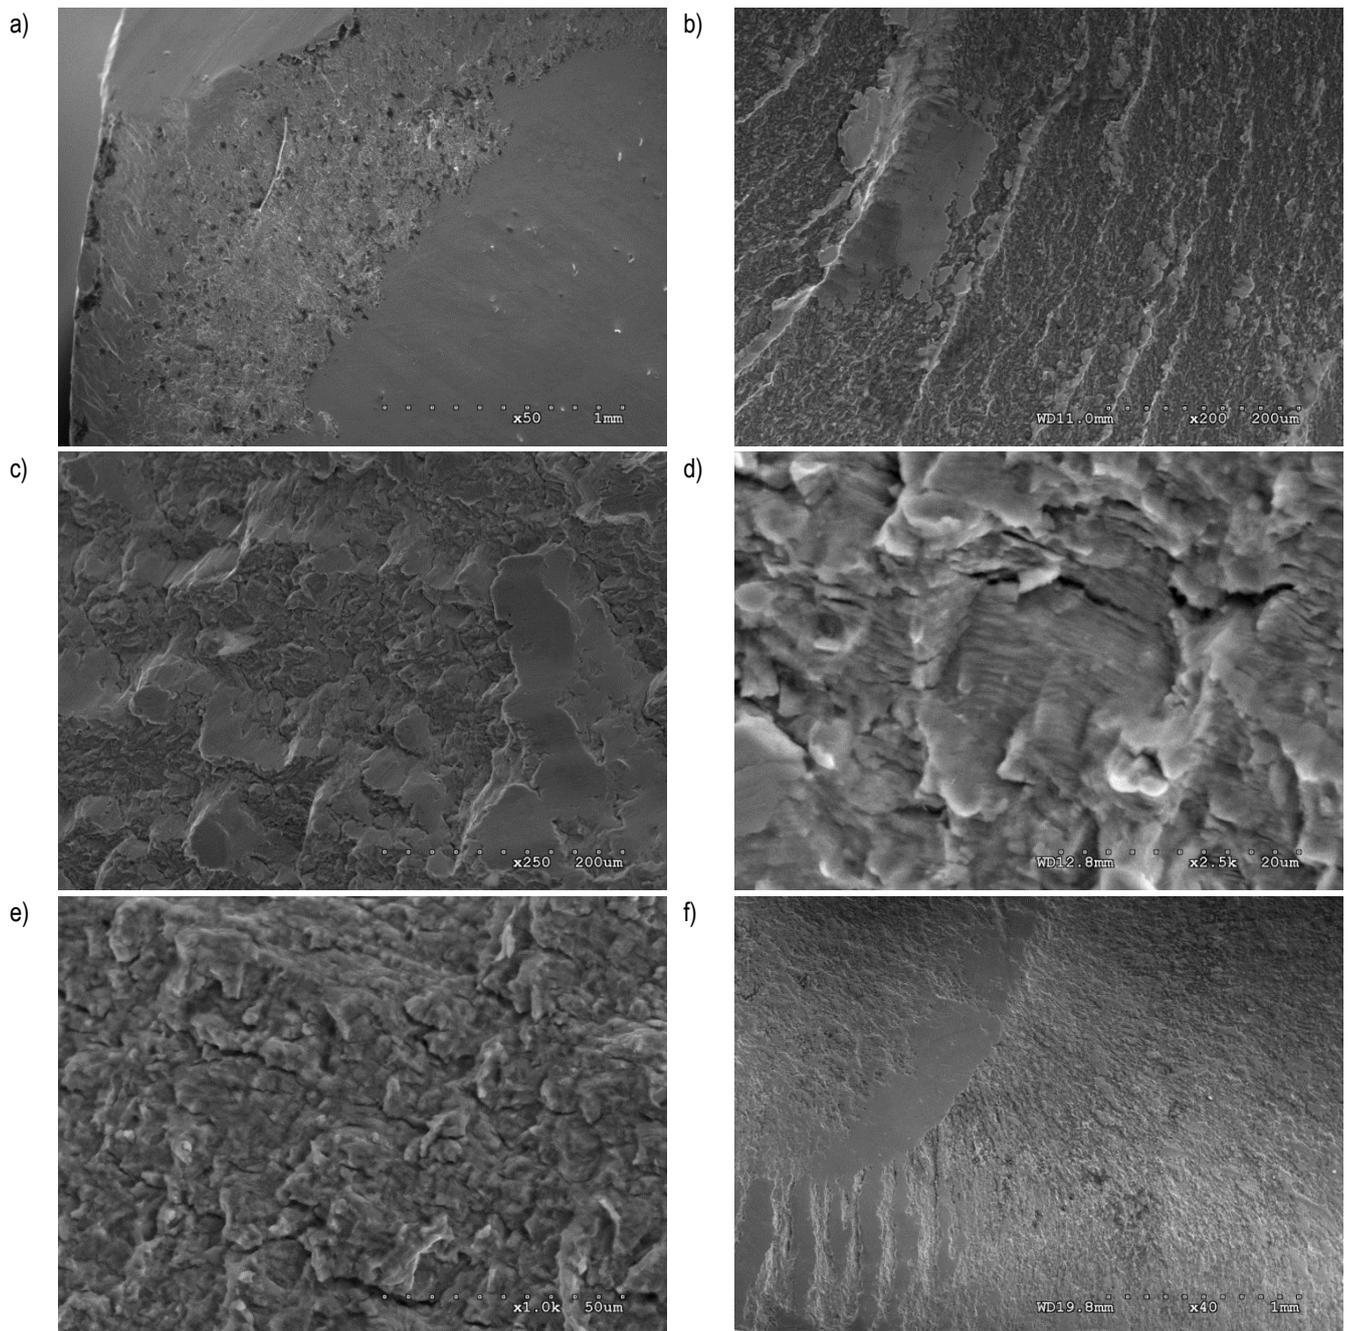
or line was created when the crack stops after short distance propagation. These patterns are not clearly visible, probably because the fracture surfaces were severally smashed, as a result of friction of both broken parts during prolonged walking after fracture. There is another possible explanation reported by Brown (2014) and related to very fine microstructure of steel or unchanged load during fatigue damage.

Fig. 5 shows SEM images of the fractured surface. Fig. 5a presents the magnified cracks initiation region whereas Fig. 5b shows some of the "beach marks" (progression lines) area. Each mark

As the cracked stem continues to be stressed, the crack progresses across the section. The amount of material carrying the load is decreasing, so the stress is obviously increasing. Fig. 5c confirms extensive friction islands at the fracture surface, however higher magnification image in Fig. 5d shows typical fatigue striations. In Fig. 5e numbers of secondary cracks were observed, propagated perpendicular to the loading direction. The length of these cracks corresponds well to the grain size of the steel. This type of fracture may be caused by the presence of non metallic inclusions. Fig. 5f shows the SEM image of the final fracture stage, where the unbroken area is reduced to the point that the applied stress exceeds the ultimate strength of the material.

Fig. 5. SEM images of the fracture surfaces of the tested steel failed by fatigue fracture demonstrating: (a) origin of the failure (b) beach marks area; (c) wear islands on the fracture surface ; (d) fatigue striation; (e) secondary cracks and fatigue tears; (f) final fracture area

Macroscopic fatigue striations, commonly known as beach marks, were visible. The beach marks were closely spaced indicating a large number of cycles to failure, which eliminates the possibility of sudden overload failure. Final failure occurred on the lateral side corner. SEM examination of the fractured surface revealed secondary cracks, which are the result of tensile and compressive stresses induced in the material during patient's walking.

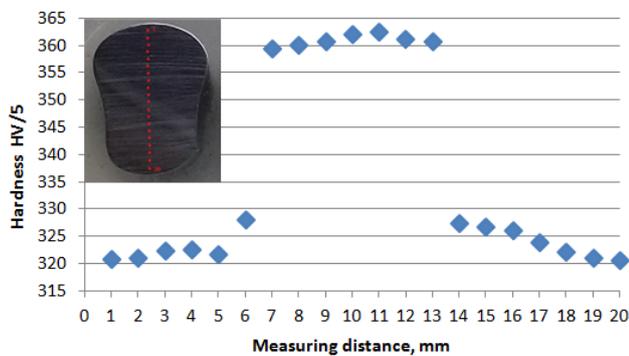
The hardness measurements of both parts of the broken stem was performed few millimeters below and above of the fracture. An average hardness of tested material is $\sim 335 \text{ HV}/5$ and fulfills ASTM requirements. However, an interesting effect was observed, not equal and strong dependence of hardness of the measurement site. In the middle of the cross section of the stem the hardness is $360 \pm 2 \text{ HV}/5$ and close to the edge of the cross section of the specimen is about 10% lower, $325 \pm 5 \text{ HV}/5$ (see Fig. 6).

Fig. 6. Hardness measurements of the tested stem as a function of the distance from the edge of the sample

It is not a significant scatter of the hardness of the tested specimen, however it is difficult to explain, because these results are not consistent with the microstructure observations presented in Fig. 3. According to the Hall-Petch equation (Petch, 1953) with decreasing the grain size the ductility and hardness of the material increase. On the other hand this statement is not valid for some groups of materials, especially with subgrain microstructure.
