DIAGNOSTICS OF WOODEN POLES SITUATED IN THE OPEN - AIR MUSEUM USING SONIC TOMOGRAPHY

Abstract

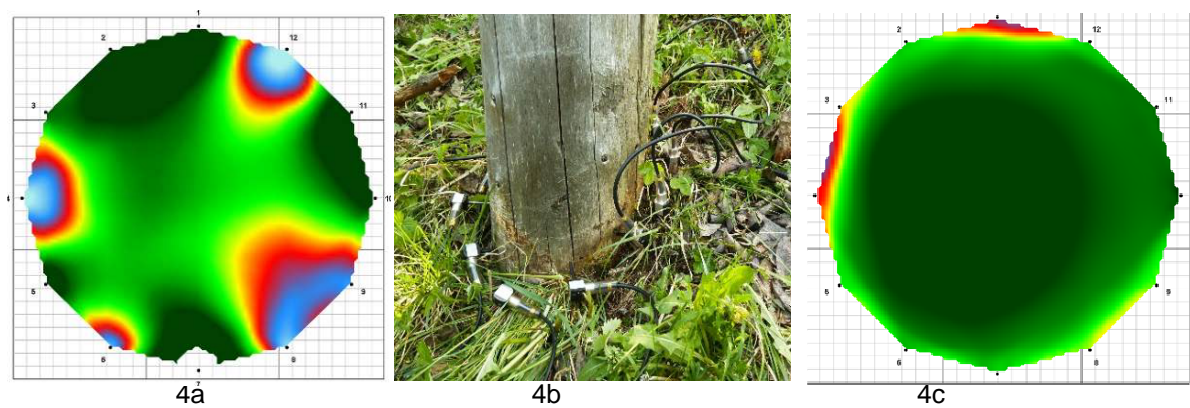
Fig. 4: Sonic scans.

Measurements were carried out on 5 May 2016 at 14:46 hours in a round barked larch pole. The pole is fixed 80 cm deeply; the pit is filled up with plain concrete. The first measurement was taken at ground level, i.e. 0 cm above the ground (Figs. 4a and 4b). The second measurement was taken 30 cm above the ground (Fig. 4c).

The absolute moisture content of the wooden element, temperature, and relative air humidity was measured along with the sound wave velocity. The sonic scan evaluation shows the lower part of the pole is more damaged, compared to the second measurement. Inside the wooden element, there is neither hollow nor damaged wood. There is a surface damage near the ground. Decayed parts reach into the diameter. The extent of damage in the first layer is 23 % (Fig. 4a) and in the second layer 3 % of a diameter (Fig. 4c).

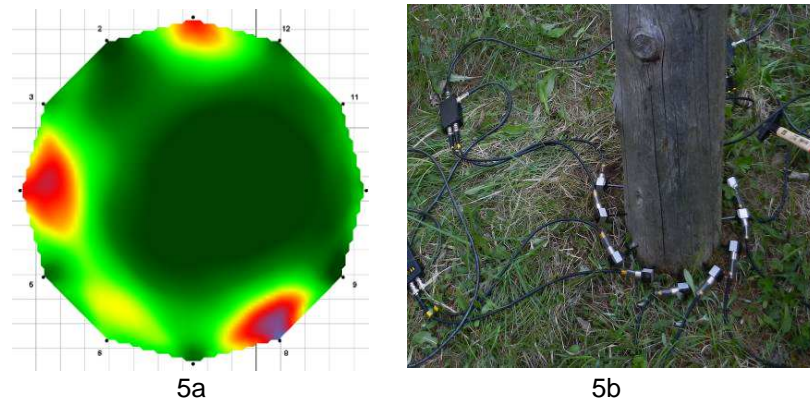
Fig. 5: Sonic scan at ground level.

Measurements were carried out on 5 May 5 2016 at 15:32 hours in a round barked larch pole. The pole is fixed 80 cm deeply; the pit is filled up with lime mortar. The first measurement was taken at ground level, i.e. 0 cm above the ground (Figs. 5a and 5b). The second measurement was taken 50 cm above the ground (Figs. 6a and 6b).

The sonic scan shows the lower part of the pole is more damaged due to the contact with the ground. Inside the wooden element, there is neither hollow nor damaged wood. The second measurement shows no surface damage, but the investigated section contains internal damage - probably damaged wood in the middle. The extent of damage in the first layer is 9 % and in the second layer 31 % of a diameter.

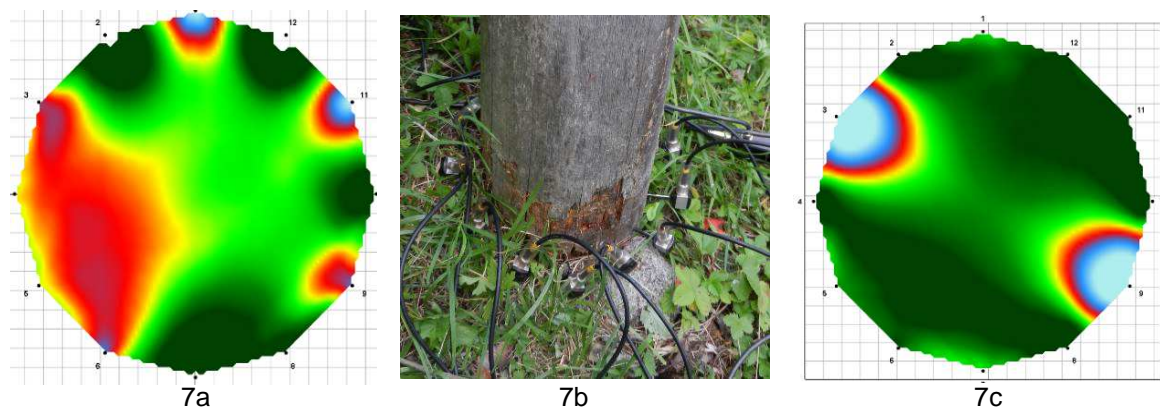
Fig. 7: Sonic scans.

Measurements were carried out on 5 May 2016 at 15:32 hours in a round barked larch pole. The pole is fixed 80 cm deeply; the pit is filled up with soil. The first measurement was taken at ground level, i.e. 0 cm above the ground (Figs. 7a and 7b). The second measurement was taken 30 cm above ground level (Fig. 7c).

The sonic scan shows the lower part of the pole is more damaged due to the contact with the ground. Inside the wooden element, there is neither hollow nor damaged wood. The second measurement shows no surface damage, but the investigated section contains surface damage. The extent of damage in the first layer is 33 % and in the second layer 15 % of a diameter.

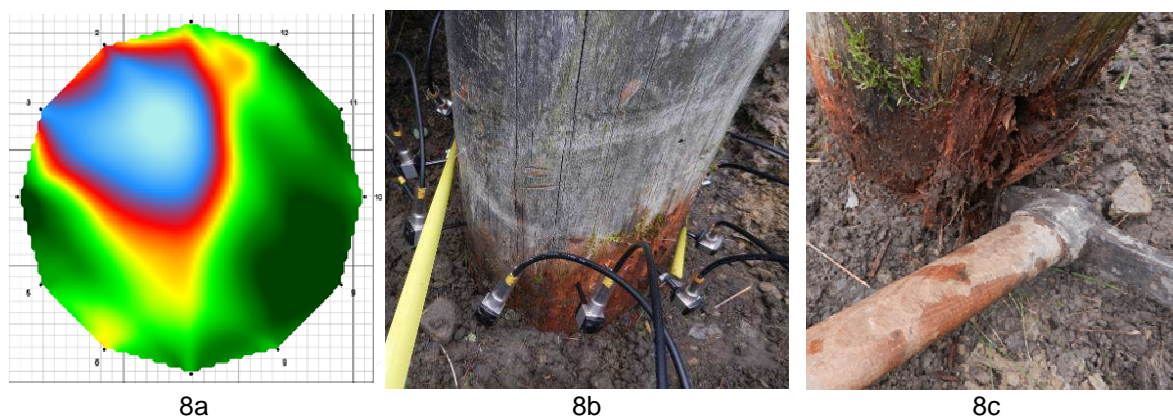
Further measurements were taken on 30 May 2016 at 15:34 hours in a round barked larch pole. The pole is fixed 80 cm deeply; the pit is filled up with soil. One measurement was taken at ground level after the grass had been removed. The pole is fixed in a soil. The visual inspection shows evident damage on the side facing the slope (Fig. 8). The extent of damage is 39 % of a diameter. The wooden pole is significantly attacked by rainwater running down the slope.

Fig. 8: Measuring of the pole fixed in soil: a - sonic scan, b - view of measurement, c - view of the damaged side - a hollow.

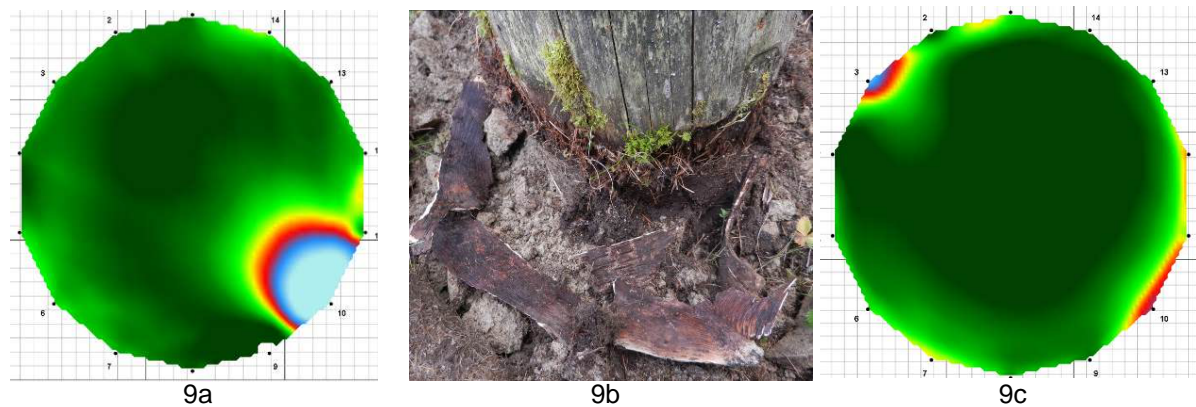
Fig. 9: Sonic scans.

with birch bark. The first measurement was taken at ground level, i.e. 0 cm above the ground, after bark and grass had been removed (Figs. 9a and 9b). The second measurement was taken 30 cm above the ground (Fig. 9c).

The visual inspection shows wood damage at ground level. Wood degradation is 1 cm deep. The sonic scan shows the lower part of the pole is more damaged due to the contact with the ground. Inside the wooden element, there is neither hollow nor damaged wood. The second measurement shows no surface damage. The extent of damage in the first layer is 9 % and in the second layer 3 % of a diameter.
