# EXPERIMENTAL CRACK PROPAGATION ANALYSIS OF THE COMPRESSOR BLADES WORKING IN HIGH CYCLE FATIGUE CONDITION

**Lucjan Witek**

*Rzeszów University of Technology  
Rzeszów, Poland*

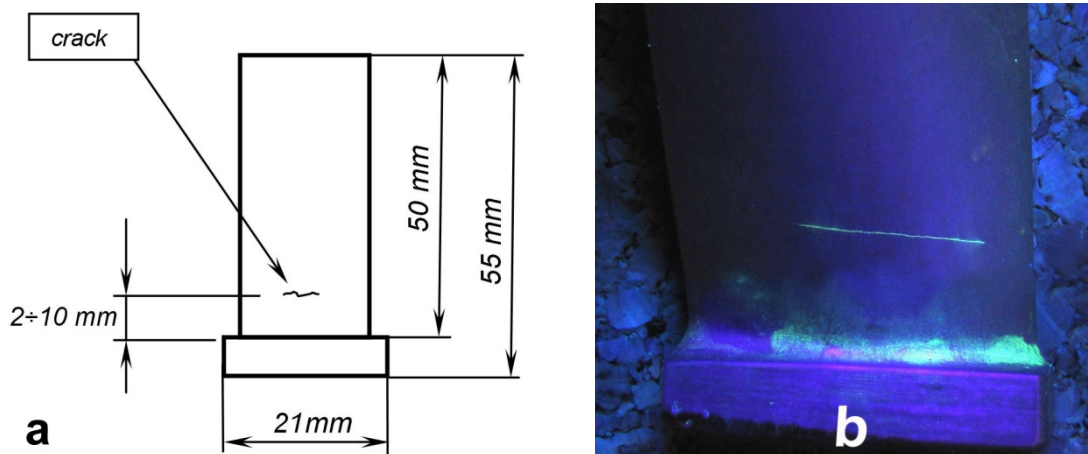
Fig. 3. Overall dimensions of the first stage blade of compressor with location of the cracks (a) and view of luminous crack in UV light (b).

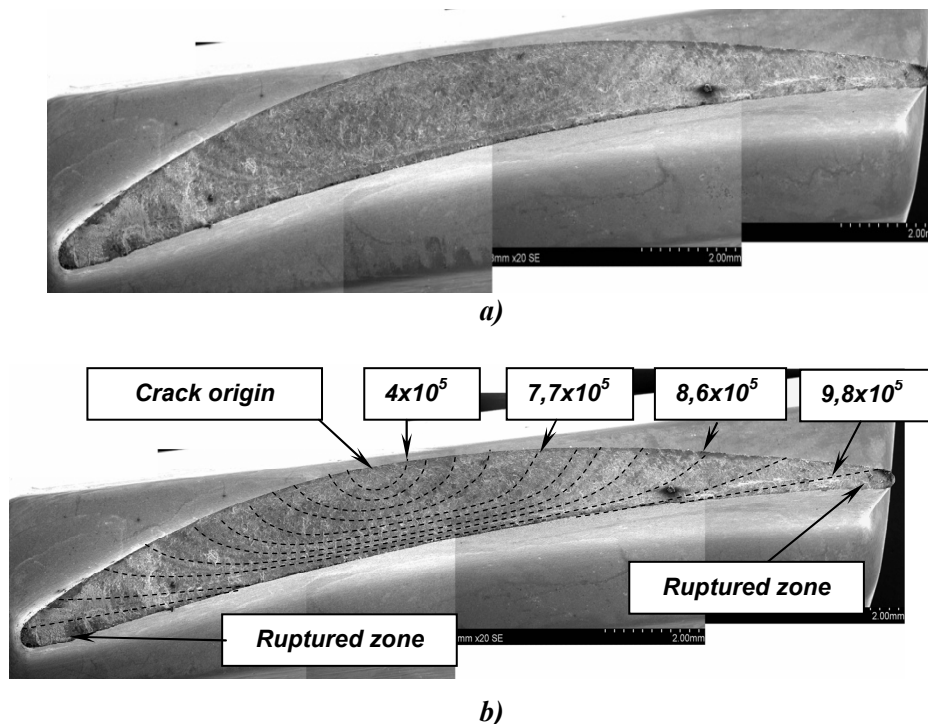
Fig. 4. View of damaged blade (a). Fracture with marked beach marks, created by different number of cycles (b), blade no. 1.

Results presented in Fig. 4÷7 and Tab. 1 are obtained from tests in which intensity of vibration was defined as 12g (for blades no. 1, 2 and 3). The fractured blade number 1 is shown in Fig. 4.

The crack was initiated on the convex surface of profile, about 6 mm above the blade locking piece. The crack origin zone was not covered by corrosion product.

The fatigue test for blade number 1 was conducted in short time and the crack was propagated in non-corrosive environment thus the beach marks presented in Fig. 4a are not well visible,

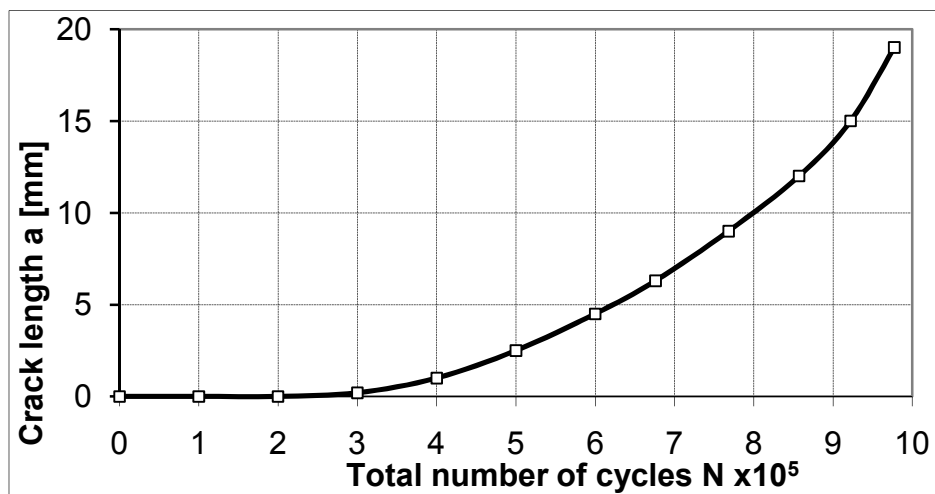
The control parameters of vibration system and results obtained for blade no. 1 are shown in Tab. 1. As seen from this table, the resonant frequency for blade is 774 Hz, and from this frequency test was started. After  $4 \times 10^5$  total number of cycles, an amplitude of blade tip decreased from 2,5 mm to 2,25 mm. Under cracking, the bending stiffness of blade is decreased. This information is very important, because decrease of amplitude by constant intensity of excitation is often related with start of crack initiation process. In this case 1 mm long crack was detected. From the  $6,76 \times 10^5$  number of cycles, the excitation frequency decreased with rate 0,2 and 1 Hz/sek. The crack length in function of the total number of cycles (crack growth plot), obtained for blade no. 1 is presented in Fig. 5.

**Fig. 5. Crack length in function of total number of cycles for I-st stage compressor blade (intensity of vibration 12g, blade no. 1).**

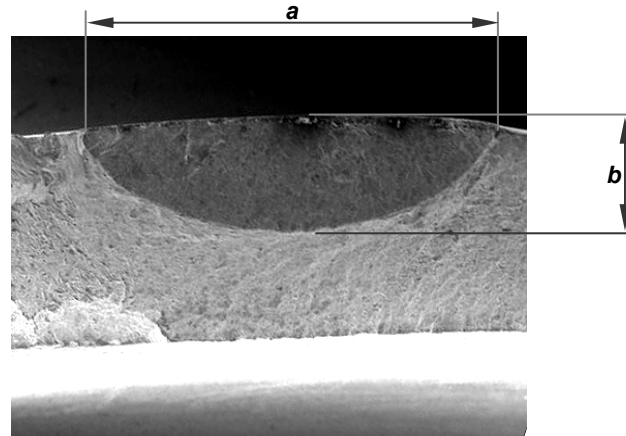
Fig. 6 is a magnified view of the fractured surface. As seen from this figure, the crack front in the early stage of fatigue intensively moves inside the structure. The depth of crack (b dimension) is about 50% of total blade thickness. The fatigue fracture area is dark grey. A fluorescent penetrant was locally heated (in result of micro-friction during vibration) hence its black color around the crack origin zone. This color is not related with corrosion products.

**Fig. 6. Shape of crack front just after crack initiation (blade no. 2).**

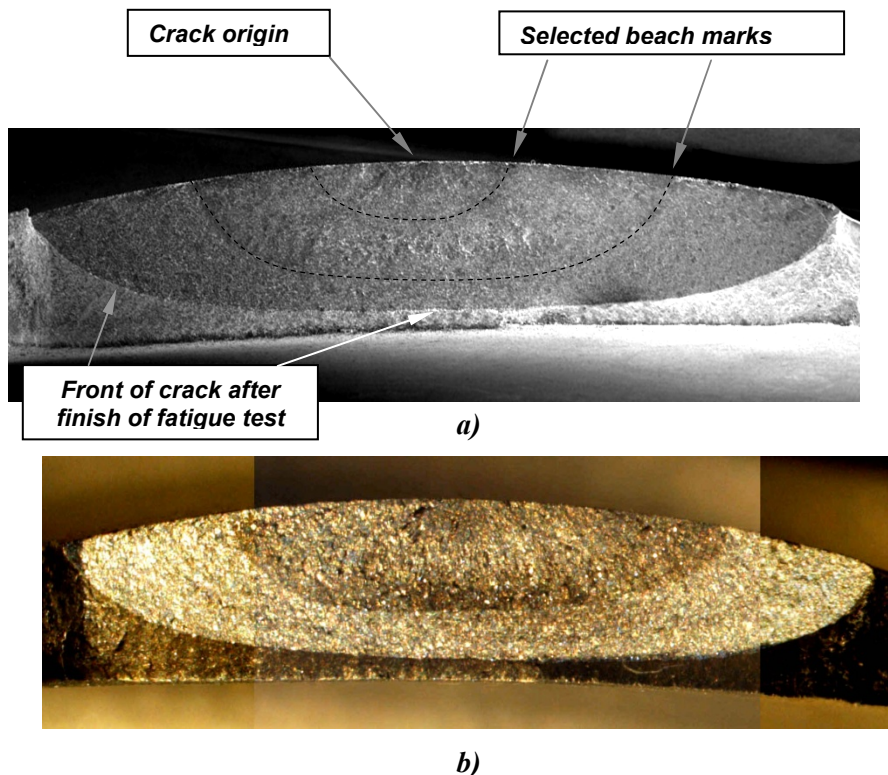
**Fig. 7. Shape of crack front in advanced phase of fatigue, after about  $8 \times 10^5$  number of cycles, visible with use scanning (a) and optical (b) microscope (blade no. 3)**

Blade number 3 was vibrated as long as the fatigue crack length (a dimension) was about 10 mm. Next the blade was statically ruptured with use the testing machine. Shape of crack in advanced phase of growth is presented in Fig. 7. As seen from this figure, the crack in advanced

phase of growth propagated quickly in the horizontal direction. By comparison Fig 7a and 7b is visible that not scanning, but optical microscope is better for beach marks observation. Blade no. 3 was tested with about 3 month pause, hence on the fatigue fracture area are visible two different regions (dark around crack origin zone and bright).

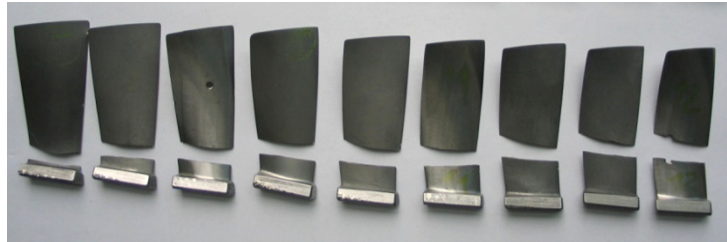
In this paper, results for only three from ten blades were in detail described. The damage schemes of remaining blades are similar to presented in Fig. 4. The cracks were initiated on the convex surface of profile, from 2 mm to 10 mm above the blade locking piece (Fig. 8). The crack origin zones were not covered by corrosion product. In one case the crack was initiated from hole, which was made for fixing of the acceleration sensor (last blade presented in Fig. 8).

**Fig. 8. Ruptured blades of the 1-st stage of compressor after investigations (b).**

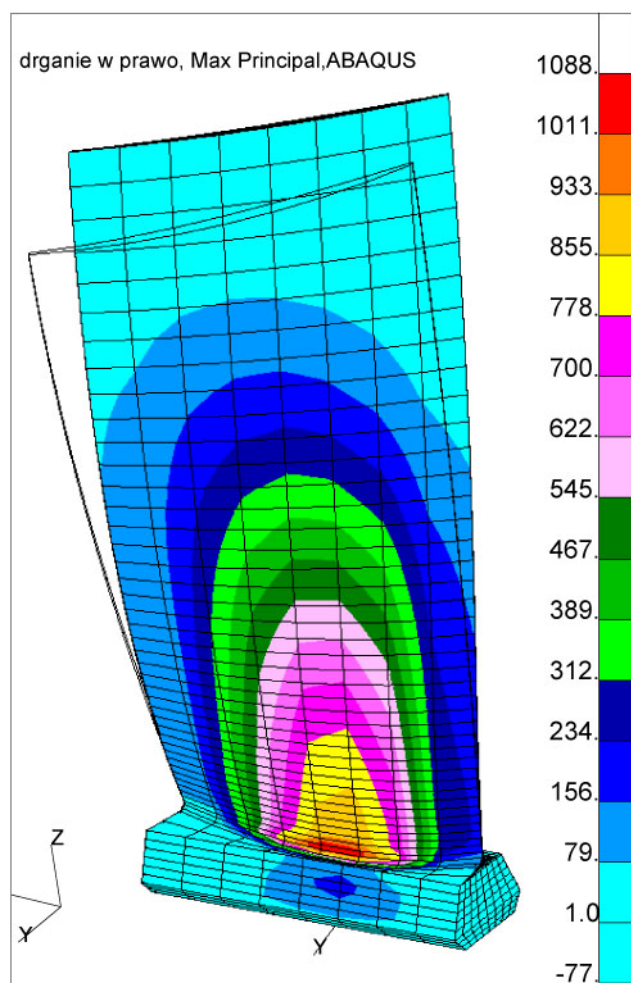
Fig. 11 shows, that the tensile stress on convex surface of blade where the cracks appeared, achieves 622-1011 MPa (for right deflection of blade). The maximum stress region (1088 MPa) is located about 1 mm above the blade locking piece, on central part of convex surface (Fig. 12a). Near the neutral axis of blade cross-section, the tensile stress decreases to 0 MPa. Between maximum stress region and the neutral axis, the high gradient of stresses is observed. During left deflection, the maximum tensile stress region (934 MPa) is located near attack edge of blade (Fig. 12b).

**Fig. 11. Maximum principal stress distribution for blade during resonance (mode I, transverse vibrations, amplitude of blade tip: 2,5 mm, right deflection of blade.**

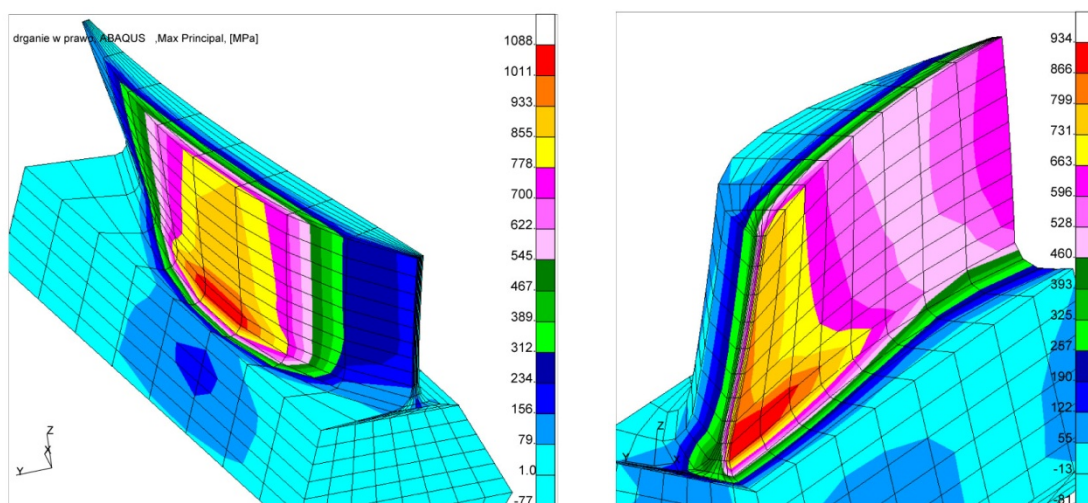
**Fig. 12. Maximum principal stress distribution during resonance (mode I, transverse vibrations, amplitude of blade tip: 2,5 mm,). Cross-section in the crack zone before crack initiation. Right (a) and left (b) deflection of blade.**

Analysis of numerical results showed, that a main reason for fatigue cracks appearing was high stress occurred during blade resonance. Moreover in the cross-section of blade high stress gradient was observed.

The general remark can be formulated based on results of this analysis: the transverse vibrations can be very dangerous for compressor blades because of high stress occurred during blade resonance. In consequence the crack cans rapidly growth to the critical size leaded to failure of engine. For these reasons, the work of engine blades in resonance condition should be avoided.
