DIAGNOSIS AND REPAIR TECHNOLOGY OF DAMAGED ELEMENTS OF CASA AIRCRAFT

The Polish military plane - CASA caught fire. The AFIT researchers have investigated the structure using the NDT methods and, together with specialists from WZL-3, have proposed the repair method.

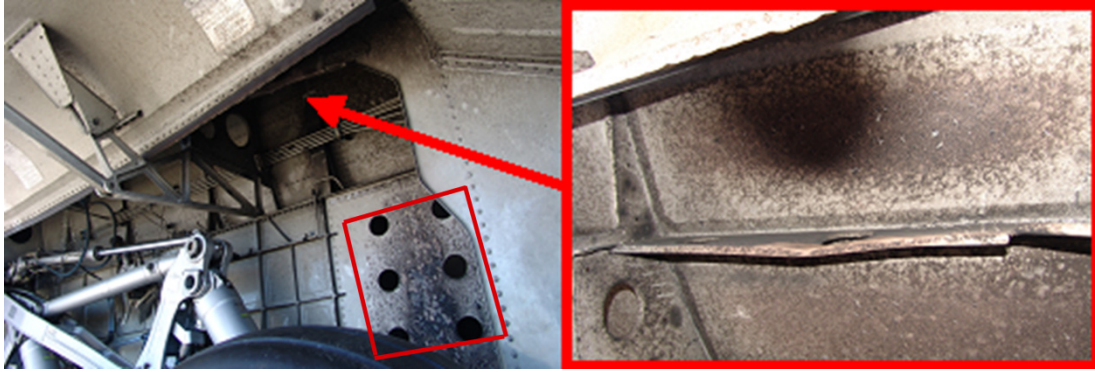
During take-off, the breaks broke down and got blocked, which caused burning of the composite panels. The fire was not big, but the composite panels and the metal longeron as well as the elements inside the left gear’s deflector required nondestructive inspection and repair.

Fig. 1. Area of interesting

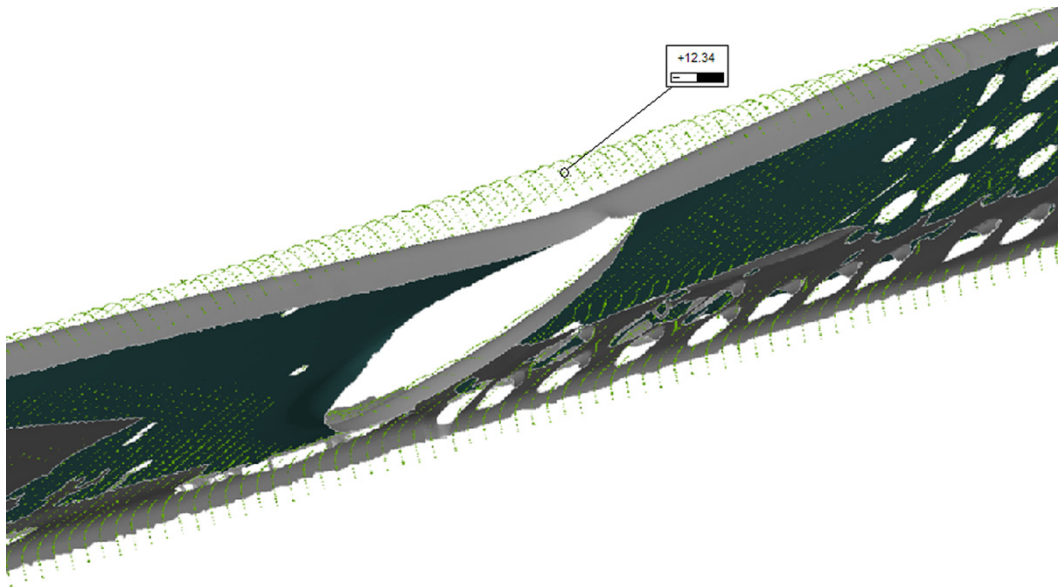
Fig. 4. Displacement of longeron in damage area

In the picture above (Fig.4), the deformation of the longeron caused by the heat treatment can be seen.

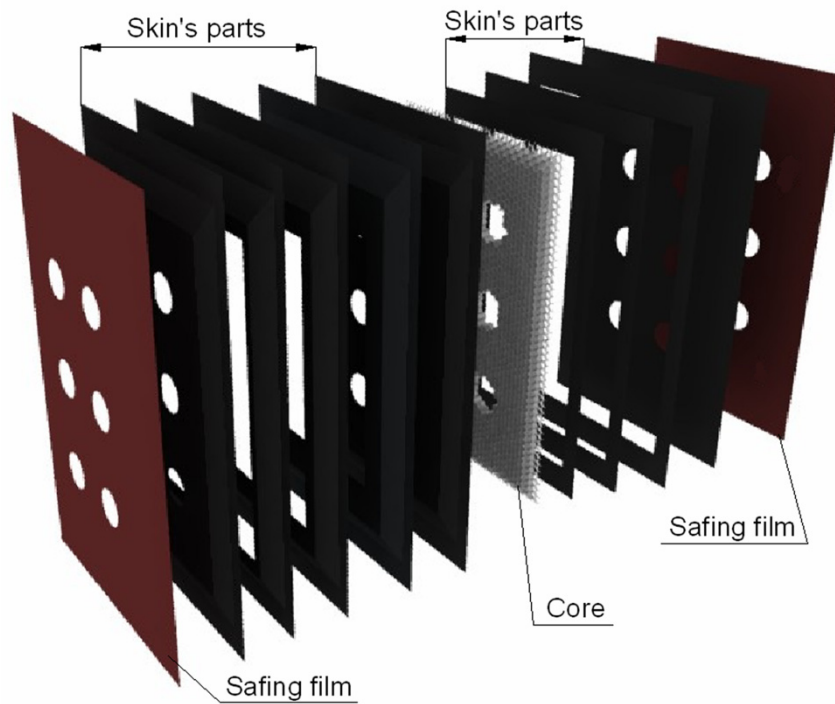
The fire caused failure in three composite elements, but this paper focuses on the vertical panel only (Fig. 1).

Fig. 5. Panel's structure

The failure found should be repaired by different methods: replacing the damaged part with a new one, filling up with resin gaps between the skin and the core, removing and reconstructing the damaged panel's parts: the skin, core and protective layer.

The latter is the best method. It is a popular method, especially when the structure is resistant to fast changes of temperature in a wide range. Resin used in these composites is resistant to high temperature (up to $\sim 130^{\circ}\text{C}$), however, the temperature during the cure is still higher ($\sim 180^{\circ}\text{C}$). In these cases, temperature is usually reduced and time of cure is extended accordingly.

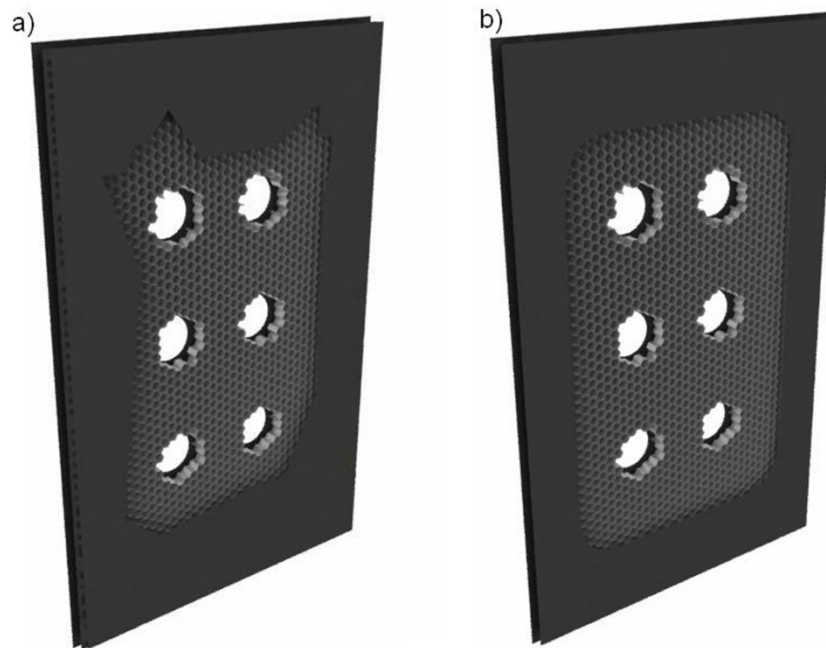
The fire caused disbonding between the skin and the core. The first step is removing the damaged skin and cleaning the core. The corner is a notch, so the corners radiuses should be increased.

Fig. 9. Reduction influence of the notch, a) before tooling, b) after tooling

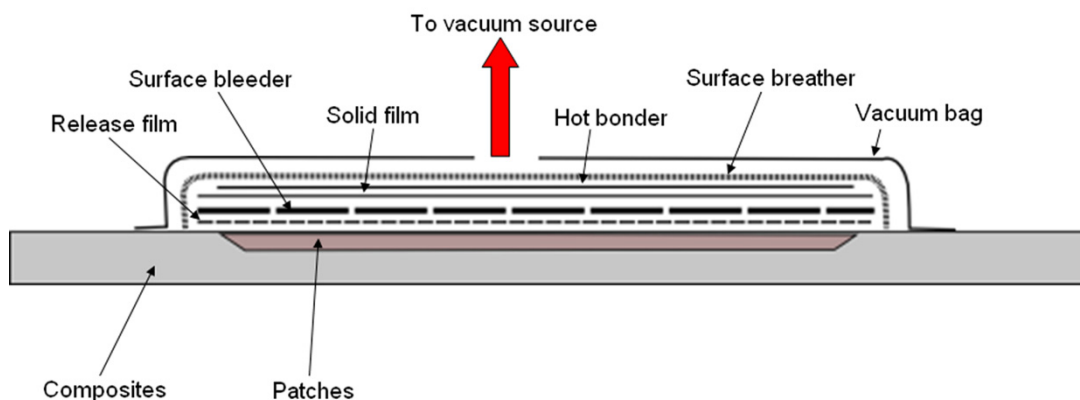
Fig. 10. Method repair and cure equipment

Chamfer of the original edges makes it possible to bond the adequate patch layers. Used in carrier elements, chamfer has the width of 60mm and the thickness of 1mm.

Big gaps in the core are filled up with the real core, in this case Hex-core or Ox-core, while smaller gaps are filled up with a composition of resin, microballoons and silicone (AEROSIL®202).

The resin cure requires temperature treatment and compression. For temperature treatment a hot bonder is used, and for compression a vacuum-bag is used. Temperature and vacuum compression are computer controlled.

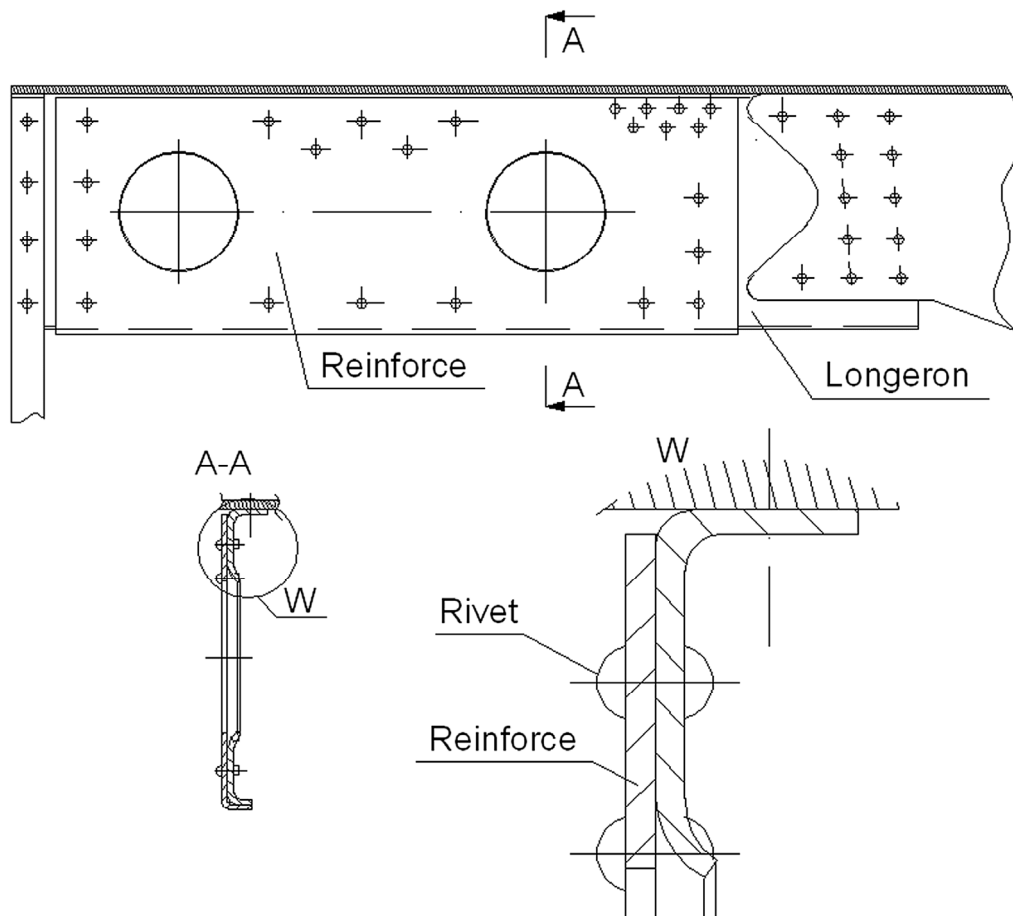
Fig. 11. Reinforced longeron

Based on NDT performance and the diagram (Fig. 2), the repair technology of riveting the alloy fastener to the longeron was developed. The properties of the alloy are same as those of the longeron (Fig. 11).
