CRACK GROWTH ANALYSIS OF THE LANDING GEAR PULL ROD OF THE FIGHTER JET AIRCRAFT

Marcin Kurdelski
Andrzej Leski

*Air Force Institute of Technology,
Warsaw, Poland*

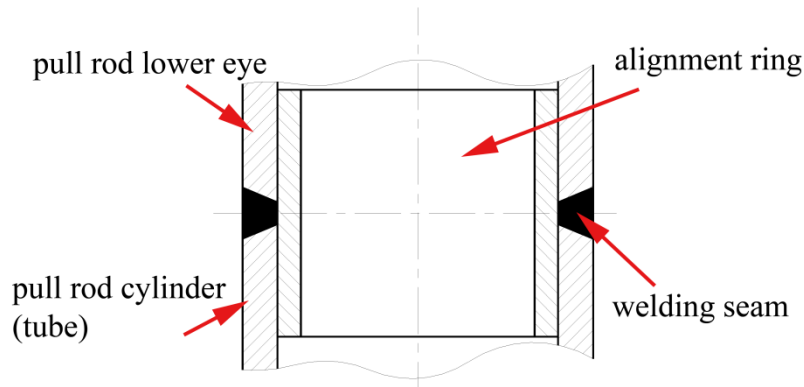
The component set-up for the welding process utilizes a steel alignment ring. The ring is attached to the cylinder of the eye component (fig. 3) by three spot welds that are evenly placed on the tube's circumference.

Fig. 3. Welded wiring diagram

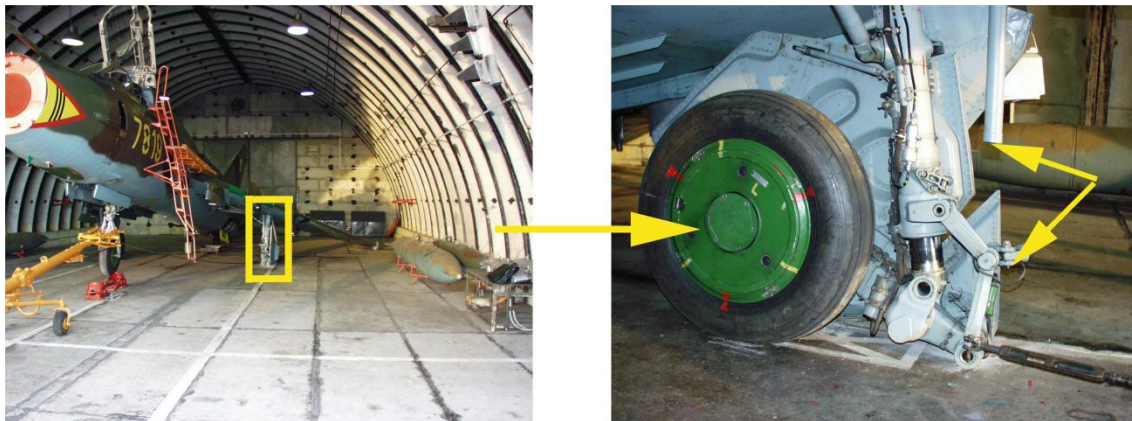
The problem described in the present paper concerns the pull rod of the Su-22's main landing gear – a critical structural element [3]. The problem is related to two incidents, of which the first (in 2004) was a surprise for the operator. During a morning inspection of the hangar buildings, the aircraft was observed lying in an untypical position. Preliminary visual inspection revealed a rupture of the pull rod (No. 8 on Fig. 2) of the left main landing gear. After the inspection, the aircraft was elevated and restored to a proper position and the damaged component was replaced. Subsequently, after a detailed inspection of the landing gear, all necessary repairs were carried out. After the repairs, necessary tests have been performed to verify the landing gear's performance – such as retraction and extension tests, automatic braking systems tests, cockpit signalization systems test and others. Next step in the landing gear's inspection was the inspection of the torsion links' structural health with the color defectoscopy method.

Fig. 4. Failure of the main landing gear

The Incident Board recommended that the inspection of the fracture face be performed with the use of a magnifying glass (x5). The analysis of the fracture face character enabled the Incident

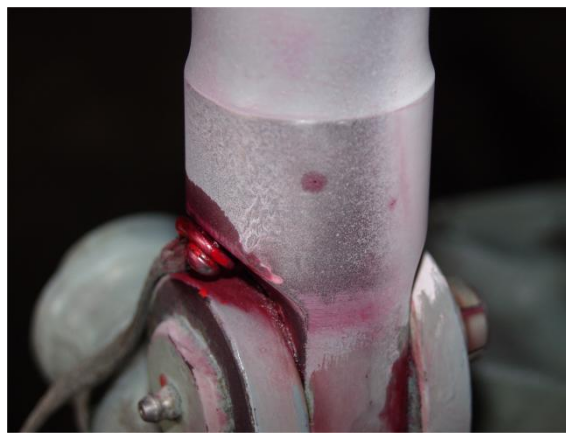
According to the instruction of the Board, tests were performed on the rest of the fleet. The tests consisted of color defectoscopy analysis of the critical welded connection. In some cases doubts were raised as to a particular pull rod's structural health.

Fig. 5. An example of a defect in the area of welded joint

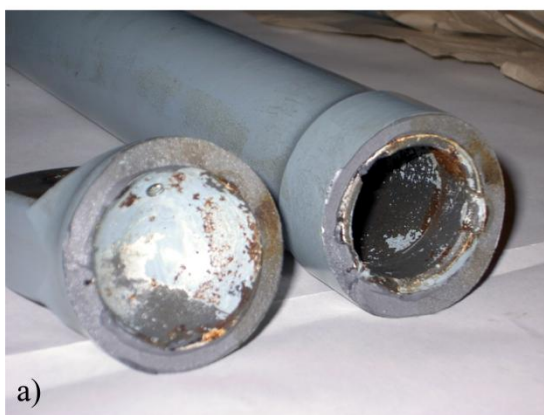
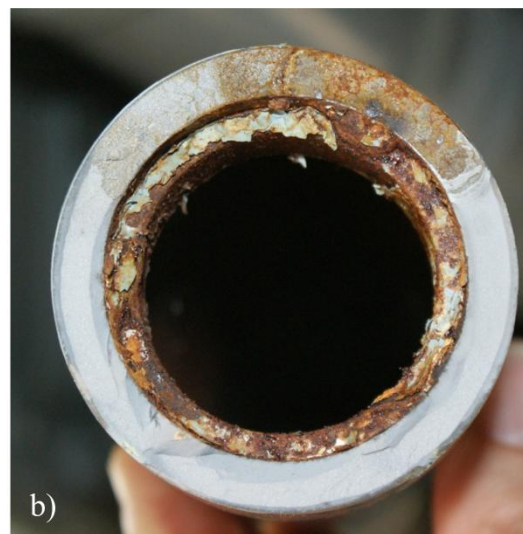
*Fig. 6. Failures of the landing gear pull rod
a) year 2004, b) year 2010*

Both rupture cases seem to have many common characteristics, and the damage occurred in the same area. The occurrence of another pull-rod rupture in an in-service aircraft suggests that the countermeasures applied following the first incident were insufficient. In consequence, further actions were carried out to determine the causes of damage. Also, NDI methods were devised and verified in an attempt to detect damage before the occurrence of the pull-rod ruptures.

The material tests and other engineering analyses made at that time pointed to the fatigue fracture as the cause of damage. The cracking process originated in the area of a structural notch on the boundary of the pull-rod base material and one of the three spot welds. The calculated crack propagation time (number of cycles) for the case was determined to be considerable. The corrosion of the inner surface of the cylinder was the factor that accelerated the crack growth.

The occurrence of yet another rupture showed that the problem is more severe than initially assumed. The crack growth calculations suggest that there exists a factor that accelerates the crack growth. Stress-corrosion appears to be the factor in question. Investigation of the first (2004) incident did not determine the presence of stress corrosion. Corrosion was detected in the second (2010) case only. Contribution of stress-corrosion to the crack growth process is very probable as significant tensile stresses occur in the pull rod discussed during the aircraft hangar standby. The Su-22 aircraft are stored in non-conditioned hangar-shelters. The presence of stress-corrosion influences the determination of the NDI inspection interval. The exact determination of the corrosion's influence on the rate of crack propagation in the pull rod requires additional research.

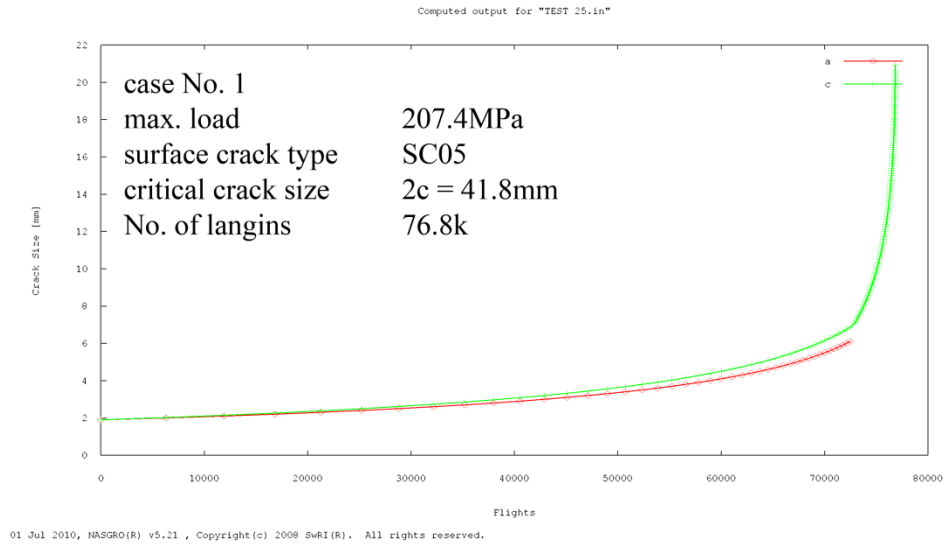
Fig. 10. Crack growth curve – case no. 1

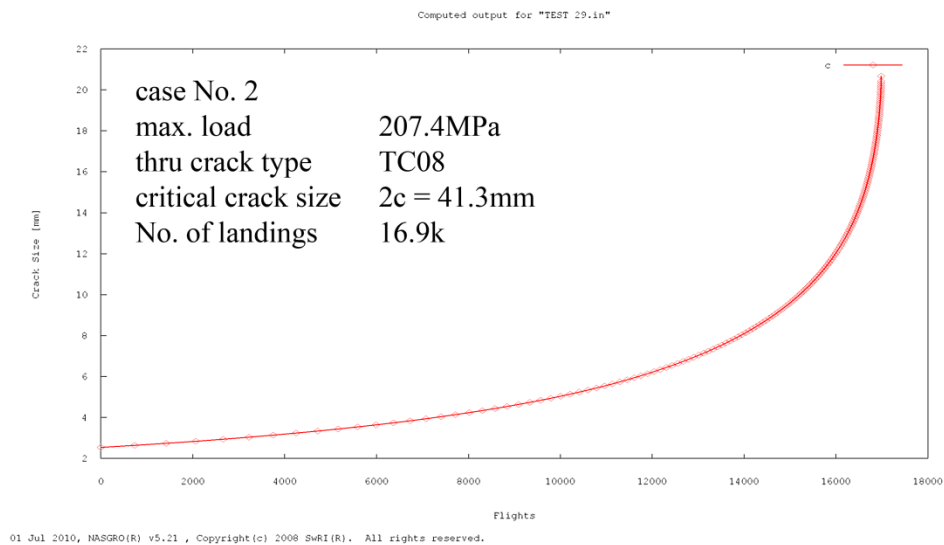
Fig. 11. Crack growth curve – case no. 2

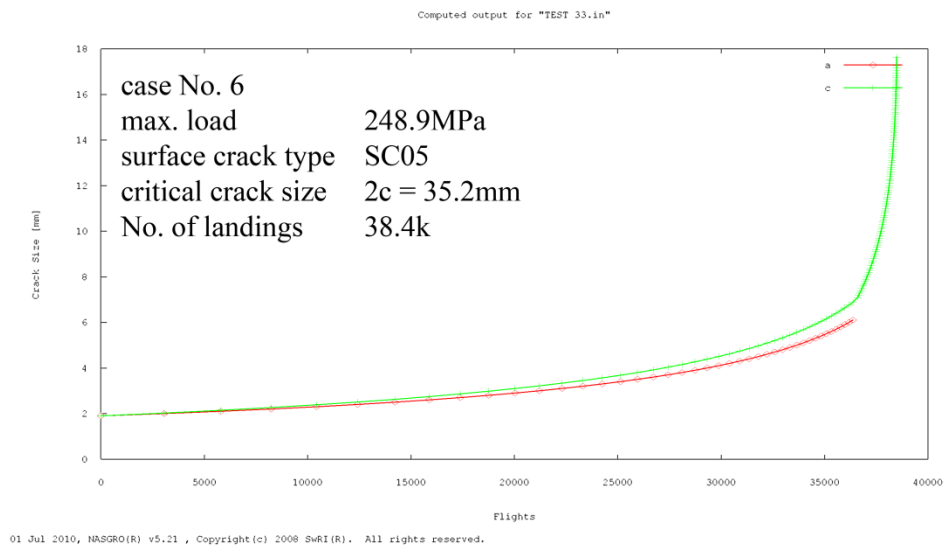
Fig. 12. Crack growth curve – case no. 6
