STRESS ANALYSIS OF THE PZL M28'S AIRFRAME SUBJECTED TO REPAIRS DURING FATIGUE TESTS

Polskie Zakłady Lotnicze Sp. z o.o., ul. Wojska Polskiego 3, 39-300 Mielec

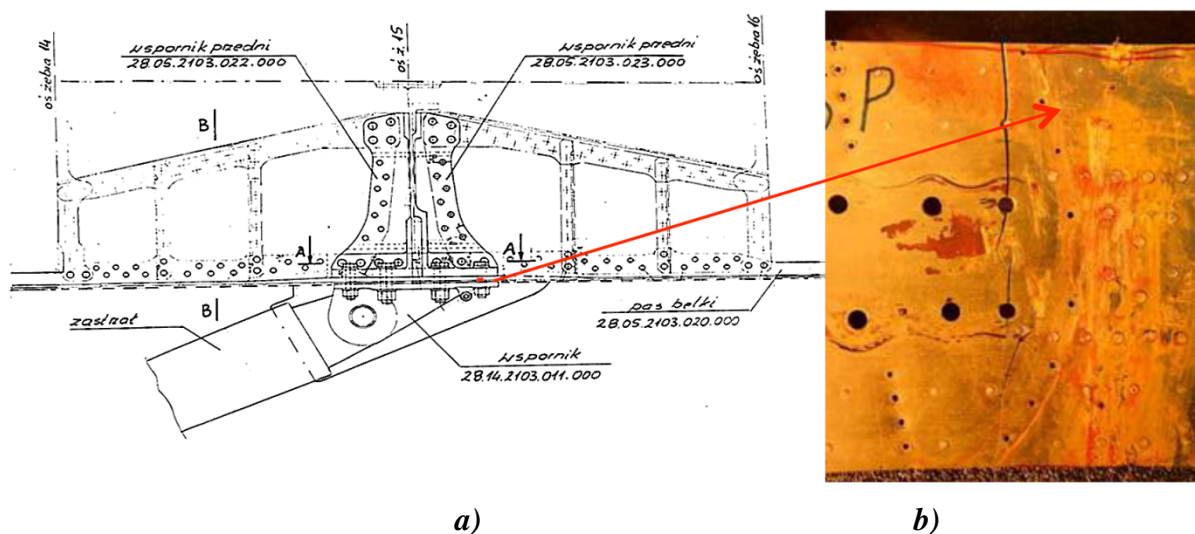
Fig. 1. PZL M28 wing area of rib 15:

The first significant event in the test was a crack in the wing, in the area where wing strut loads are introduced at the rib 15. The crack was caused by the fatigue damage of the wing in the area of the local stress concentration (holes for bolts in the wing strut fitting mounting). The test was terminated before the damage of the tested wing could spread – see Fig. 1. The subsequent analysis showed that it was possible to repair the critical wing area on the airplane in operation, and in this way significantly extend the airplane's service life. A careful stress analysis was performed for the PZL M28's outer wing, in which the most interesting area was the rib 15, where the wing strut loads were introduced. A detailed FEM model covers the wing area from rib 10 (the root rib of the outer wing, with four fittings of the junction with the centerwing) to the rib 19 – see Fig. 1(c) and Fig. 2.

- (a) Sketch of the area of rib 15 with a crack indicated
- (b) Cracked wing skin after removal of a wing strut fitting
- (c) The FEM model of the wing, general view

The wing area aft of the rib 19 was modeled as a beam. Design changes implemented in the structural beam lying between the front and rear wingspans considerably increased the service life of the wing. These changes can be introduced to the wing taken from the airplane in operation during the repair process.

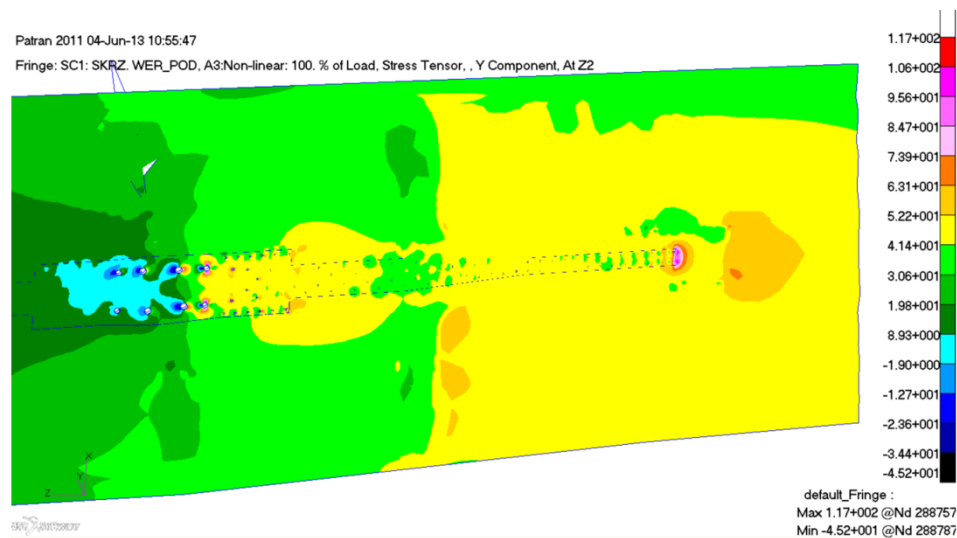
a)

(a) Stress in the lower skin critical area

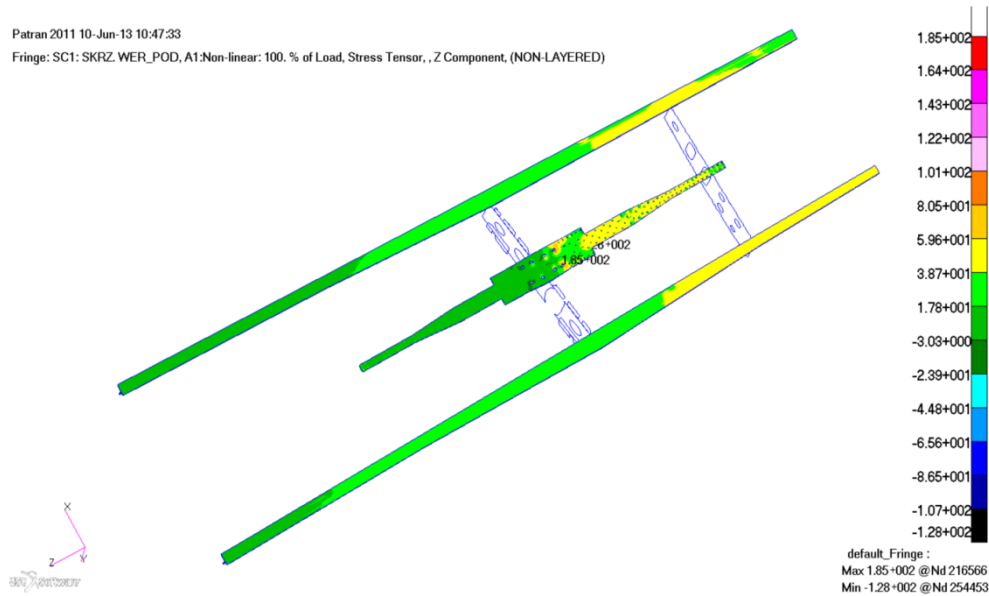
b)

(b) Stress in the wing spars' lower caps and the beam's lower cap

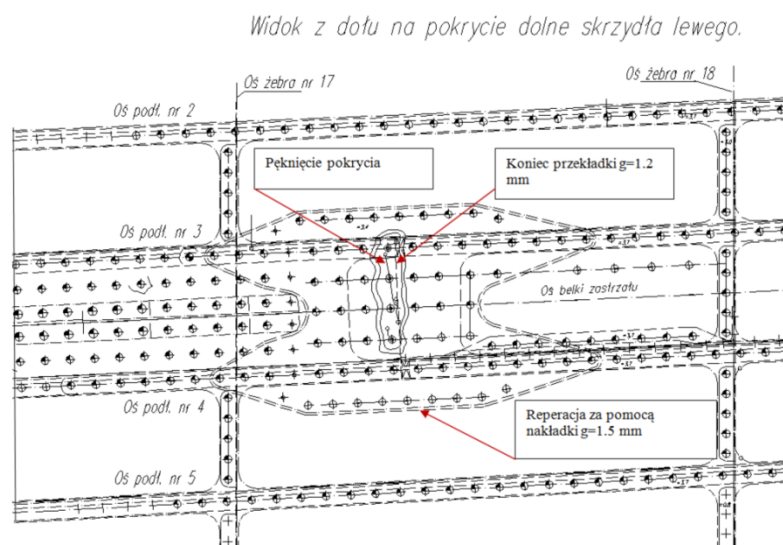
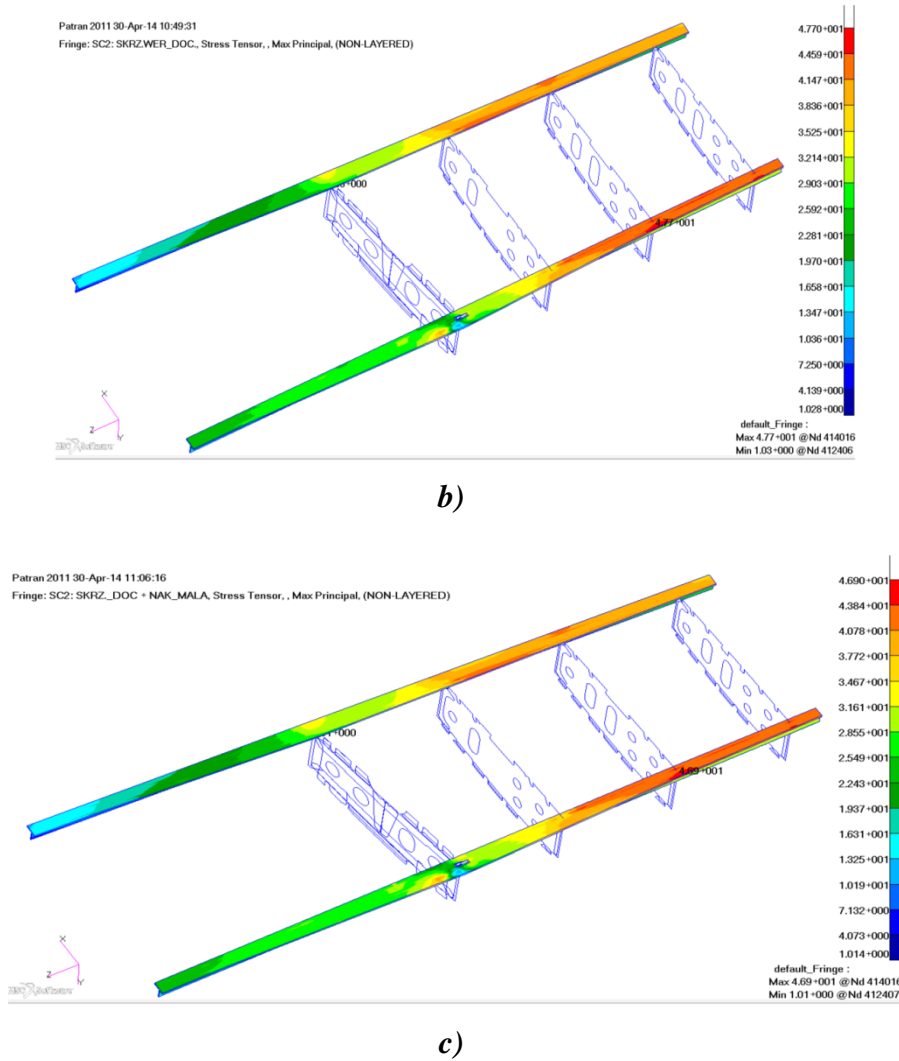
Another crack in the wing was observed at rib 17. The crack was in the wing skin only, so it was assessed as not critical. As it is the area of the integral fuel tank, a crack occurrence is signalized by a fuel leakage. Repair of the airplane in operation is possible, so such repair was made in the tested wing. The FEM stress analysis was performed in order to check the effect of the repair on the stress level in the wing spars – see Fig. 3.
