Problem of Clogging in Drainage Systems in the Examples of the Żur and Podgaje Dams

Witold Sterpejkowicz-Wersocki

Gdańsk University of Technology, Faculty of Civil and Environmental Engineering, ul. G. Narutowicza 11/12, 80-233 Gdańsk, Poland, e-mail: wste@pg.gda.pl

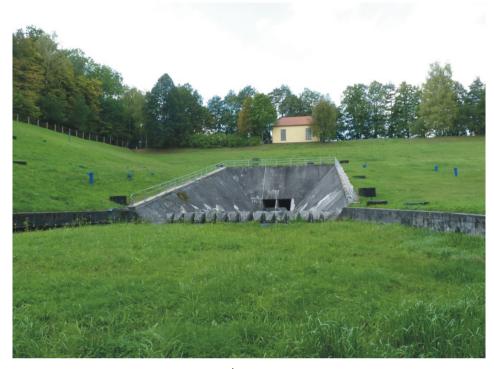
In the mid 1970s, a decision was made to build a new drainage system, as the rock toe filter had been clogged, and it was pointless to renovate the filtration capacity

Fig. 1. General view of the Żur earth dam and the bottom outlet

of the rip-rap that had worked since the beginning of the construction. There is no further information about the type of clogging. It was probably related to the development of vegetation, with layers of soil and root, and the consequent reduction in the permeability of the drainage prism at the base of the downstream slope of the dam.

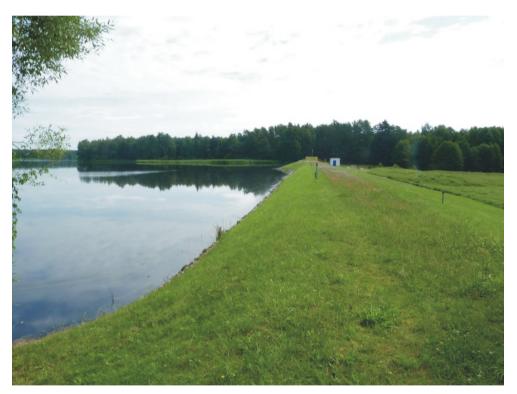
Fig. 2. General view of the Podgaje earth dam

This earth dam is also afflicted with cyclical drainage dysfunctions caused by clogging with iron compounds. Its present drainage system was constructed in 1991. It consists of ceramic drainage pipes, a sand filter, and a geotextile.

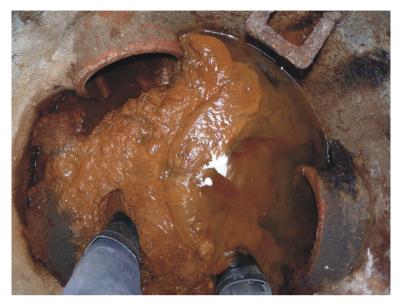
During operation, a slow but steady increase in pressure filtration can be observed. Inside wells and drainage pipes, clogging is caused by iron oxide in the form of fer-

Fig. 3. Ferruginous substance in a well

ruginous deposits, which reappear within a few months after being removed (Fig. 3 and Fig. 4).

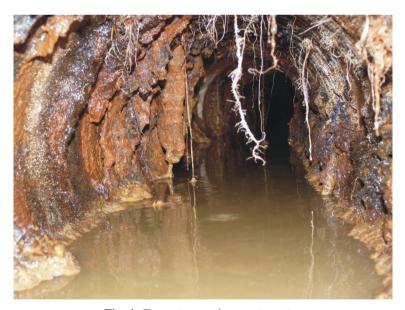
Fig. 4. Ferruginous substance in a pipe

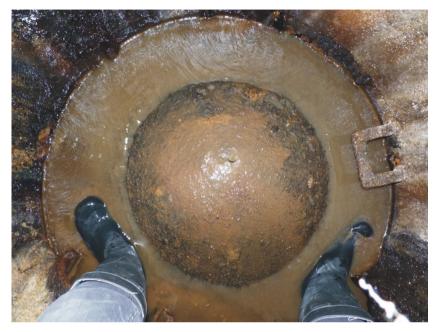
Some of the drainage wells have been mounted only on a geotextile (without a concrete plug). Inside the wells, a severe clogging of the geotextile can be observed, which

results in a bulge of the material (Fig. 5) caused by groundwater pressure, which is stabilized at a height of about 2 m above the bottom of the well.

Fig. 5. A bulge caused by groundwater pressure in geotextile at the bottom of a well

The technical condition of the drain and the observed upward trend of the phreatic curve clearly demonstrate the need to restore the drainage system. Under the existing conditions, it is impossible to protect the drain effectively against the precipitation of iron oxide, but measures should be taken to delay the consequences of progressive clogging.

These measures include the replacement of the geotextile as a drainage layer with classic mineral inverted filters. The author's experiences (Bolt, Sterpejkowicz-Wersocki 2006; Sterpejkowicz-Wersocki Szudek 2011, 2013; Sterpejkowicz-Wersocki 2013) regarding the effectiveness of geotextiles in filtration and drainage solutions indicate that the presence of ferruginous groundwater results in the formation of an impermeable film on the surface of geosynthetics. In other cases, geotextiles retain their function, acting effectively as filters.
