THE INFLUENCE OF FOUNDATION SOILS CONCERNING THE BEHAVIOUR OF BUILDINGS

M. Tudorică^{a,*}, C. Bob^b

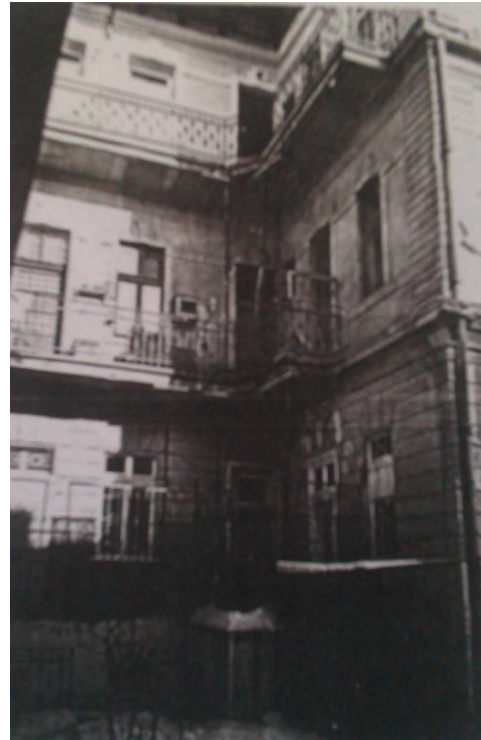
The damaged building illustrated in figure 1, was analyzed in accordance with the requirements of "Seismic Design Code - Part III - Provisions seismic evaluation of existing buildings, Sings P100- 3/2008", in order to place the construction in seismic risk classes.

Figure 1. The analyzed masonry building

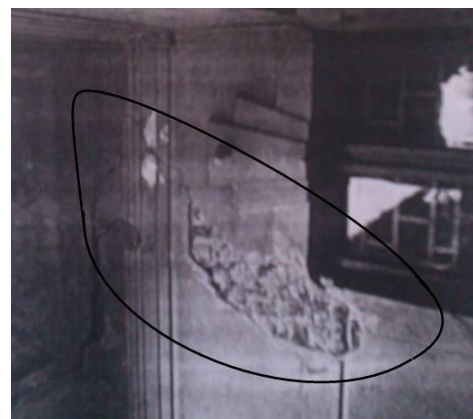
The main damages of the resistance structure can be grouped in 2 categories. The first category is represented by the cracks in the masonry bearing walls as seen in figure 2 and some cracks at the interior corners of the walls as seen in figure 3. The second category is illustrated by the corrosion and deformation of some metallic elements from the interior courtyard balconies and some slabs.

Figure 2. Cracks in masonry bearing walls

6th stage. Consolidation of walls with cracks or fissures, by fitting gibs Ø6 – Ø8 mm on the channel of fissures and injecting them with epoxy resins SIKAREPAIR.

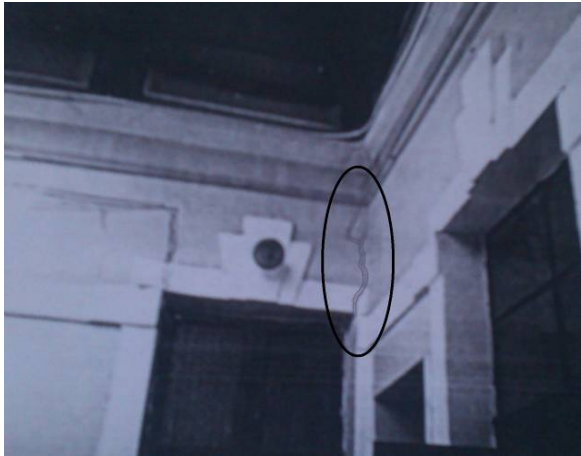
Figure 3 Cracks at interior corners of the walls

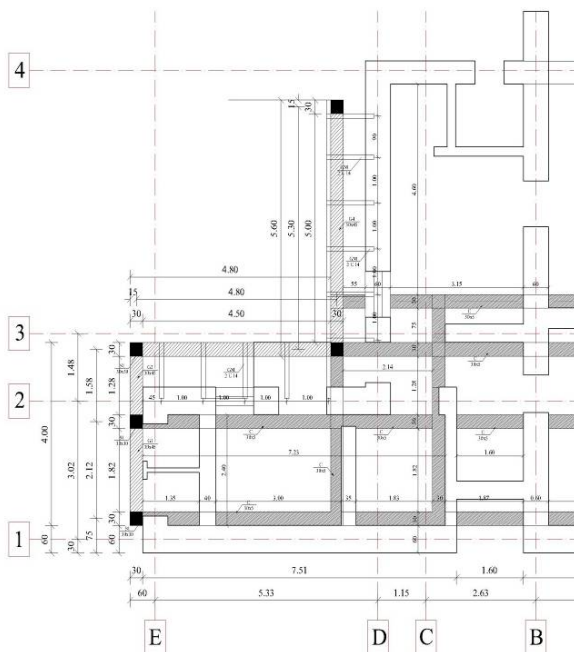
By the configuration and orientation of those cracks it can be concluded that the part of construction situated between axes B 1-3 and E 1-3 as seen in figure 4, was affected by a strong subsidence, with more pronounced tendency of subsidence at the blind wall E 1-3. This is illustrated by both cracks: first is an oblique crack from the blind wall, positioned on the building section D- E of row 1, second crack is in the lintels of the analyzed section.

Figure 4. Section analyzed between axes B 1-3 and E 1-3

Another factor that contributed to the degradation of the analyzed section is represented by the presence of a walnut tree about 15 m height placed near the blind wall E 1-2, which is found at the distance of 1.9 m from the analyzed building, as well as a tree placed at 7 m from the building.

This degradation factor is highlighted by the fact that the phenomenon of subsidence, that led to the occurrence of fissures and cracks, occurred predominantly in the influence area of the tree, on the section B 1-3 and E 1-3, as well as the building residents statements, like there were "slight fissures and apparent cracks" before 2001, when the arrangement of the building basement started.

1st stage. Cutting and uprooting the two trees located near the building. It is known that the tree roots remain active a long period after cutting the trees.

2nd stage. Soil consolidation by injection of laitance - bentonite in the ground under foundations, to increase the bearing capacity of the soil and to decrease the deformation capacity. There will be realised 144 points of injection of a cement-bentonite suspension under the existing foundations.

3rd stage. Execution of isolated foundations under the new columns of the reinforced concrete frame.

4th stage. Realization of reinforced concrete frames, with the purpose to stabilize the entire ensemble of the building.

5th stage. The reinforced concrete frames are connected to the existent structure through flat girdles 30x5cm (30cm wide and 5cm thick) placed at each level.
