Defects of copper patina

Stoulil J., Šedá P., Anisová M., Fencl Z., Novák P., Děd J.
University of Chemistry and Technology Prague,
Department of Metals and Corrosion Engineering
E-mail: jan.stoulil@vscht.cz

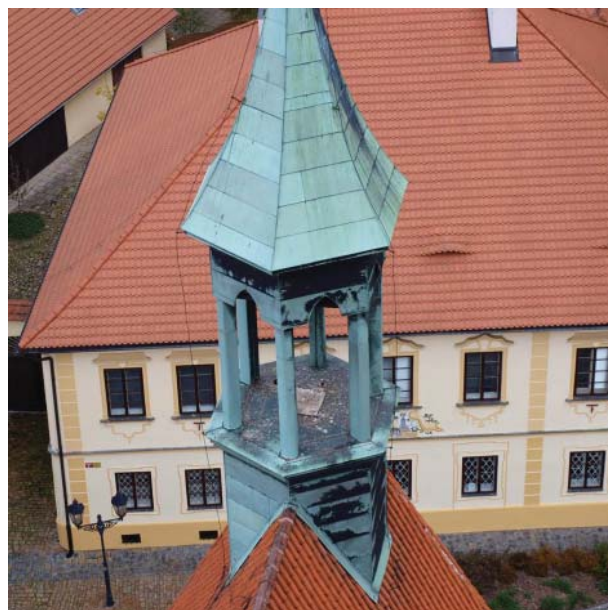
Fig. 1. The tower of the church of the Birth of the Virgin Mary in Písek

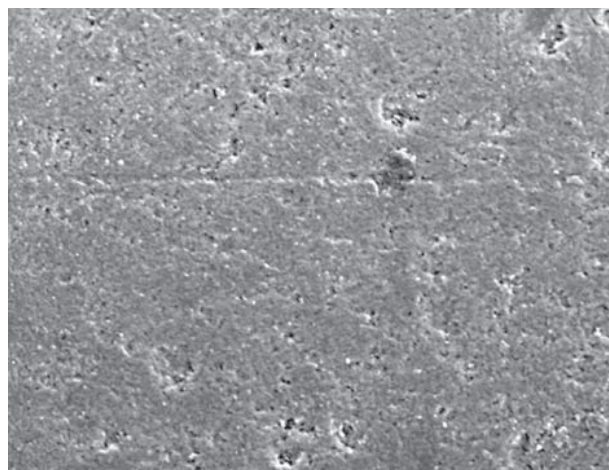
The surface of the samples was first observed by SEM. The surfaces of both green patina samples (from the University of Chemistry and Technology building and Queen Anne's Summer Palace) are flat (see Fig. 2 and 4) when compared to dark patinas (Fig. 3 and 5). The EDS analyses presented in Tab. 1 show the elemental

Fig. 2. SEM image of the UCT green patina surface
Obr. 2. SEM snímek povrchu zelené patiny z VŠCHT

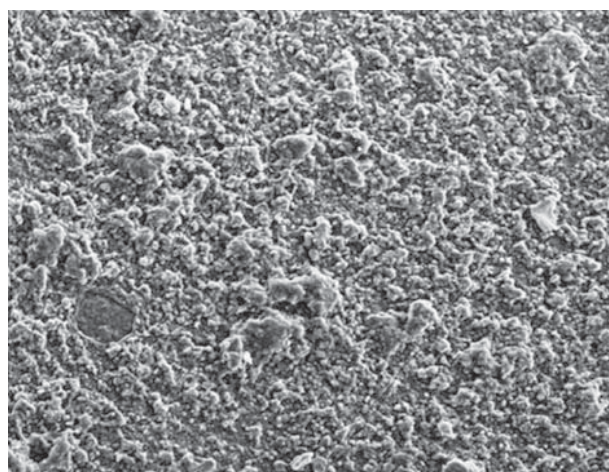
composition of patinas. Dark patinas contain more impurities, silicon and aluminium (dust), and less of the main elements for patina formation, copper and sulphur.

Fig. 3. SEM image of the UCT black patina surface
Obr. 3. SEM snímek povrchu černé patiny z VŠCHT

These species were probably present on the surface and they are the reason for the easier dissolution of substrate copper and consequently the rough morphology of the dark patinas.

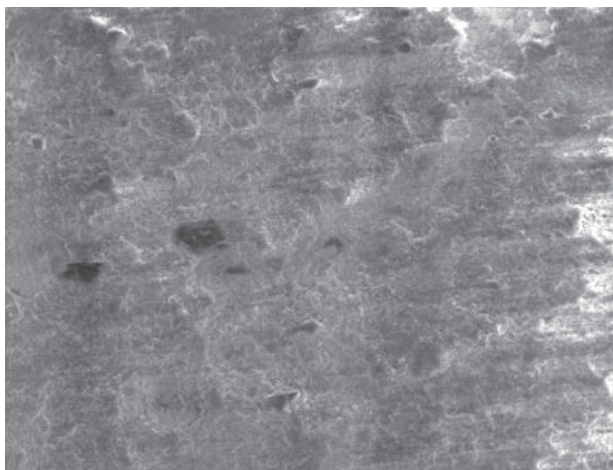
Fig. 4. SEM image of the Summer Palace green patina surface
Obr. 4. SEM snímek povrchu zelené patiny z Letohrádku královny Anny

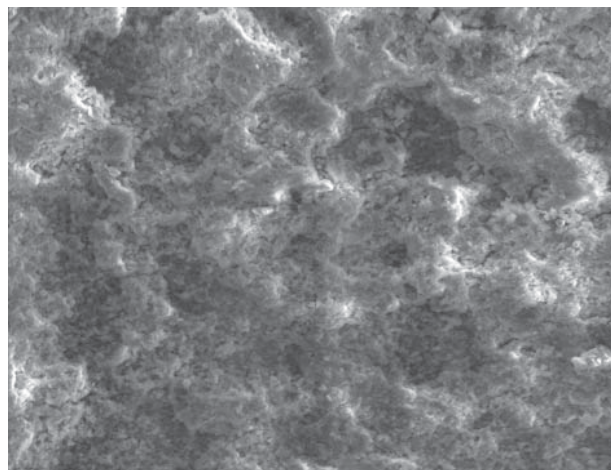
Fig. 5. SEM image of the Summer Palace black patina surface
Obr. 5. SEM snímek povrchu černé patiny z Letohrádku královny Anny

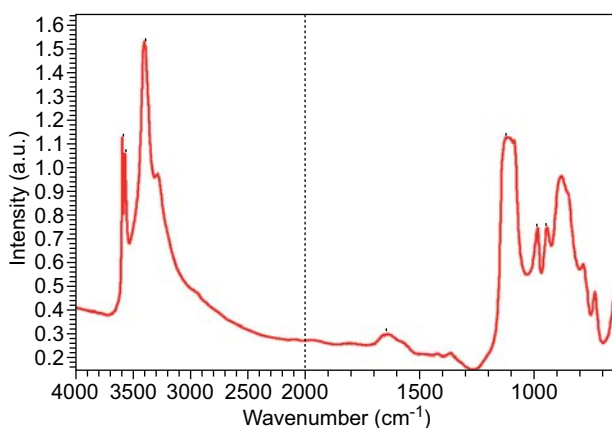
X-ray diffraction confirmed that both crystallographic lattices are based on brochantite. Infrared spectra are given in Fig. 6 and 7. FTIR showed the green patina is composed of pure brochantite while dark patina contains significant amounts of impurities (Fig. 7). Inert silicates were identified, but aggressive ions such as nitrates or ammonia cations were also present. These species are very aggressive to the copper surface. They work as chelating agents and they may have their origin in bird excrement. Nevertheless, these species were present in insoluble form. The increased presence of dust particles in dark patinas could be a consequence of their rough morphology. Conversely, the presence of insoluble nitrates and ammonia cations in the lattice of brochantite is evidence of their long period of formation.

Fig. 6. FTIR spectrum of the Summer Palace green patina sample
Obr. 6. Infračervené spektrum zelené patiny z Letohrádku královny Anny

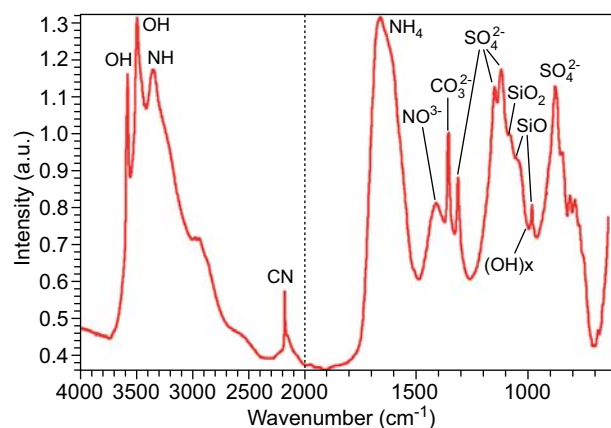
Fig. 7. FTIR spectrum of the Summer Palace black patina sample
Obr. 7. Infračervené spektrum tmavé patiny z Letohrádku královny Anny

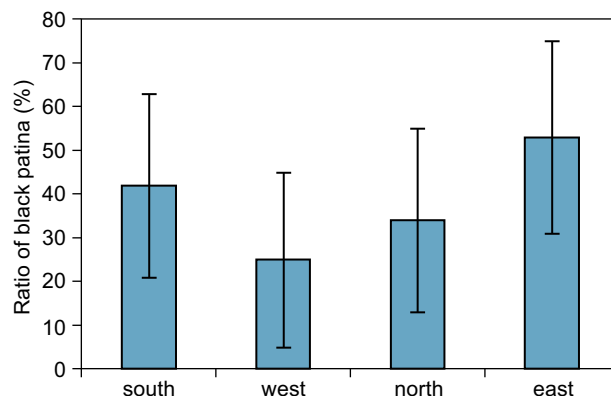
The results of image analyses are shown in Fig. 8. The highest ratio of dark patina is on roofs facing south and east. A lower ratio was found on north facing surfaces and the lowest in west facing surfaces. This corresponds well with the main direction of wind and rainfall in the district of Prague, west and northwest. Rainfall allows the washing of impurities from the surface of copper sheets.

Fig. 8. Ratio of black patina as a function of orientation (the ratio was estimated by image analysis of the roofs of 10 historical objects)

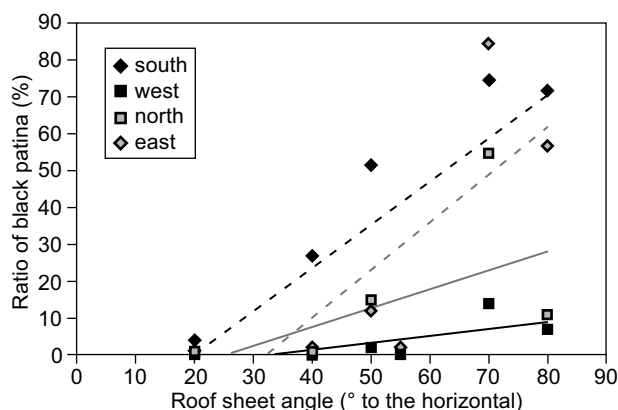
Even more obvious data was provided by analysis of the roof angle (see Fig. 9). The ratio of dark patina is

the same for low roof angles (close to horizontal). Sheets are well washed regardless of their cardinal direction. When roof angle increases, the ratio of dark patina increases especially in the south and east facing cases where washing is more difficult. A roof angle close to vertical decreases the degree of washing.

Fig. 9. Ratio of black patina as a function of a roof angle (the ratio was estimated by image analysis of the roofs of 3 historical objects)
