Condition evaluation of steel X65 in one of the sections of “Soyuz” gas main after long-term operation

Maruschak P.¹, Bishchak R.², Maruschak O.², Draganovská D.³, Pylypenko A.⁴

¹ Ternopil Ivan Pul'uj National Technical University, Ternopil

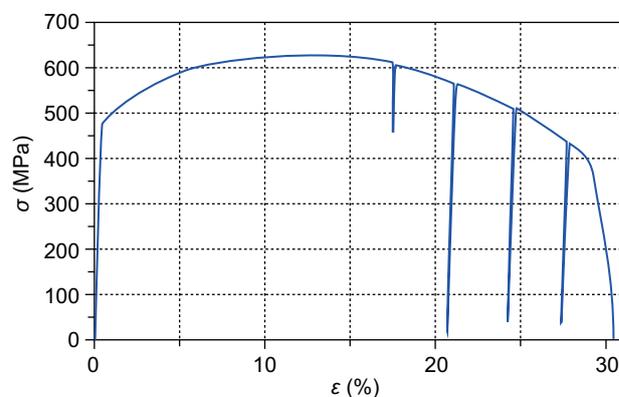
A complete stress-strain diagram was constructed. It was found that the X65 steel has sufficient strength and plasticity at the macro level (Fig. 2). This is evident because the diagram is sufficiently long, that is, the plasticity of the material allows it to accumulate microstructural defects and microcracks on a sufficiently large area.

This indicates the accumulation of insignificant scattered structural damage, which slightly affects the variation of the mechanical properties of the pipe steel of the gas main. Several unloadings were made on the descending area, which allowed detecting the degradation of the elastic modulus as a result of accumulation of structural defects and pores.

Fig. 2. Complete stress-strain diagram of exploited steel X65 of the Soyuz gas main

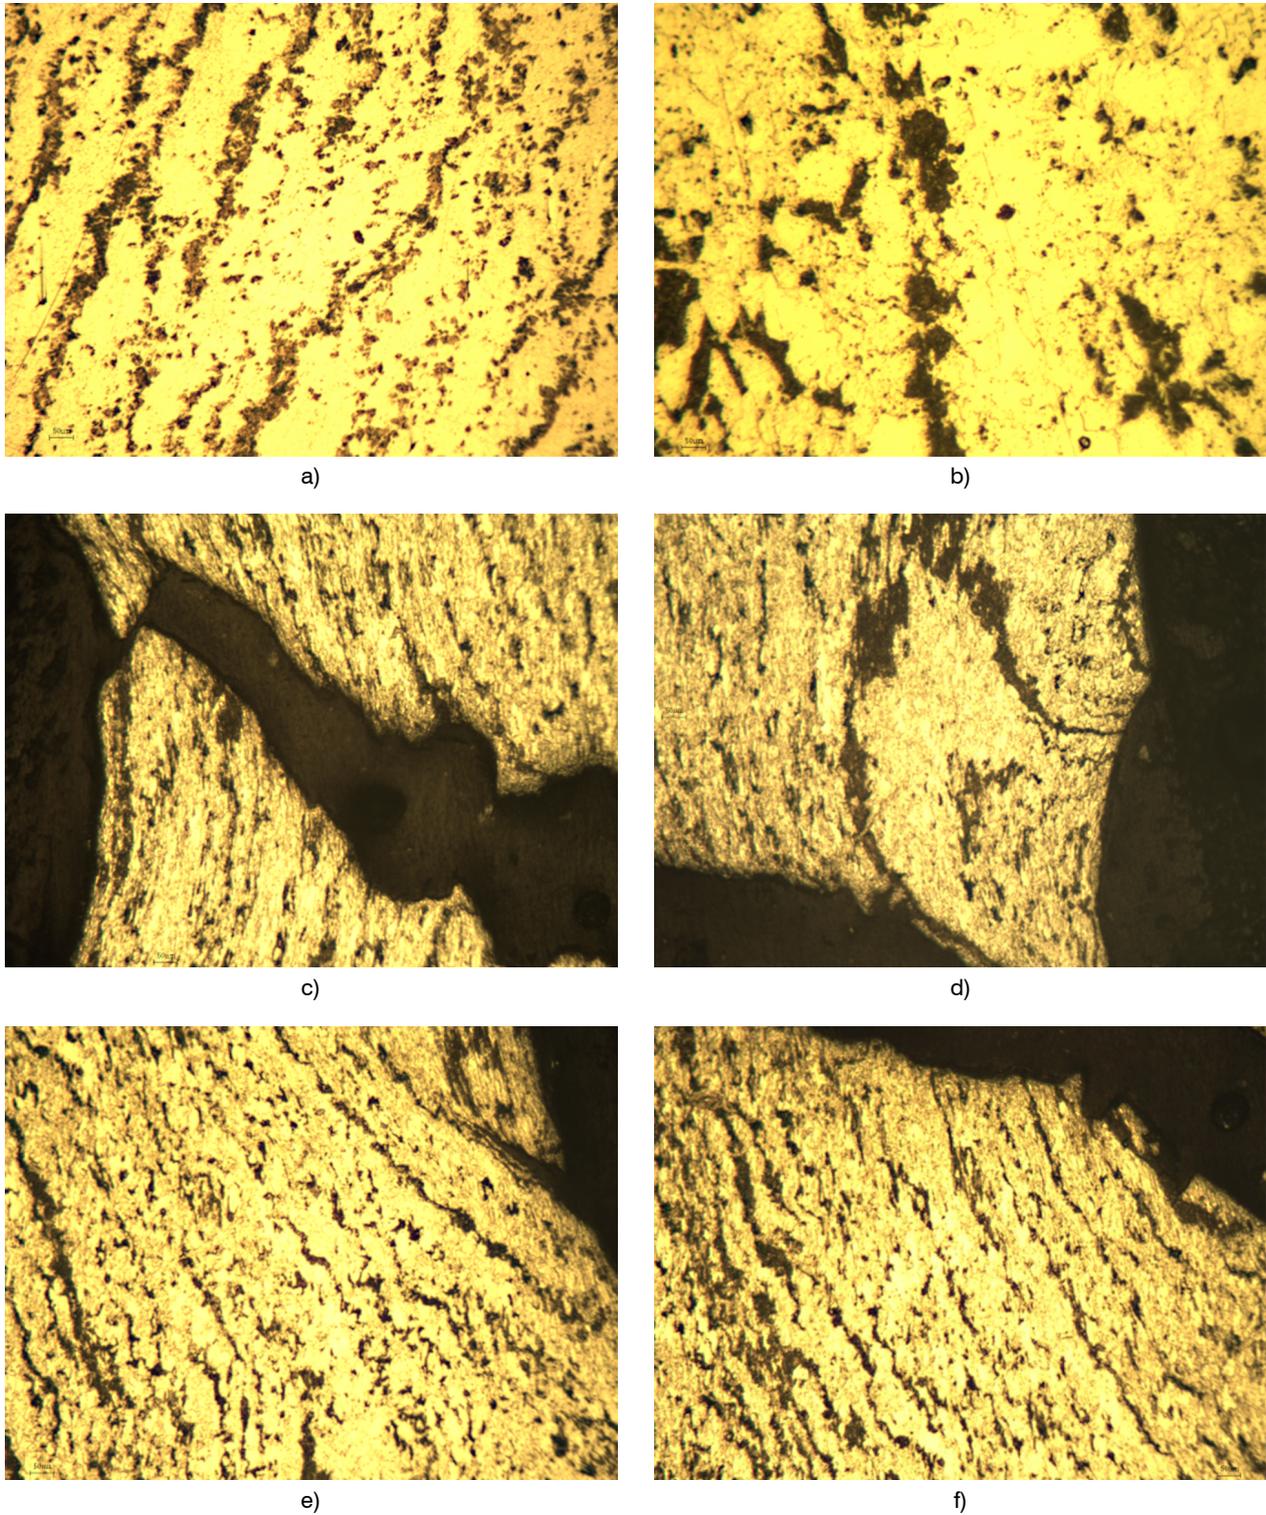
Metallographic investigations of the steel of the gas main revealed that steel X65 has a ferrite-perlite structure, there are some stripes obtained as a result of controlled rolling (Fig. 3a,b). In the macroanalysis of the trenches of the destroyed specimens of the exploited steel, numerous pores and separate microcracks were found in the zone of fracture. This indicates the localization of

the deformation process, as well as the coherent impact of the separation and tear mechanisms. In the vicinity of the lateral surfaces of the specimen neck were identified zones of structural heterogeneity, which may have been sections of the specimen delamination. Fragmentation and deformation of the structure were revealed along with the occurrence of local delaminations, indicating a significant energy dissipation during the propagation of the macrocrack (Fig. 3c,d).

A high degree of disorientation of the material structure in the vicinity of the crack front is evidenced by metallographic images. The lack of clarity and “blurriness” of the structural components is due to the deformation localization and significant deformation in the zone of the specimen fracture, indicating its high plasticity. It is noticeable that macro- and microfracture of the exploited steel X65 is ductile in general and was accompanied by significant plastic deformation. Both in the initial and exploited states, the steel was destroyed by the typical ductile mechanism of nucleation, coalescence and growth of cavities due to the elongation of interstices between cavities to rupture. At the same time, against the background of the dimple-like relief, we found the breakage texture in the exploited steel, which is associated with the rolling direction of the pipe steel. Defects in the form of stratifications oriented along the same direction were found on breakages. Such stratifications, in our opinion, were the result of the formation of scattered damage under the influence of rigid force conditions of the long-term exploitation of the steel in the gas main (Fig. 3c,d). They were formed due to the weakening of the bonds between the structural components of the steel across the pipe wall, making it easier to separate them [11]. In the image presented in Figure 3e,f, it is noticeable that the breakage has deformed grains, as well as the grains that fell into the zone of polishing the pores and cracks, which clearly illustrates a decrease in the deformation resistance of the material during the growth

Fig. 3. Structure of steel X65 after 30 years of operation of the Soyuz gas main: a), b) in the non-deformed and c) – f) deformed states ($\times 400$)

conditions for macrofracture of the specimen. It should be noted that the analyzed pipe steel contains a number of microdefects and scattered damage, however, they slightly affect the mechanical properties of the material, which has a satisfactory load-bearing capacity and crack resistance, as evidenced by experiments. Thus, the processes of deformation and fracture of the exploited material are described in this paper, and the mechanisms of accumulation of structural defects are generalized based on the use of the method of complete stress-strain diagrams and metallographic analysis.
