Evaluation of mechanical properties of gas pipeline DN 500 after more than 40 years of its operation

Hagarová M.¹, Jakubéczyová D.², Baranová G.¹, Fujda M.¹

¹ Institute of Materials and Quality Engineering

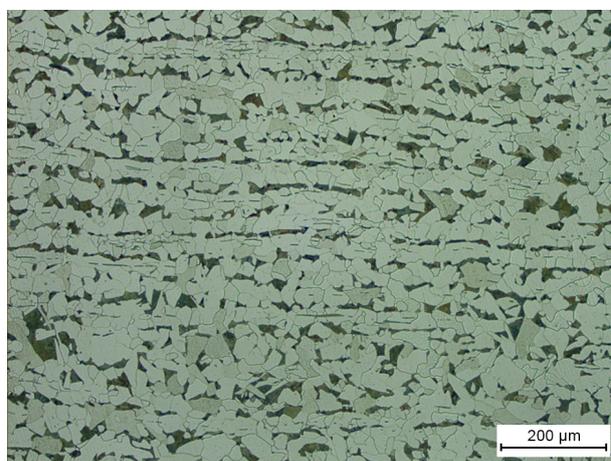
Microstructure of steel in the direction parallel to the longitudinal axis of the pipe was banded pearlitic-ferritic with the grains of non-uniform size, as documented in Figure 2. The values of the mechanical

Fig. 2. Ferrite – pearlite banded structure of P295 GH steel (LM)
Obr. 2. Feriticko – perlitická riadková štruktúra ocele P295 GH (LM)

- Microstructure of steel in the direction parallel to the longitudinal axis of the pipe was banded pearlitic-ferritic with the grains of non-uniform size.

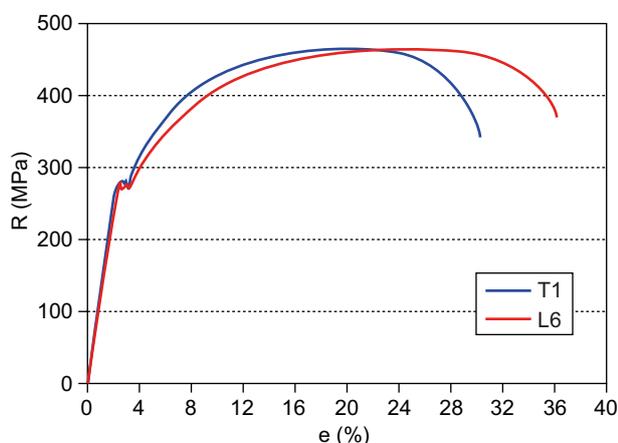
characteristics obtained by the tensile test according to the standard EN ISO 6892-1:2009: yield strength R_e , tensile strength R_m and elongation A_5 of specimens (L) directed parallel with the longitudinal pipeline axis were following: $R_e = 275$ MPa, $R_m = 464$ MPa and $A_5 = 27.6$ %. The values of the mechanical characteristics of specimens (T) directed perpendicular to the longitudinal pipeline axis were: $R_e = 280$ MPa, $R_m = 465$ MPa, $A_5 = 33.0$ %. The measured values are presented in Table 2. The values of elongation A_5 measured in directions L and T (according to Table 2) differed due to anisotropy of properties resulting from the texture of the material processed by rolling and distribution of inclusions elongated in the direction of steel rolling.

This is a general phenomenon related to texture, orientation of structural components in the direction of forming, braking effects of grain boundaries during the movement of dislocations at plastic deformation, etc. [23]. Comparison of the measured values of strength characteristics of the initial and exposed material allowed us to conclude that the exposure of the test material during the operation only slightly increased the yield strength but on the other hand led to increase in its ductility, as shown in Table 2. The graphical illustration of the tensile test diagram is illustrated in Figure 3.

Fig. 3. Comparison of mechanical properties of samples oriented parallel (L) and perpendicular (T) to the longitudinal axis of the pipe

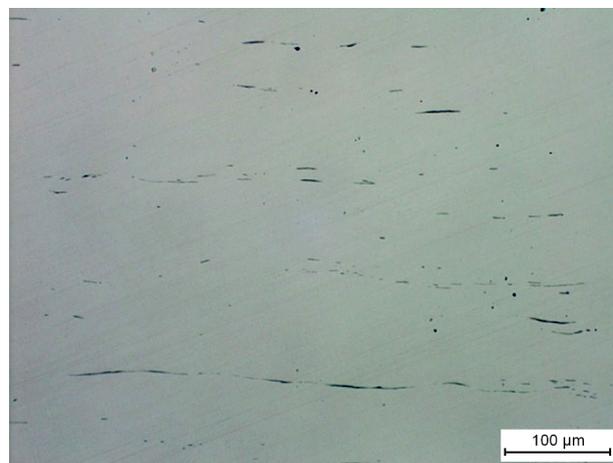
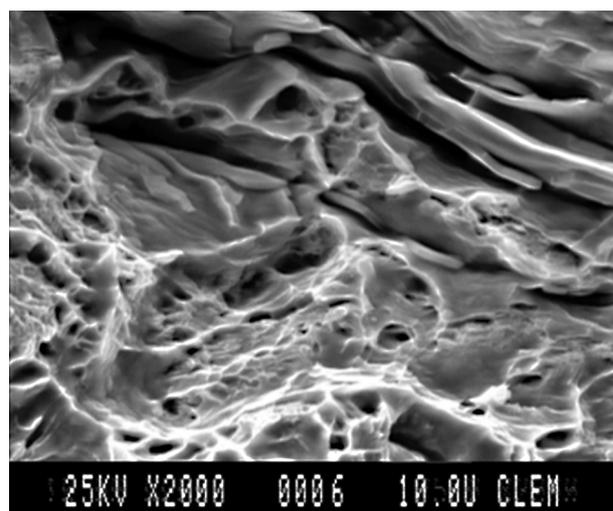
In Figure 4 are documented inclusions which affected a fracture initiation places elongated in the direction of rolling. The area of elongated inclusion particles in the direction of rolling was bigger and thus the load-bearing cross section of specimens collected in

Fig. 4. a) The presence of inclusions elongated in the direction of steel rolling. Magn. $50\times$ (LM); b) The fracture surface of steel with inclusions elongated in the direction of steel rolling (SEM)

the direction perpendicular to direction of forming was reduced, which was reflected in de-creased ductility.

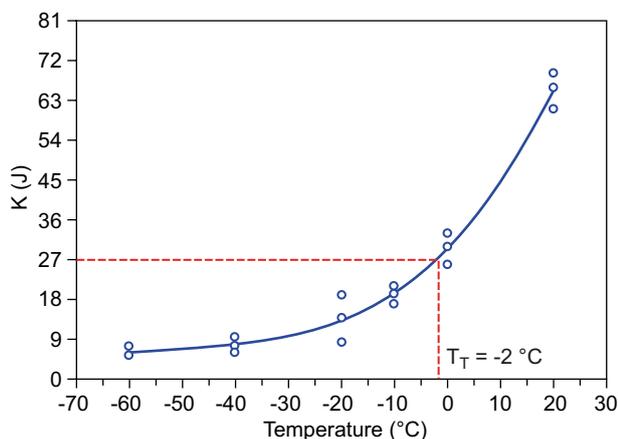
The values of absorbed energy K obtained by Charpy impact test are presented in Table 3. We used the measurements of absorbed energy to construct a transition curve, which is presented in Fig. 5. According to the criterion of absorbed energy $K = 27$ J, the transition

Fig. 5. Transition curve constructed on the basis of absorbed energy criterion

temperature reached the value $T_1 = -2$ °C. The lowest operating temperature of the pipeline is +4 °C in winter months. From the point of view of technical practice it is important to ensure that loading of the material takes place above the transition temperature (T_1) [24].

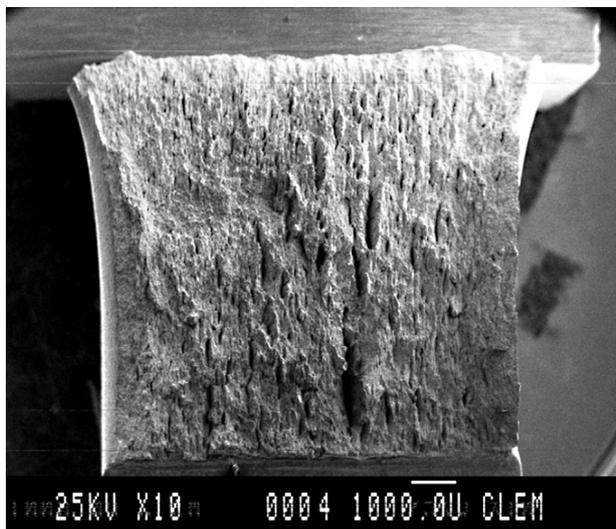
Fig. 6. Morphology of the specimen fracture surface fractured at 20 °C

Decrease in absorbing energy at individual temperatures is well reflected in the character of the fracture surface of the tested samples. Figure 6 shows the fracture surface of the specimen fractured by Charpy pendulum at 20 °C. The fracture surface is rough; higher energy was needed to cause specimen failure. We could observe mostly transgranular ductile fracture with dimple morphology in which lines of elongated dimples oriented in the direction of rolling were visible. EDX analysis identified the presence of iron and manganese sulfides of type (Fe,Mn)S in the holes of fracture surface (Fig. 7).

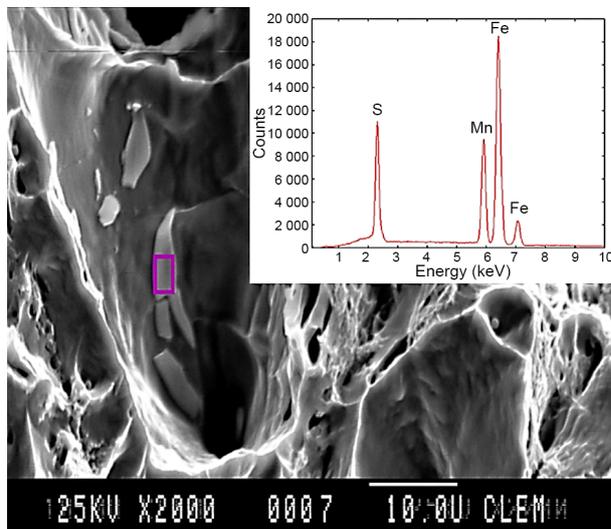
Fig. 7. Inclusions located in the dimples of ductile fracture

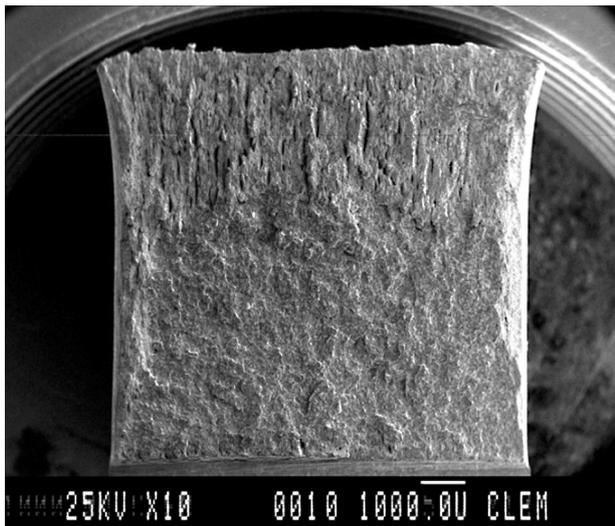
Figure 8 shows the fracture surface of the specimen broken at 0 °C. The relief of fracture surface is less pronounced in comparison with fracture surface illustrated in Fig. 6. Fracture of this specimen after Charpy impact caused only minimal plastic deformation of specimen edges. These observations corresponded to the lower value of absorbed energy necessary for specimen failure.

Fig. 8. Morphology of the fracture surface of the specimen fractured at 0 °C

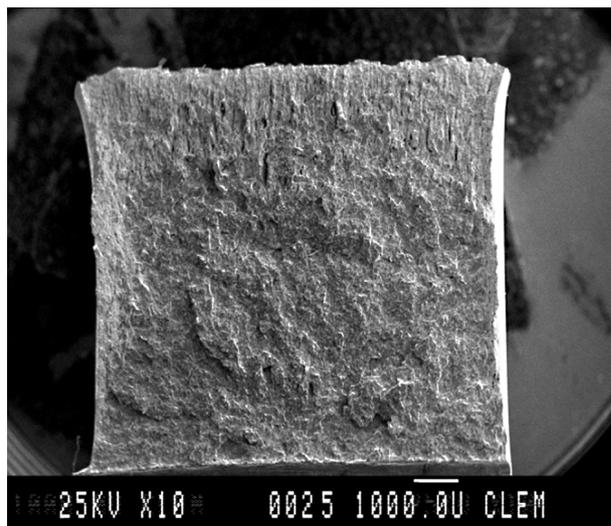
Fig. 10. Morphology of the fracture surface of the specimen fractured at -10 °C

Figure 10 illustrates the fracture surface of the specimen broken at -10 °C. The fracture surface appears to be embossed and specimen edges show little deformation. Fracture surface in Fig. 11 is composed of transcrystalline cleavage facets.

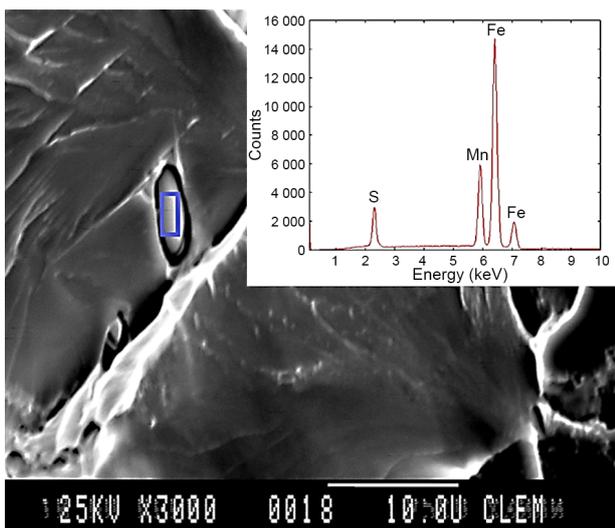
Fig. 9. Detail of the morphology of inclusion particles on the fracture surface

Figure 9 shows a transgranular character of the fracture surface of specimen fractured in a brittle manner. Fracture surface comprises facets of transgranular cleavage and the inclusion (Fe,Mn)S were located in the area of a cleavage facets.

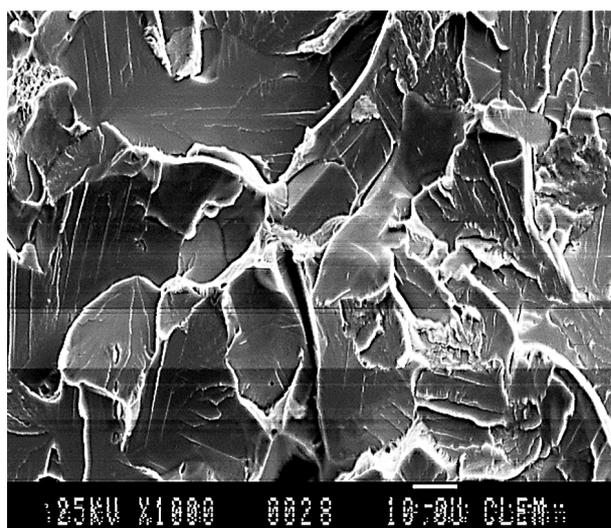
Fig. 11. Facets of transgranular cleavage
