EVALUATION OF DAMAGE AND DEFORMATION
OF RT-32 RADIO TELESCOPE

R. Joffe, N. Jēkabsons*, A. Bērziņš, M. Klapers, S. Upnere

Engineering Research Institute "Ventspils International Radio
Astronomy Centre" of Ventspils University College,
101 Inženieru Str., Ventspils, LV-3601, LATVIA
*e-mail: normundsj@venta.lv

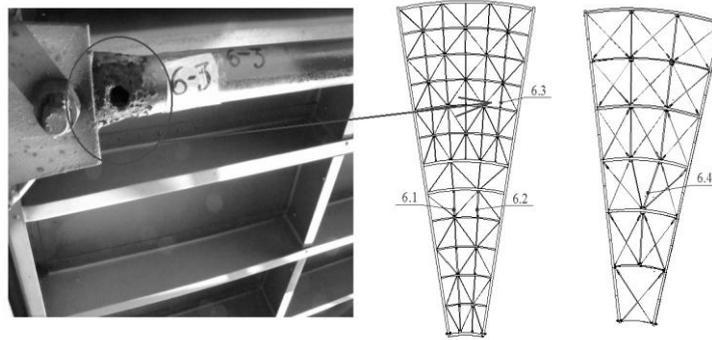
Fig. 2. Corrosion of small/medium beams near the holes for water evacuation.

The results of the complete mapping of damage show that most of the corrosion in the structural elements has formed around the holes that were drilled in order to evacuate the water accumulated in the hollow pipes (beams). The water in pipes most likely accumulated due to condensation but also due to precipitation (rain, snow etc.) which penetrated pipes through microcracks and other defects. The hole drilling in the original structure was performed by the former owners of telescope (Soviet Army). When analyzing the location of holes we revealed that – in general – the drilling had not been done in the optimal places of beams, and many holes are located above the bottom of pipes thus forming cavities from which water could not escape. Moreover, in some dish segments the holes in the beams were drilled in the upper rather than bottom part of the structure, which means that water was rather accumulated than evacuated. This undoubtedly caused much more rapid damage initiation and spread of corrosion over a considerably larger area. It should also be noted that – perhaps – after the drilling the freshly exposed metal was not treated (coated) in any way, thus creating the points for corrosion initiation.

The supporting substructure for the mirror consists of 6886 elements (beams). Analysis of this substructure has shown that 183 elements are severely damaged and have to be replaced in the nearest future. The majority of damaged beams (~75%) are located in the upper part of the structure, with the highest level of damage in segments 13, 14, which are located in the upper right quarter (see Table 1 and Fig. 1). The cause of such uneven distribution of damage can be attributed to the poor choice of location for the holes to evacuate water, as mentioned above.

hollow beams thus causing premature corrosion of metal. Most likely, this is also the reason why the damage is not distributed evenly across the mirror supporting substructure – in some segments of the dish upper part the damage is much more spread than in bottom segments. Even if most of the damaged elements do not pose immediate threat for the structural integrity of the antenna, the severely damaged beams and joints have to be replaced as soon as possible to ensure safe and precise operation of the telescope.

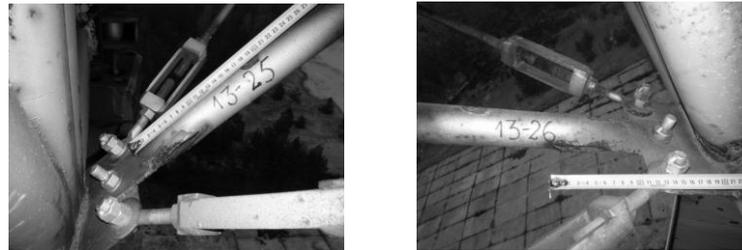
1. Corrosion of small/medium beams near the holes for water evacuation (Fig. 2).
2. Splitting of large/medium beams, most likely caused by internal ice pressure (Fig. 3). This type of damage is most often observed at the ends of beams.
3. Corrosion in the areas adjacent to the joints of multiple beams (Fig. 4).

Fig. 3. Splitting of a large/medium beam.

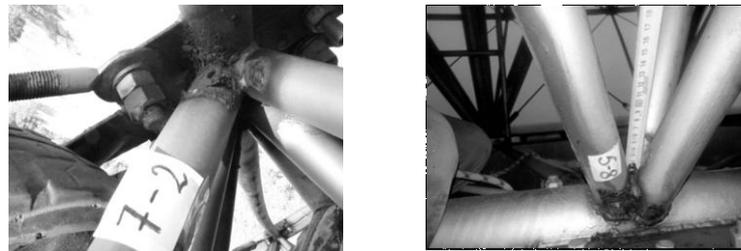
Fig.4. Corrosion in the areas adjacent to the joints of multiple beams.

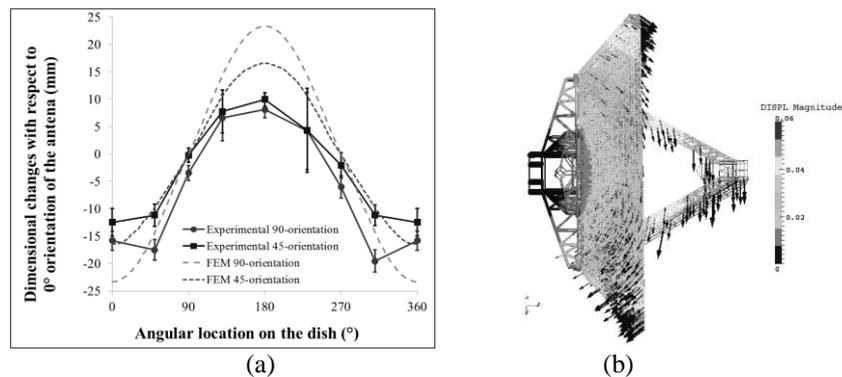
Fig. 6. Results of FEM calculation: the displacement on the circumference of the dish (a); overall distribution of the whole antenna’s displacements (b).

The numerical simulation results for undamaged antenna are presented in Fig. 6 as the displacement on the dish circumference (Fig. 6a), and the overall distribution of displacements for the whole antenna structure (Fig. 6b). These results fit fairly well the experimental measurements – the total maximum displacement is in the order of 15...25 mm.

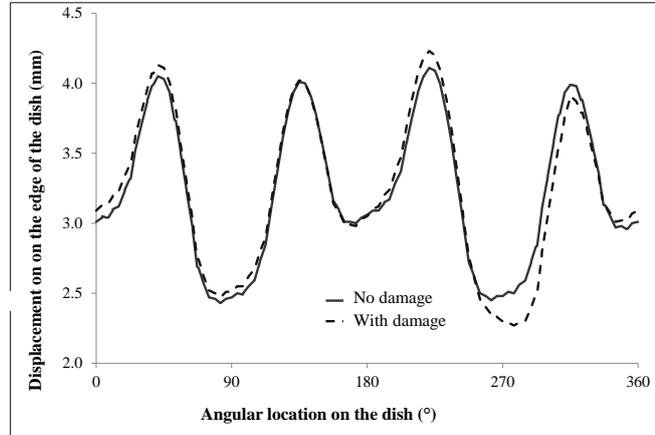
Fig. 7. Results of FEM calculation: the displacement on dish circumference for the antenna with and without damage.

The results presented in Fig. 7 show the total displacement within 2.5... 4 mm; there is no significant difference between the displacements of antenna edges in the cases with and without damage. The largest differences are observed around point D (270°) on the dish (Fig. 5b), which corresponds to sectors 13 and 14 of the antenna (see Fig. 1). As the results presented above (Table 1) show, these sectors had the largest number of damaged elements.

The analysis of displacements on the dish edge calculated by FEM for the antenna oriented vertically up (0°-orientation) has shown that the influence of damaged elements on the total displacement is only minor (practically negligible), except for the highly damaged areas (sectors 13 and 14).
