Performance evaluation of a rectifier column using gamma column scanning

Abstract. Rectifier columns are considered to be a critical component in petroleum refineries and petrochemical processing installations as they are able to affect the overall performance of these facilities. It is deemed necessary to monitor the operational conditions of such vessels to optimize processes and prevent anomalies which could pose undesired consequences on product quality that might lead to huge financial losses. A rectifier column was subjected to gamma scanning using a 10-mCi Co-60 source and a 2-inch-long detector in tandem. Several scans were performed to gather information on the operating conditions of the column under different sets of operating parameters. The scan profiles revealed unexpected decreases in the radiation intensity at vapour levels between trays 2 and 3, and between trays 4 and 5. Flooding also occurred during several scans which could be attributed to parametric settings.

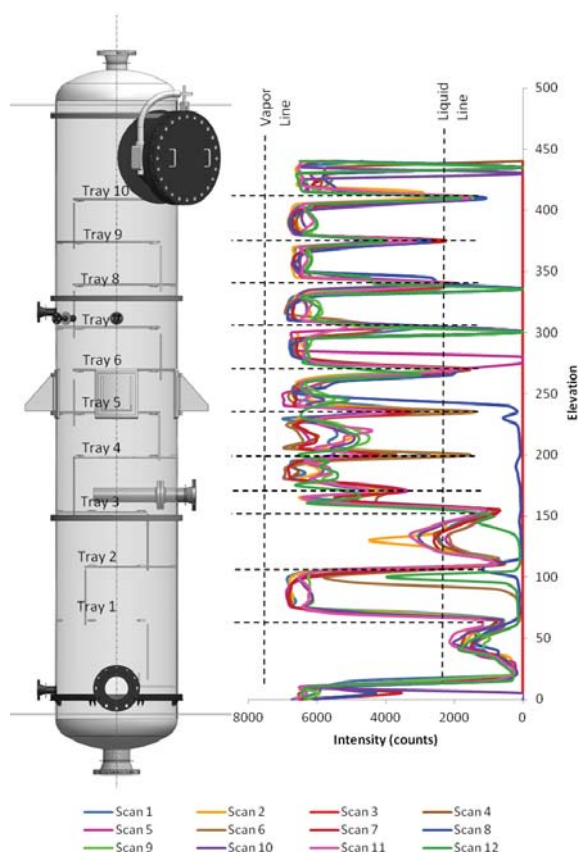
Fig. 3. Resulting density profiles for each scan.

Scan 1 reflects the presence of all trays at their respective positions. Interestingly, the intensities dropped at the vapour level between trays 2 and 3, and between trays 4 and 5. Radiation intensities at these levels are expected to be high since there are no obstructions along the pathway of the gamma rays. These same observations were also present in scans 2, 4–7 and 9–11. The low radiation intensities that were detected may be due to a high liquid level due to weeping, foaming or a blockage. Low radiation intensity readings were also recorded just below tray 1 in these scan lines which could indicate a high liquid level at the bottom of the column or a high density material below the tray obstructing the gamma rays along the pathway.

Flooding conditions were observed during scans 3, 6, 8 and 12. During scan 3, flooding started in tray 1 and reached up to tray 7. Flooding during scan 6 reached tray 1, while during scan 8, it reached tray 5. During scan 12, flooding rose up to tray 2. The differences in the height of the tray up to which flooding occurred could be attributed to the varying feed-rate settings during the scans.

The gamma column scanning technique was used to determine the operating conditions of a rectifier under various process parameter settings. Twelve scan lines were plotted to represent the conditions inside the column under twelve parameter settings set by the operators. Scan lines 1–2, 4–7 and 9–11 indicate unexpected low radiation intensities at the vapour level between trays 2 and 3, and between trays 4 and 5. This could indicate a high liquid level due to foaming, weeping or a blockage.

The technique was also able to identify the occurrence of flooding under certain parameter settings as reflected in scan lines 3, 6, 8 and 12. This could possibly be attributed to the parameter settings such as the different feed rates as well as the presence of a blockage along the pathway of the liquid flow.
