# PRODUCTION ENGINEERING ARCHIVES

## An analysis of the causes of track twist at high speed of driving

Andrzej Pacana<sup>1</sup>, Dominika Siwiec<sup>2</sup>

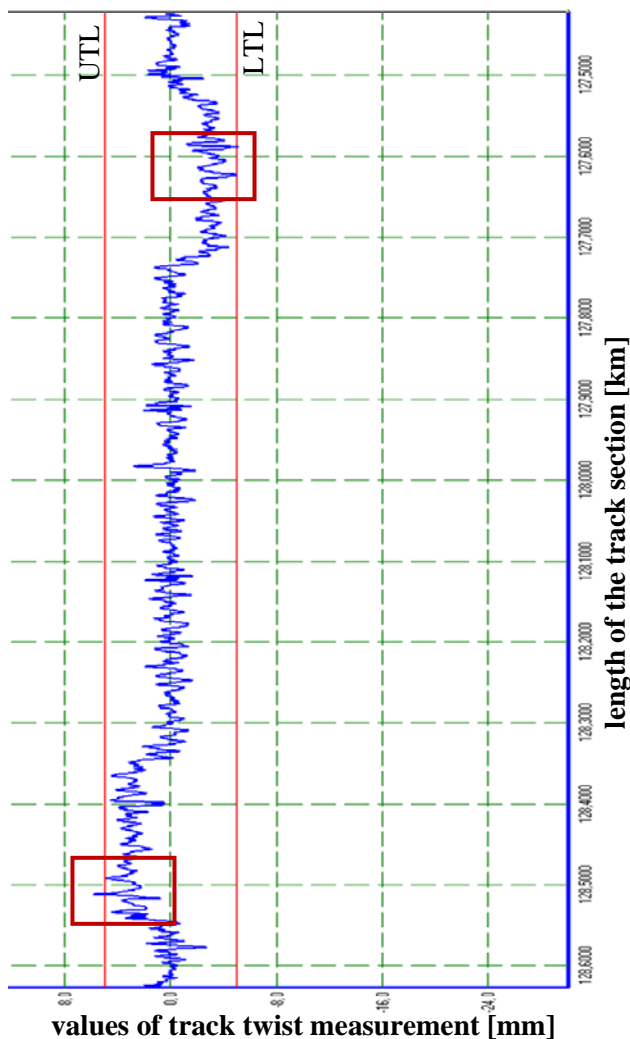
After analyzing the results from the geometric measurement of the track in the case of achieving the possible speed of 180 km/h the track twist was identified (fig. 3). Three values occurred that were not within the tolerance limit of the admissible deviation of track twist. The first value, which was not within the upper tolerance limit (UTL) amounted 6,25 mm and it occurred on the measuring section at the point of 127,5120 km. The second and third value, which was not within the lower tolerance limit (LTL) of the admissible deviation of track twist amounted respectively -6,05 mm and - 6,09 mm and they occurred on the measuring section of, respectively 127,6240 km and 127,5900 km.

**Fig. 3.** An example of a chart for twisted track at a rail vehicle speed of 180 km/h for the total measurement performed on a 1,1270 km section. Own study

The first of the track (from 128,5470 km to 128,3400 km) was characterized by the values of track twist significantly close to the upper tolerance limit of the admissible deviation of track twist (6 mm). While the second section of the track

(from 127,7130 km to 127,5350 km) was characterized by the values of track twist significantly close to the lower tolerance limit of the admissible deviation of track twist (-6 mm). It was concluded that in the case of achieving the possible speed of 180 km/h on the section track which was analyzed, the track twist occurred and it could be problem in the view of safety and the comfort of driving a rail vehicle. In order to identify the potential causes of the problem (the track twist) the Ishikawa diagram was drawn up (fig. 4).

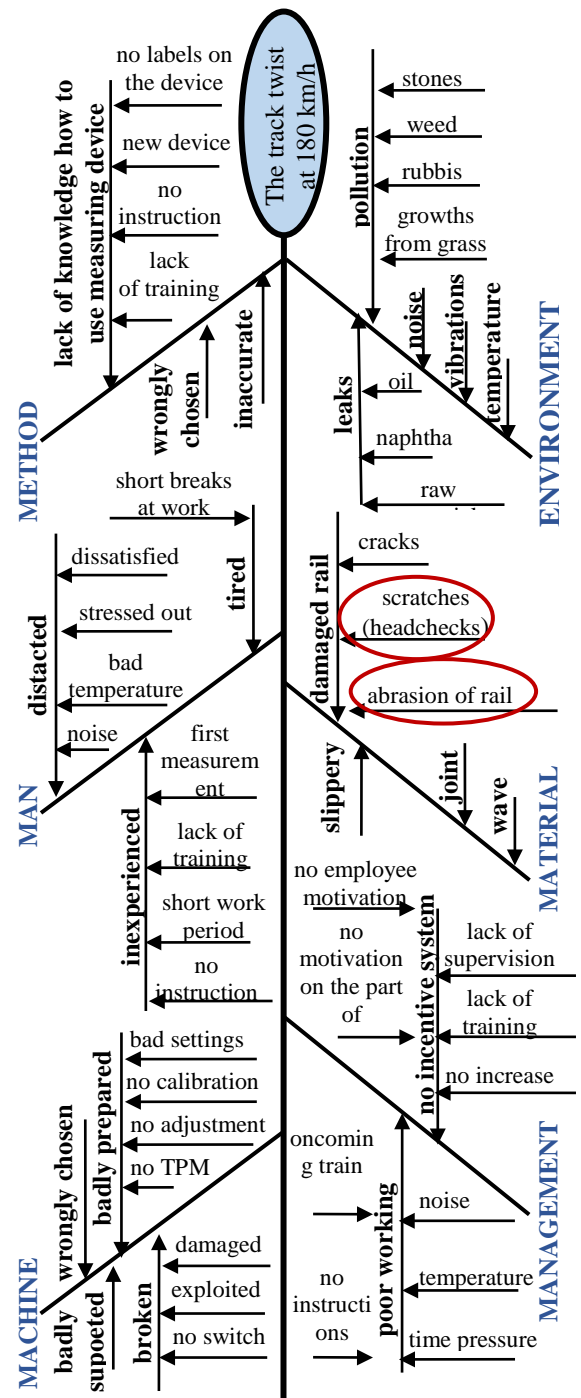
**Fig. 4.** An example of Ishikawa diagram for the analyzed problem. Own study

After analyzing the problem (the track twist at the speed of 180 km/h occurred) by using the Ishikawa diagram it was concluded that the main causes of the problem are scratches (the so-called headchecks) and abrasion of rail. These inconsistencies occurred locally on the rolling surface and both side surfaces of the head of the rails (Guide, 2017). The scratches, or headchecks, developed mainly in the arches with radius of 600 – 1000 m. The abrasion of rail appeared as local wipe-down of rails, which resulted from start of heavy trains. These faults occurred at the depths ranging from a fraction to a few millimeters from the surface of the rail (Bałuch, 2009; Grulkowski, 2014; Stencel, 2016). In order to identify the source cause of the problem (the track twist) the 5Why method was applied (fig. 5).
