## THE SUPPORT OF UNDERWATER WORKS WITH THE USE OF REMOTELY OPERATED VEHICLES ON THE EXAMPLE OF WORKS CONDUCTED ON THE WRECK OF THE FISHING BOAT WŁA-127

Marek Dawidziuk<sup>1)</sup>, Adam Olejnik<sup>2)</sup>

### ABSTRACT

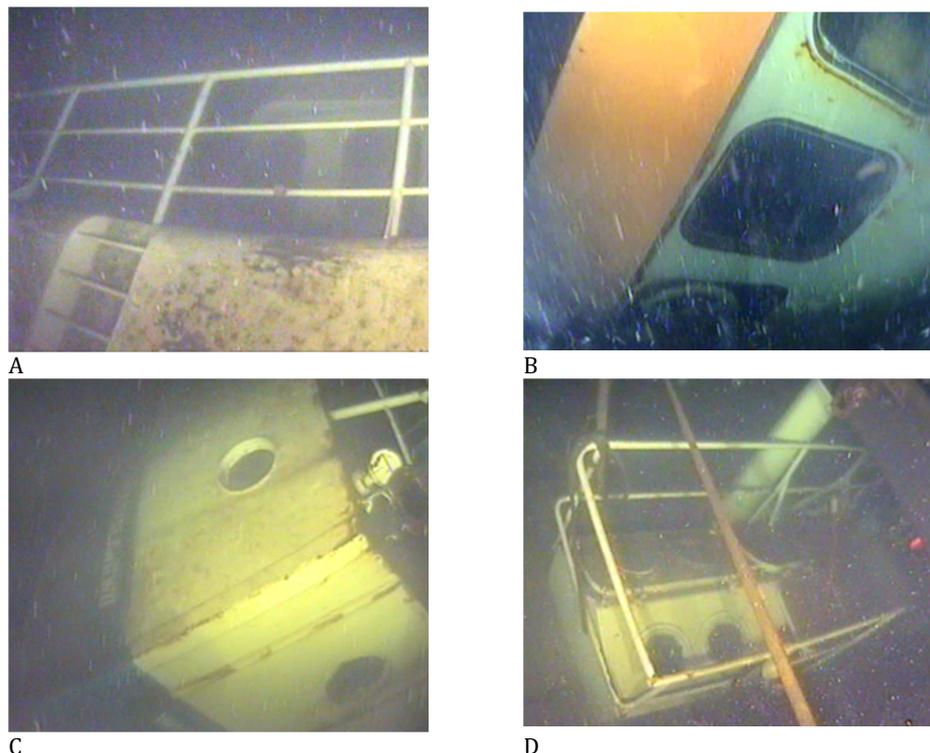
Fig. 4. Structure elements of the sunken boat shown in underwater position using the vision system installed on the Falcon ROV (own studies). A – companionway on the port side amidships, B – superstructure, C – stern, D – stern, engine room skylights.

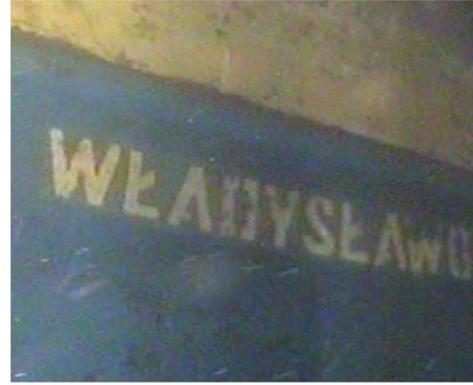
The definitive element confirming the identification of the wreck sought was the well-visible name of the wreck "WŁA-127" on the bow section of the widoczna nazwa wraku „WŁA-127” w części dziobowej na lewej burcie i desce trałowej, jak również nazwa portu pochodzenia „WŁADYSŁAWO” na jego rufie (Rys. 5). port side and trawl board as well as the name of the port of origin "WŁADYSŁAWO" on its stern (Fig. 5).

Fig. 5. Identification inscriptions on the hull of the sunken boat (own research).

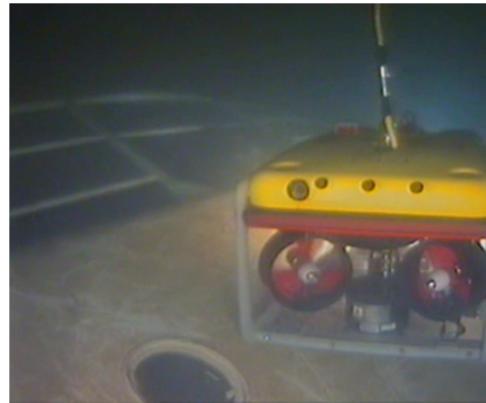
An inspection of the outer hull was initiated with a visual inspection on the port side of the wreck (Fig. 6). The first surveyed areas were the midships and the bow section. The inspection consisted in an assessment of the

shell condition for any dents, damage, leaks, or the condition of the fishing boat equipment.

Fig. 6. The Falcon ROV during WLA-127 wreckage inspection (own studies).

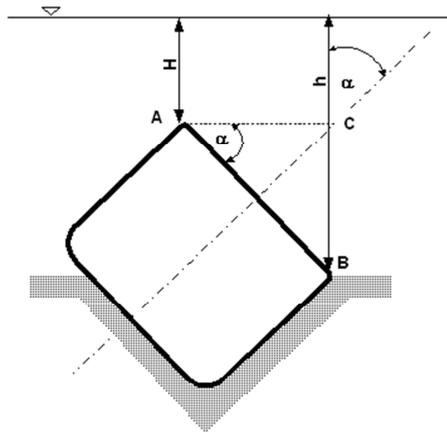
One of the tasks carried out during the inspections was to determine the angle of heel of the wreck by the ROV operator. Analysis of the pictures of the stem and mast allowed only an estimation of this angle. Additionally, using the vertical propulsion drive, the vehicle was "glued" to the ship's side to read the vehicle's tilt angle from the on-board navigational unit which then corresponded to the tilt angle of the wreck. Measurement of this parameter was also made indirectly using the methodology based on two depth measurements conducted with the use of the vehicle's on-board devices (Fig. 7).

Fig. 7. Graphical representation of the wreck position for calculating its heel angle based on two depth measurements (schematic diagram without a scale).

A depth gauge mounted on the vehicle was used to measure depths at point A and point B, then using the known AB value and simple trigonometric relations (1), (2) the hull angle of the wreck was calculated.

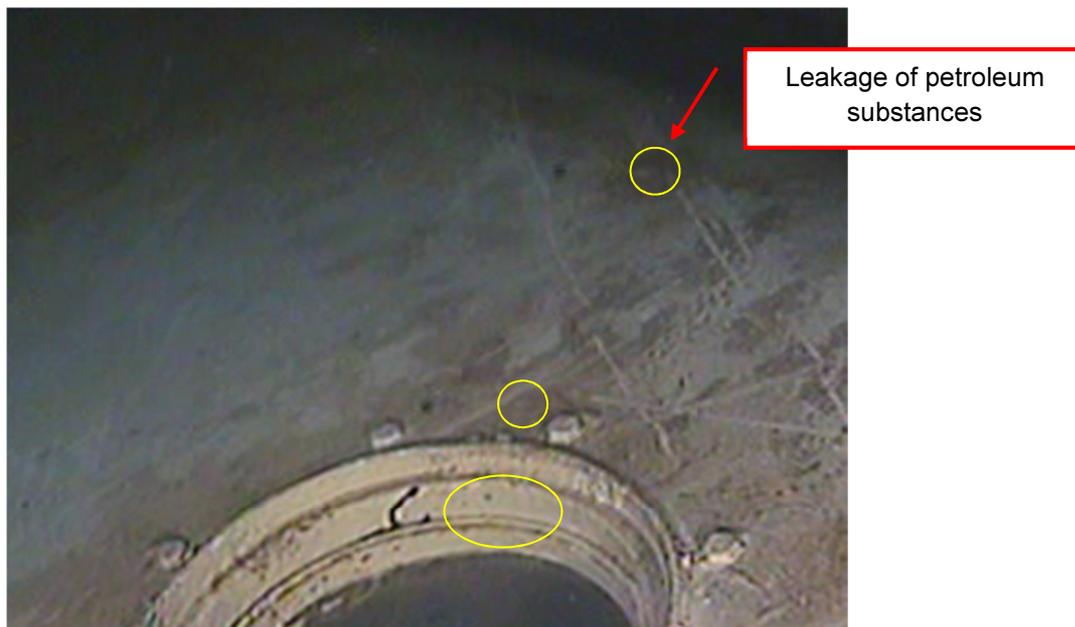
As a result of the inspection of the hull plating, a petroleum substance leakage was detected from one of the wreckage compartments (Fig. 8).

A more thorough investigation has indicated its cause. The leakage source was a porthole. Then, based on the archived video, the leakage scale was estimated and the method of its sealing was developed.

Fig. 8. Leakage of petroleum substances (own studies).

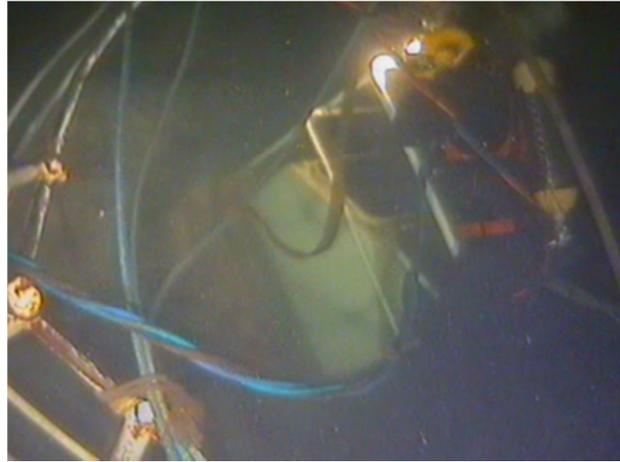
Fig. 12. Supervision at the entrance to the engine room during the penetration of the fishing boat's (own studies).
