INFLUENCE OF GEOTECHNICAL CONDITIONS ON DAMAGE STATES OF GDANSK BAY COAST CLIFF FORMATIONS

A geotechnical aspect of destruction processes of seashores was identified based on the case of erosion of Gdansk Bay Coast cliff formations. Causative factors of landslide were described in the context of natural phenomena, land development and its anthropogenic transformations. Possible directions of theoretical analysis of changes in ground-water relations were indicated.

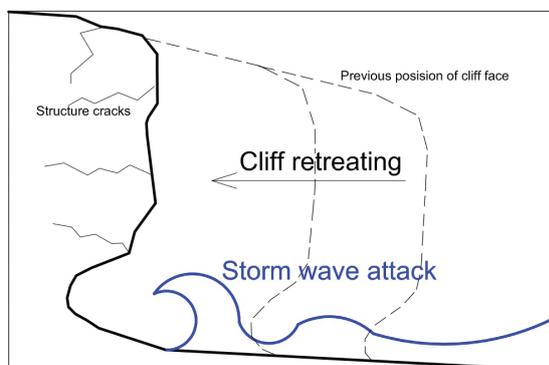
- permanent or periodical attacks of storm sea waves against cliff base [4], as a result of which cliff slope retreats step by step back into the land (Fig. 1),

Fig. 1. Erosion of cliff resulting from storm wave attack

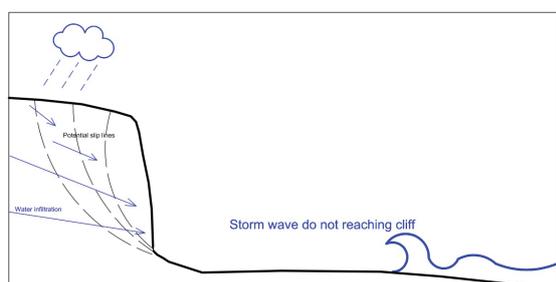
- effects of ground mass forces onto sheer slopes, that results in loss of stability and landslides,
- infiltration and flow of underground water from the side of land towards sea, which liquefies the ground and changes its state (Fig. 2).

Fig. 2. Cliff erosion due to geotechnical effects from the side of land

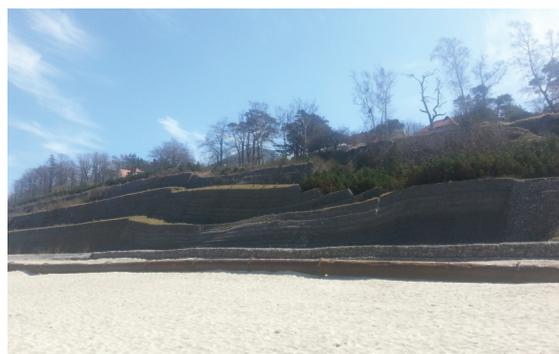
Landslide effects usually cause also destructions of shore protection structures, for instance such as the damage of cliff protection gabion structure shown in Fig. 3.

The deformations could not be caused by storm waves in view of that the beach is a dozen or so meters wide [11]; their causes should be searched in periodical changes in ground-water relations within the cliff itself.

Fig. 3. Deformations of the cliff protection structure made of reinforced ground and gabions (2014) [8]

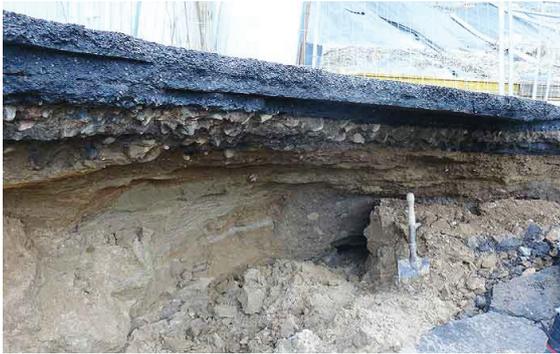
As a result of the critical water pressure produced in pores of the ground, the hydraulic piping flow and its significant pressure occurred, that caused washing away the road embankment and liquefying the ground. This is a frequent cause of building damages associated with changes in ground-water relations, that is described in the geotechnical literature [2]. In the photographic documentation there are visible a hydraulic piping flow canal and a cavern formed as a result of the washing out of

anthropogenic ground layers placed under the roadway (Fig. 4, Fig. 5a, Fig. 5b, Fig. 5c).

Fig. 4. A cavern and hydraulic piping flow canal revealed after the damage [10]

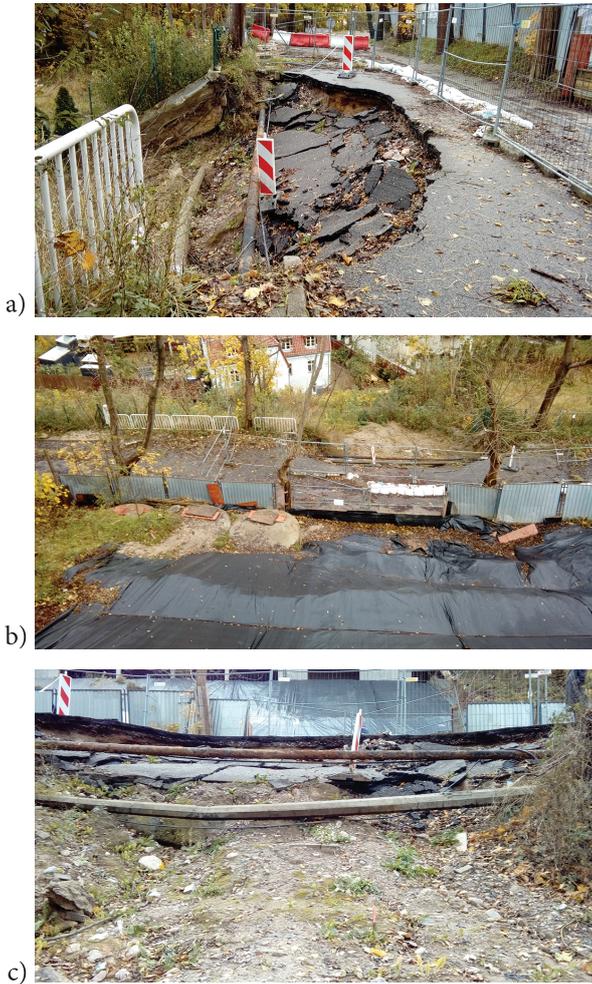
In the night from 23rd to 24th February 2017, in Gdynia, below Sienkiewicz Street, a sudden landslide and run-off of ground-water mass occurred from the escarpment. The slid-down and watered ground mass displaced forming a precipice. Simultaneously, the active tongue of the landslide locally deformed the lie of the land, rising the terrain level by 1,5 m in some places.

A 7 m fragment of the street pavement and roadway was damaged. A geotechnical consequence of the occurred situation is a new state of force equilibrium spontaneously settled in the ground. The geotechnical investigations of the terrain in question show [10] that this state is not stable and may be changed after subsequent intensive watering the ground. A week after the reported event some water flow sources and symptoms of the significant ground watering were found in the site of the landslide.

Fig. 5. State of the landslide 8 months after the damage

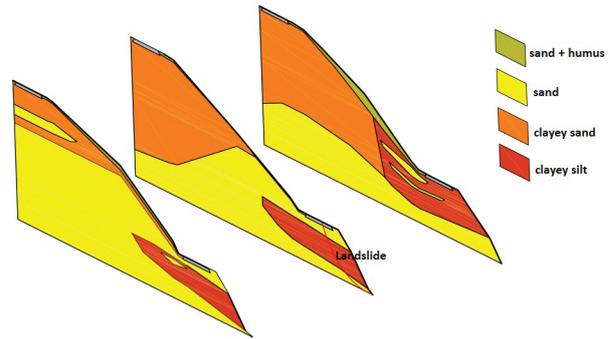
The geotechnical cross-sections in the line of the landslide have confirmed possible water accumulation in ground lens (Fig. 6). On this basis it is possible to conclude that the geological structure of the base in which ground layers of a higher and lower water permeability alternately appear, helps in forming privileged ways of water filtration in the ground and underground water flows concentrated within a rather small space. In the base there are ashy ground layers

which are characteristic of substantially decreased strength parameters in case of watering.

Fig. 6. The geological cross-sections showing stratified grounds of variable filtration ratio within the landslide

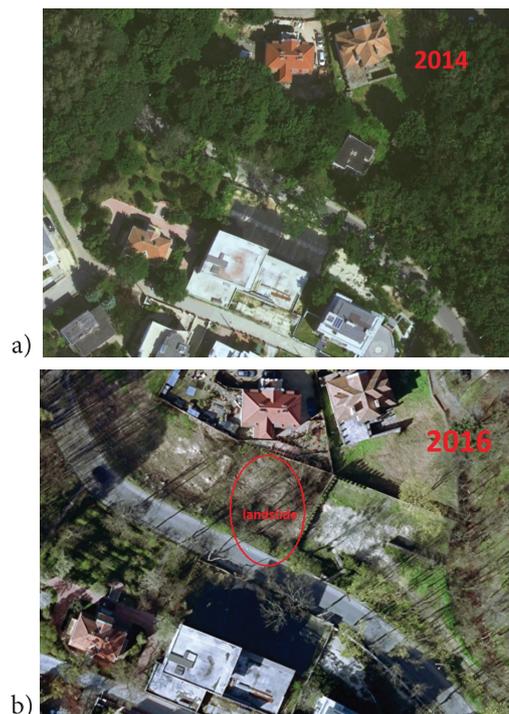
For several years before the landslide event, a devastation of the existing stand of trees has been observed. As a result, a lack of the natural factor holding the ground on the slope has been introduced. The attached photographs reveal a wastage of the stand of trees in this area (Fig. 7a, Fig. 7b).

Fig. 7. Changes in the stand of trees within the landslide, which occurred between the years 2014 and 2016, (Aerial photographs shot by MGGP AERO)

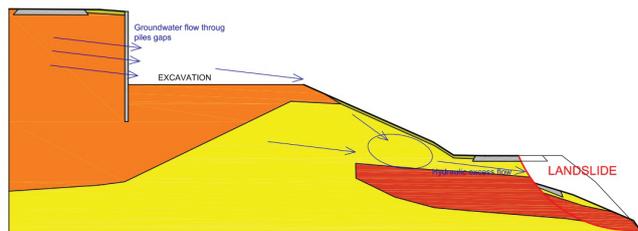
In the building site a complete drainage system has not been made. Till the break in the building works only a part of band drainage has been worked out. No storage reservoir, the crucial element of the drainage system, intended for storing the rainfall water, has been built. The completion of only a part of the rainfall water intake and storage system had more detrimental effect onto stability of the slope than a complete lack of it. The drained rainfall water was directed straight into the ground, penetrating its deeper layers, directly.

Fig. 8. Direction of hydraulic excess flow under the road of Sienkiewicz street.

Over the entire cliff area there is legally forbidden to discharge the rainfall water off the buildings and hardened surface areas directly into the ground because the terrain is deemed susceptible to landslides [10]. Till the occurrence of slope damage, the rainfall waters were discharged directly into the ground. It resulted in a degradation of its strength parameters in the analyzed area, especially in places where ashy ground layers were present. The damage mechanism is highlighted in Fig. 8.
