SURVEY ON ROAD-TYRE CONTACT PATCH PATTERN AND WEAR RELATED ASPECTS

AZODO Adinife Patrick¹

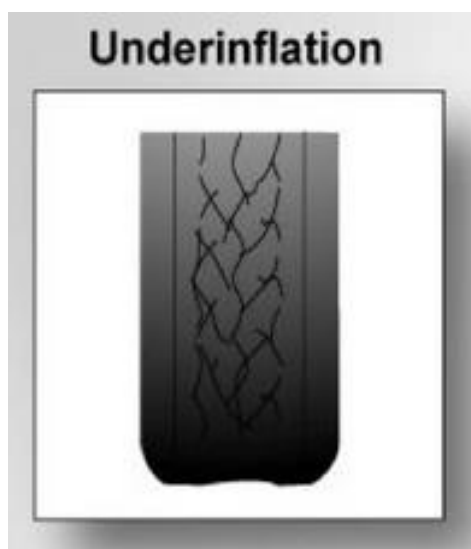
Under-inflation; wear at the edges of the tyre tread (Figure 1) [16, 19].

Figure 1. Wear due to under inflation (<https://www.rv.net>)

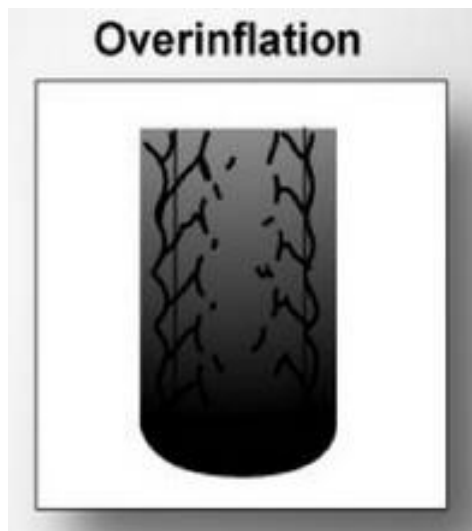
Over-inflation of tyre; wear at the middle of the tyre tread (Figure 2) [16, 19].

Figure 2. Wear due to over inflation (<https://www.rv.net>)

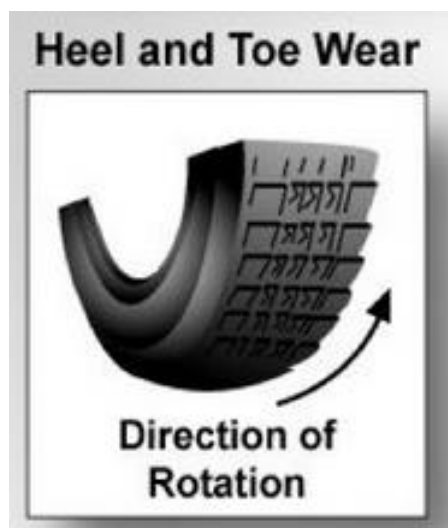
Heel/toe tire wear; circumferential faster of one side of the tread than the other side (Figure 3) [16, 19].

Figure 3. Wear due to heel and toe effects (<https://www.rv.net>)

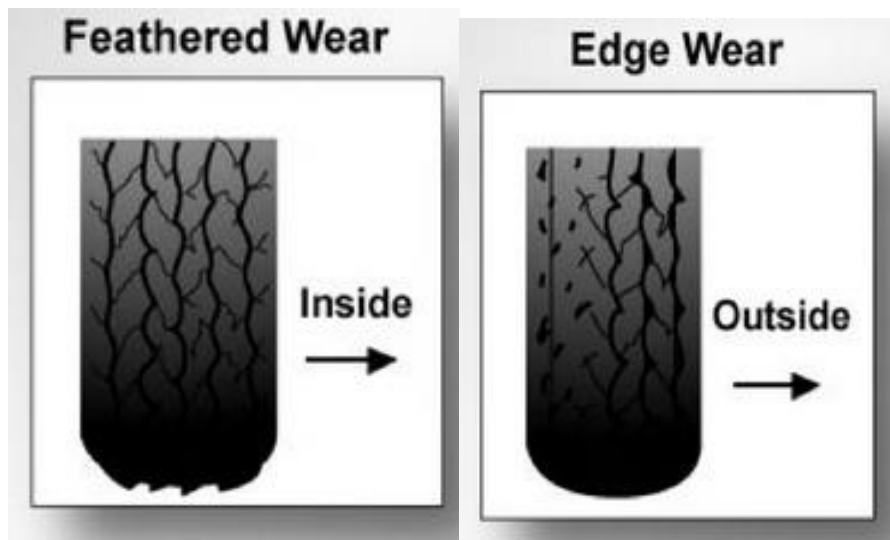
Feather edge tire wear; worn lower/smoothen on one side and higher/sharper on the other on the tread ribs (Figure 4) [16, 19].

Figure 4. Wear due to feathered edge (<https://www.rv.net>)

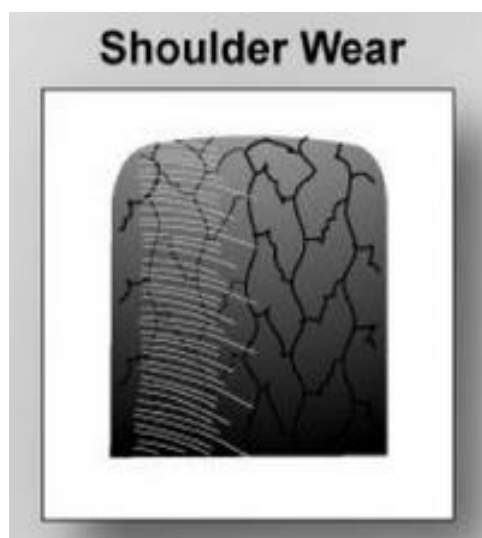
One-sided shoulder tire wear; significant inside or outside shoulder tread rib more worn than the other (Figure 5) [16, 19].

Figure 5. Wear due to shoulder wear (<https://www.rv.net>)
