## EXAMPLE BUILDING DAMAGE CAUSED BY MINING EXPLOITATION IN DISTURBED ROCK MASS

LUCYNA FLORKOWSKA

The Strata Mechanics Research Institute of the Polish Academy of Sciences,  
ul. W. Reymonta 27, 30-059 Kraków, Poland.

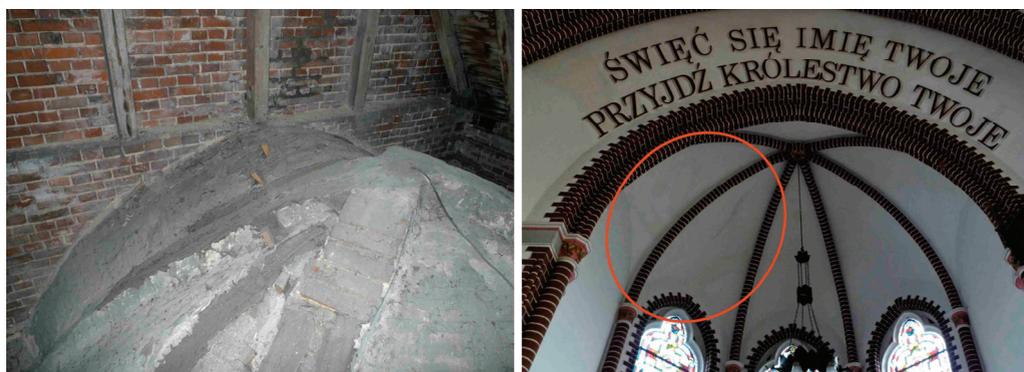
Fig. 8. Repair work done to top and bottom surfaces of vaults

levels. Despite repairs and reinforcements fitted to church building, new damage occurred on a regular basis. It was predominantly cracking vaults – repaired several times through wedging and cementation at first. In recent years, epoxy resin packing materials were used (Fig. 8). Cracked walls were also repaired, as was damaged floor. Stained glass windows were replaced – mining damage.

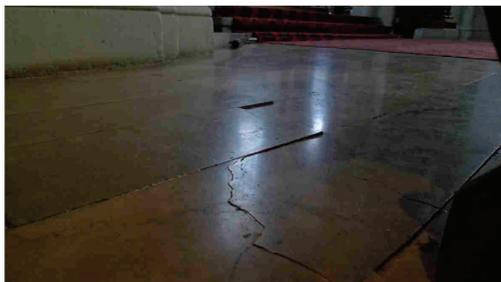
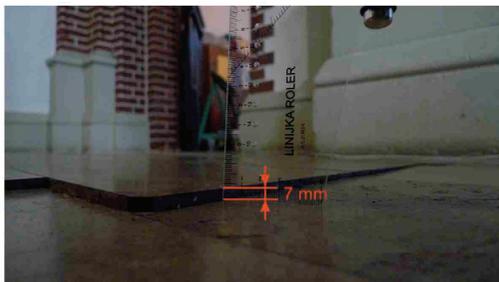
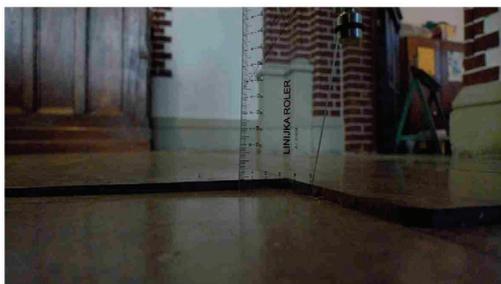
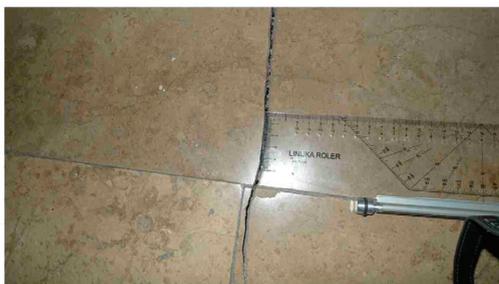
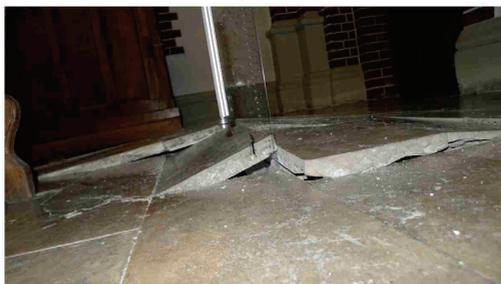
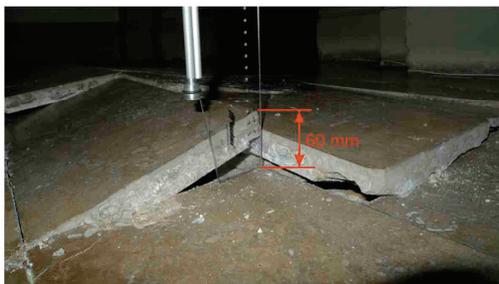
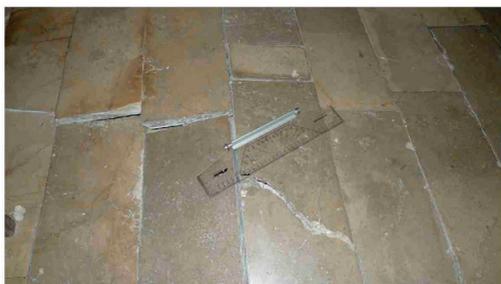
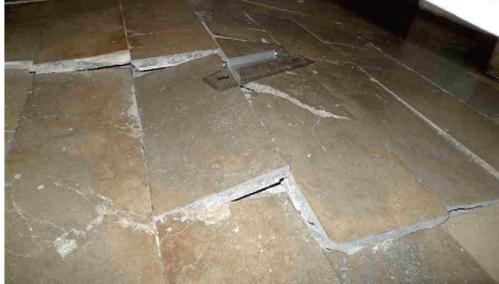
the state prior to December 9, 2012 (fot. 02-12-2011 r.)

the state after 9 December 2012 (fot. 5-01-2012 r.)

Fig. 9. Damaged church floor

the longwall 18a/bed 510wd is being mined, which progresses from South to North. Despite longwall face being beyond the reach of major influences (as on January 2012), both the building and its surrounding show worrying deformation and damage. The church's floor made of stone plates became unevenly deformed. There are considerable floor bulges in the aisle located in the Northern part of the church. Evident were also cracks and vertical displacements of tiles. The condition of the building significantly worsened as of 9 December 2011, when the floor abruptly elevated and shattered with acoustic effects accompanying. Figure 9 illustrates a comparison between the state of the floor from 2 December when property condition was surveyed and its state after the abrupt event.

Cracks in the floor have also surfaced in other parts of the church. The crevice above the alter becomes ever-more evident. The line demarcating change in the slope of church's body also runs through that point. Said line seems "broken" along the wall parting presbytery and main nave. Vast cracks in the vault are also visible there, which lately (about 5 January 2012) increased enough for the rain water to leak in and drip on the altar's steps. This is indicative of sheet metal roof also becoming damaged. Figure 10 illustrates said damage. The stack partition, which is under shear stress becomes alarmingly deformed. The photograph shows major displacement of bricks composing stack partition, both in the loft and exterior wall – Southern elevation.

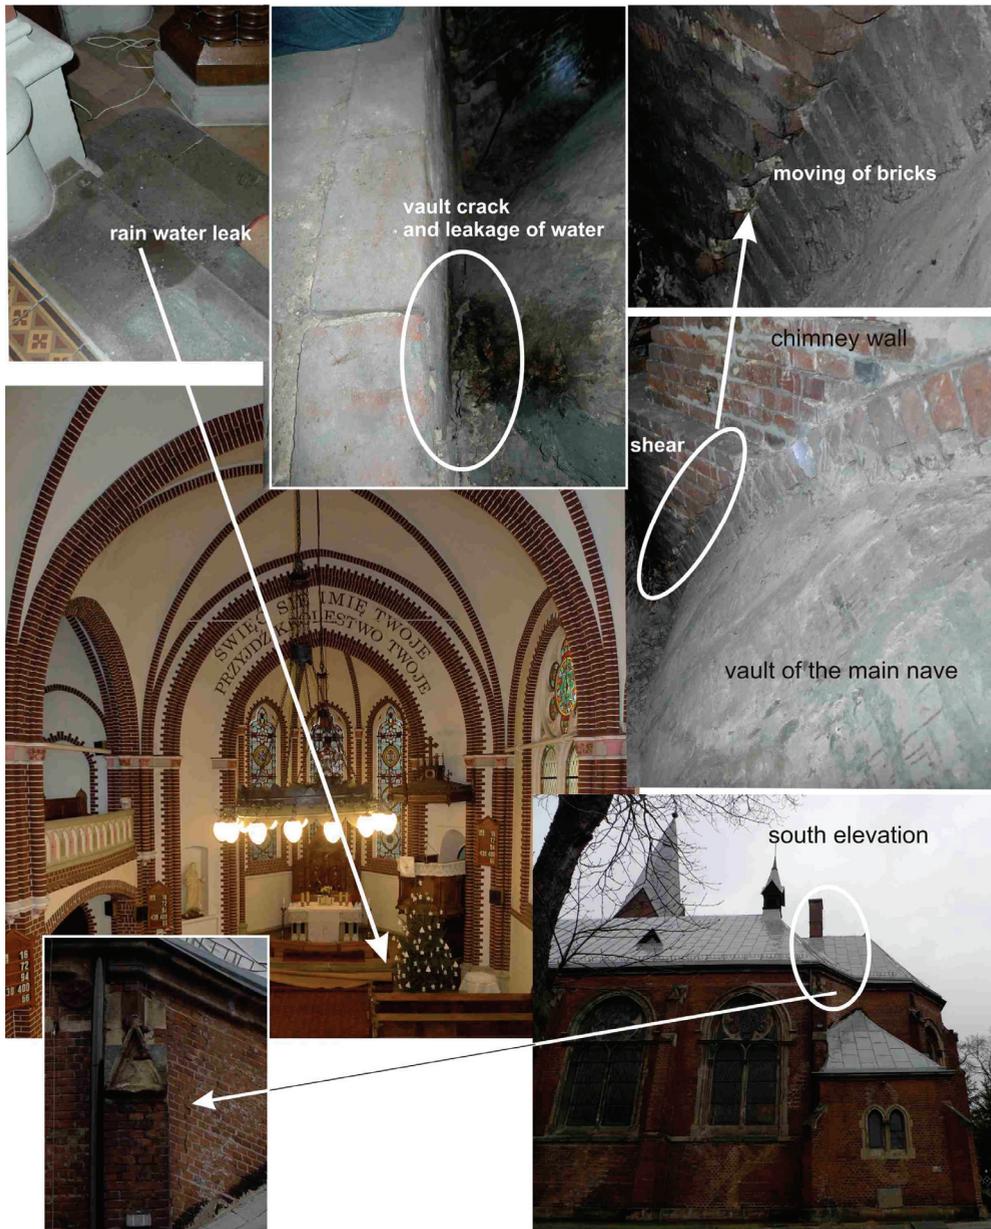
The church due to repeated mining influences sustained multiple damage, which manifests itself as cracked vaults and walls. In a bid to protect the structure against mining damage, it was fitted with a reinforced concrete slab – a so-called Ledwon slab. Steel tie-beams were also fitted, which fasten together the main nave both longitudinally and transversally. Numerous maintenance repairs and major repairs predominantly involved wedging and gluing together vaults. In recent year epoxy resin fillings have been employed (Fig. 8). Cracked walls were also repaired and stained glass windows were replaced – mining damage.

Fig. 10. Damaged vaults and crosswall of the church

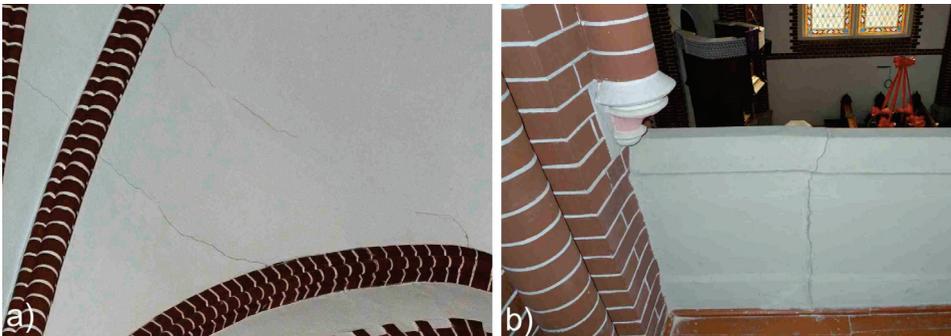
Fig. 11. Damage sustained by the church: (a) cracks in vault above main nave, (b) cracks in choir loft

Apart from the aforementioned, the entire church is riddled with numerous cracks both in church's vaults and walls. Figure 11 illustrates a selection of places, where damage surfaced: main nave's vault cracks and cracks in choir loft's parapet, located in the aisle.

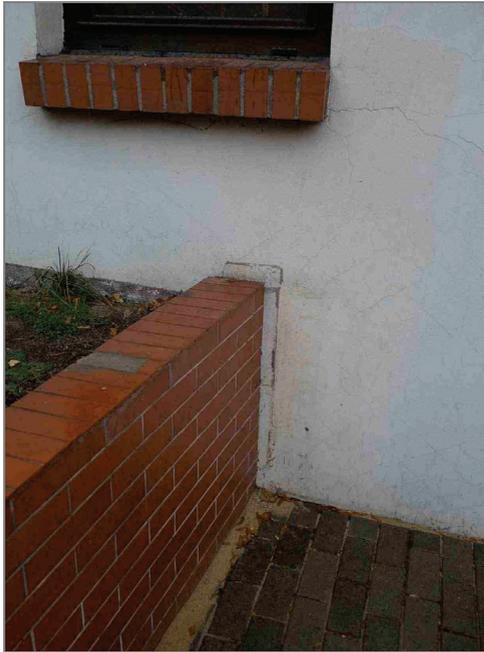
years. Figure 12 shows displacement of small wall's curvature, illustrating surface deformation. Figure 13 illustrates crack in the exterior wall near the South-East corner of the structure.

Fig. 12. Displacement of the building illustrated by original location of retaining wall

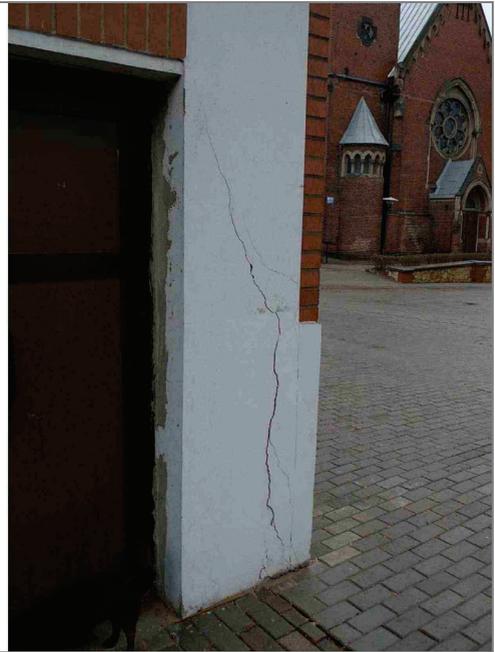
Fig. 13. Cracked wall near South-West corner of the Nursing Home

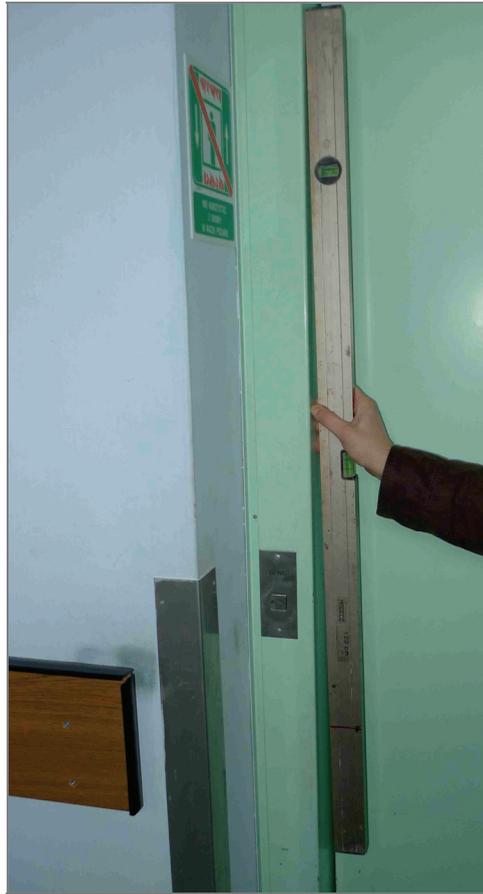
The tilted body of the building makes it difficult to use it. Moreover, due to specific function of the building, even the slightest ignorable for healthy individuals slope of the floor is spawning issues. According to the measurements that were made in August 2012 the tilt of the building is 1.6% in the southern part and more than 3% in the northern part. Significant vertical tilt hampers using the lift (Fig. 14). Substantial cracks in segment joints are visible (Fig. 15). Due to displacements of walls and ceilings, also deformed became sanitary and heating infrastructures. Figure 16 illustrates a pipe indented caused by pressure of wall, which had to be removed to prevent major damage to the installation. Similar situation is illustrated in Fig. 17, where apart from indent pipes and need to wall cutting, deformation of vertical segment of the pipe is shown.

Fig. 14. Vertical tilt of lift shaft

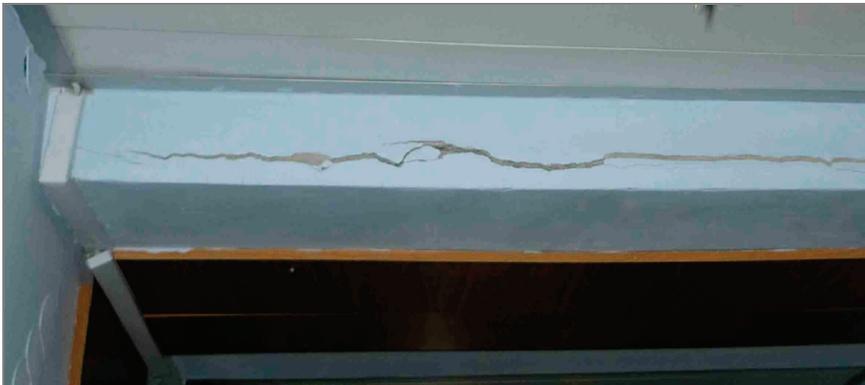
Fig. 15. Crack in places of dilation between building's segments

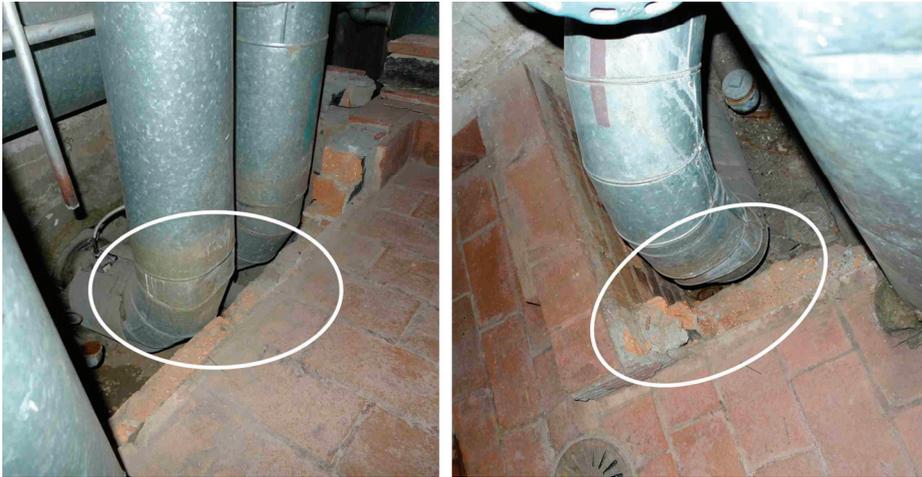
Fig. 16. NH boiler room. Visibly bent pipes and incuts made to protect the piping from damage

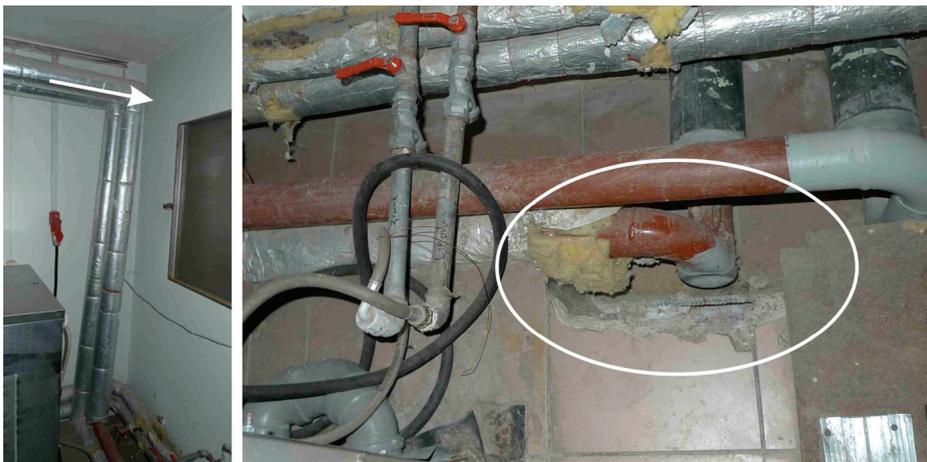
Fig. 17. NH laundry room. Visibly bent pipes and incuts made to protect the piping from damage
