Ż. A. Mierzejewska

Białystok University of Technology, Faculty of Mechanical Engineering, Department of Materials Science and Biomedical Engineering, ul. Wiejska 45C, 15-351 Białystok, Poland, a.mierzejewska@doktoranci.pb.edu.pl

CASE STUDY AND FAILURE ANALYSIS OF A TOTAL HIP STEM FRACTURE

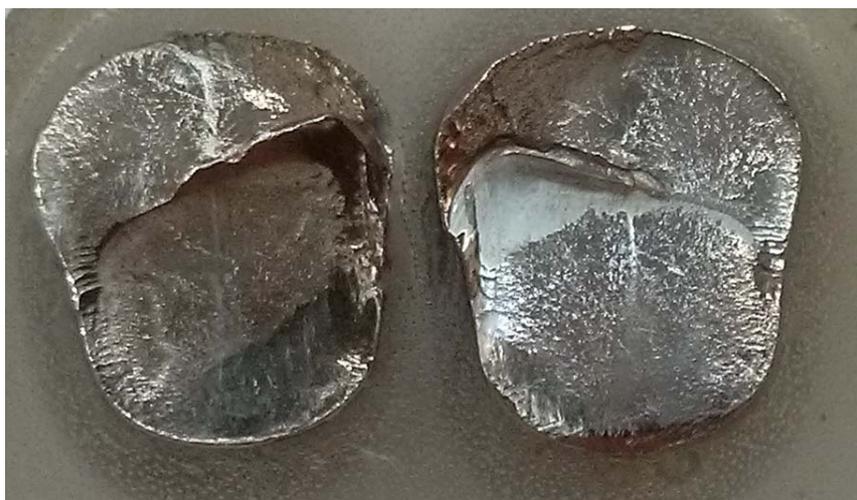
The stem was forged using high nitrogen stainless steel. The failure occurred after only 3 years service. A general view of fractured stem surface in the Fig.1 was presented. After revision, the two sections of the fractured stems were prepared for further analysis. A small piece was cut from the stainless steel sample and prepared metallographically by using a standard techniques, so that a microstructure could be observed in cross-section and evaluated. To compare the chemical composition of the fractured stem with ASTM F1586 standard spark emission spectroscopy (Thermo ARL Quantris, Switzerland) was used. Detailed microscopic examinations of the microstructure after etching polished samples were carried out by a Nikon Eclipse LV1000 optical microscope (OM). The fracture surfaces of the stems were examined by means of a Hitachi S-3000N Scanning Electron Microscopy (SEM) equipped with Energy Dispersive Spectroscopy (EDS) detector. Hardness measurements were performed using Vickers Carl Zeiss Jena NEOPHOT 21 universal indenters. Grain size and hardness tests were performed according to ASTM standards E112 and E384. For the FEM

Fig. 1. General view of fractured stem surface

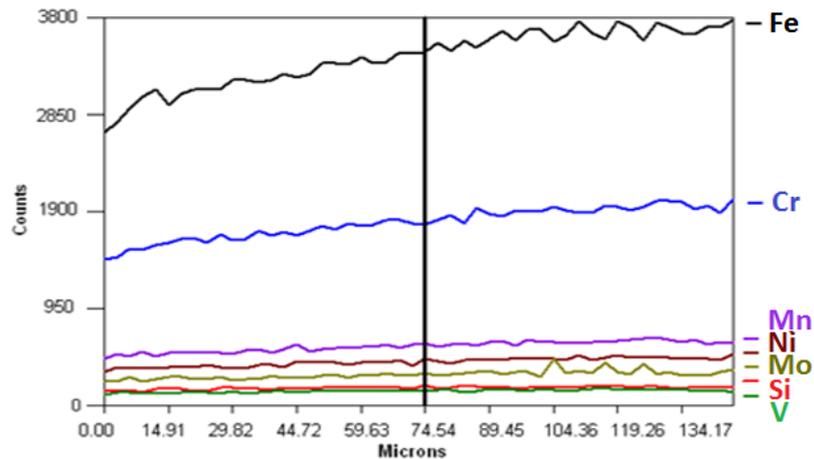
The chemical composition of tested stems is shown in Table 1. For comparison the chemical composition of the high nitrogen austenitic stainless steel according to ASTM F1586 standard (REX 734 grade) is also presented. The results of chemical analysis of the tested steel revealed, that the material of the stem, in general, fulfils the ISO standards requirements. Only the manganese and sulphur content is slightly higher than specified (see Table 1). Additionally, to confirm the chemical composition of the tested sample a SEM-EDS measurements were performed. Linear analysis enables the observation of changes in the concentrations of selected elements along the lines applied to the image topographic cross-sectional area of the sample. The results presented in Fig.2 revealed non-homogeneous distribution of alloying elements in the steel matrix.

Fig. 2. SEM-EDS linear analysis of the elements concentration on the surface of the stem

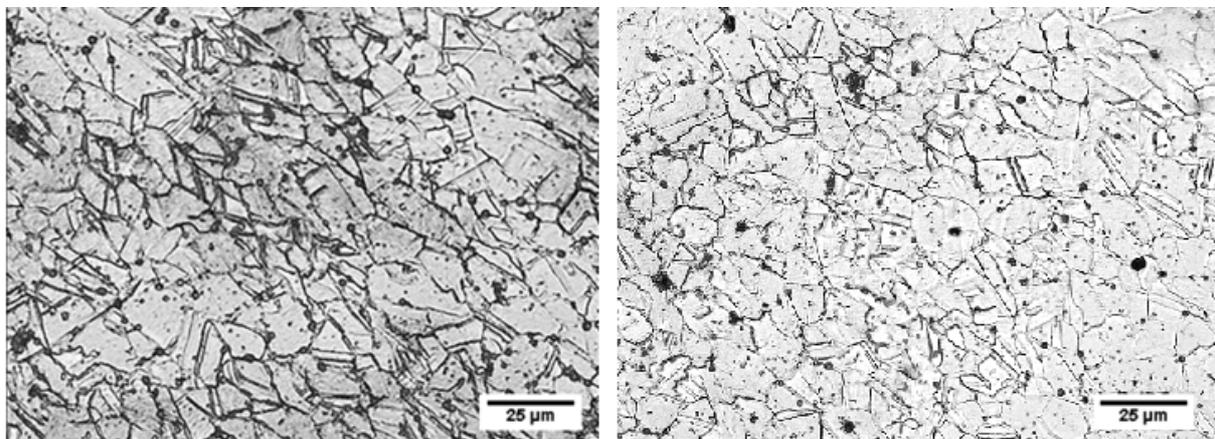
The microstructure of the stem material close to the fracture has been examined. No form of corrosion such as pitting close to the point of fracture was discovered. The etched metallographic sample showed a normal equiaxed twinned austenitic grain structure (see Fig. 3). Metallurgical analysis showed excessively variable grain size with some large grains near the surface, which may reduce the fatigue properties of the austenitic stainless steel. However, mostly the grain structure in all areas was found to be homogeneous and possessed a relatively small, elongated shape, typical for a forged stainless steel. The grain size has a very significant influence on the properties of the material [16]. Appropriate determination of grain size is based on comparison of the microscopic image, counting the average number of grains per unit of area or the measurement of grain diameters randomly selected and compared the result with the respective measurement scale pattern. Recommended grain size for austenitic stainless steel used for implants is ASTM #6 or finer [17]. In this case the Jeffer's method was used. Based on photographs showing a metallographic structure of the steel was estimated amount of particles per unit area. The result is approximately 800 grains/mm². Based on to the American Society for Testing Materials [17] scale size is equivalent the pattern between 6 and 7. The pattern indicates for a fine – grained structure. Visual examination non-etched samples revealed carbides, which are typical for high-nitrogen stainless steel due to the nitrogen being a strong carbide former.

Fig. 3. Optical microscope on the femoral component micrograph of a typical austenitic matrix

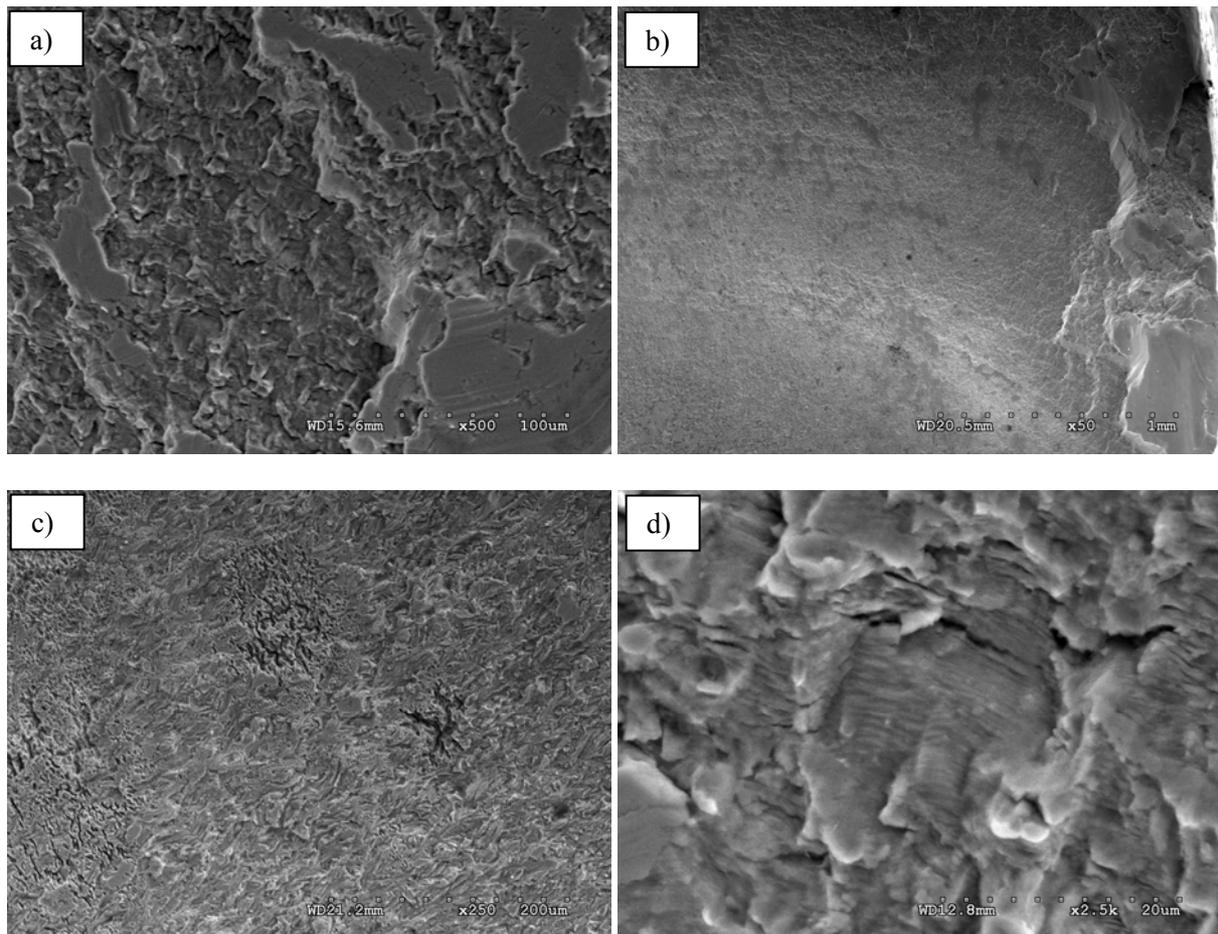
Fig. 4. Scanning electron microscopic analysis of the fracture surfaces of austenitic stainless steel failed by low cycle fatigue demonstrating: wear islands on the fracture surface (a), propagation lines (b), material discontinuities and pores (c), image of a fracture surface revealing fatigue striations (d)

Using a scanning electron microscope photographs of breakthrough examined stems were taken (see Fig.4). The study a breakthrough the fatigue area, a recess and dissection of the material due to its overload has revealed. The area of fatigue breakthrough, a multiple secondary cracks and additionally transverse cracks was clearly shown. Secondary tears (cracks) are commonly observed in fatigue failures and are created by tensile and compressive cyclic stresses induced in the material during cyclic flexing movements. There are also shown few signs of plastically deformed areas on the stem fracture surface, indicating low nominal applied stress. The study revealed the destruction, the nature of which indicates a loss of coherence. This type of fracture may be caused either by the action of a corrosive environment on the material or due to the weakening of the strength of grain boundaries by the presence of inclusions, segregation of impurities or other elements. Clear bands, also called striated fatigue, which are proof of the fact that the stem broke due to loads that caused material fatigue were not observed, due to smashed the surfaces as a result of walking after the fracture had occurred. Macroscopic fatigue striations (beach marks) were visible and created due to variances in loading parameters such as amplitude and frequency. The beach marks were closely spaced and well defined, indicating a large number of cycles to failure, which eliminated the possibility of sudden overload failure. The macroscopic analysis shows beach marks indicating crack propagation and a rough aspect commonly associated with coarse microstructure. Fatigue nucleated at the lateral part of the stem. The fatigue process

commonly takes place at this site in total hip stems due to higher positive stresses under in-service loads. A fatigue crack propagated in the most of the fracture surface, leaving beach marks until the last minor part, when a final rupture can be correlated to shear lips formation. Additionally, the flattened surfaces, which may indicate that the broken prosthesis worked for a long time in the body before it was reimplanted was seen. Chafed against each other abutting surface of fractured stem deformation and abrasion have caused.

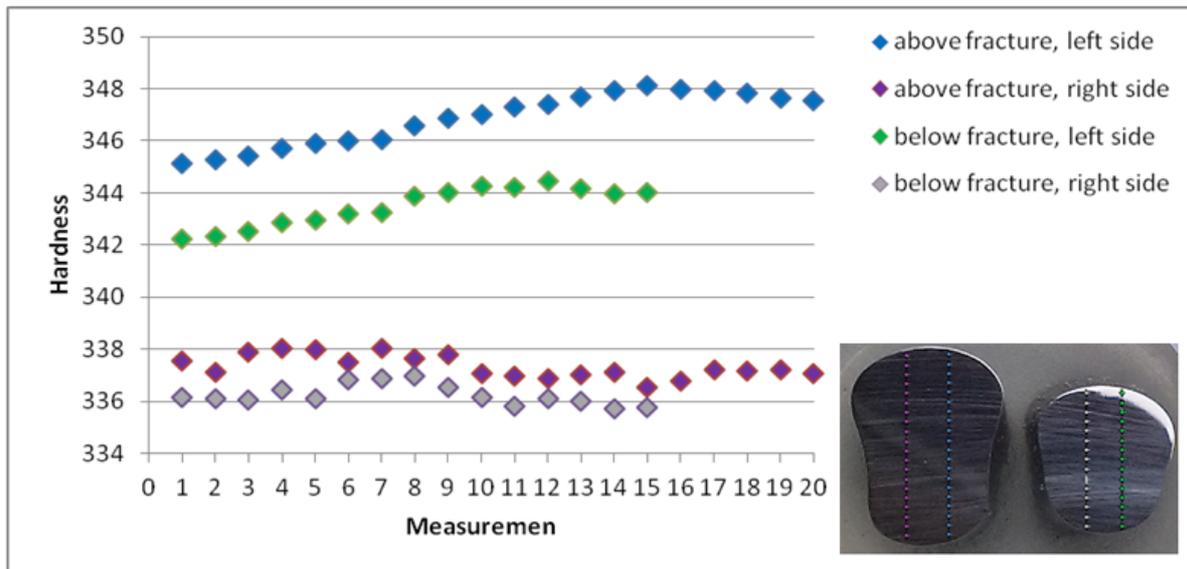
Fig. 5. Hardness measurements of the tested stem as a function of the distance from the edge of the sample

The characteristics of the mechanical properties of the samples after the surface treatment was performed on the basis of hardness measurements, by means of Vickers methods with load of 5 kg. Hardness of stem material was measured at $342 \text{ HV}/5 \pm 6$ above the fracture and $340 \text{ HV}/5 \pm 4$ below the fracture. The hardness average obtained of 341 HV agree with ASTM F1586 standard [16]. Hardness measurements indicate explicitly that the left side of the stem is slightly harder than the right side. This may be caused by uneven distribution of forces during plastic forming and shaping the implant or underlying reasons for this heterogeneity can be improperly carried out heat treatment.

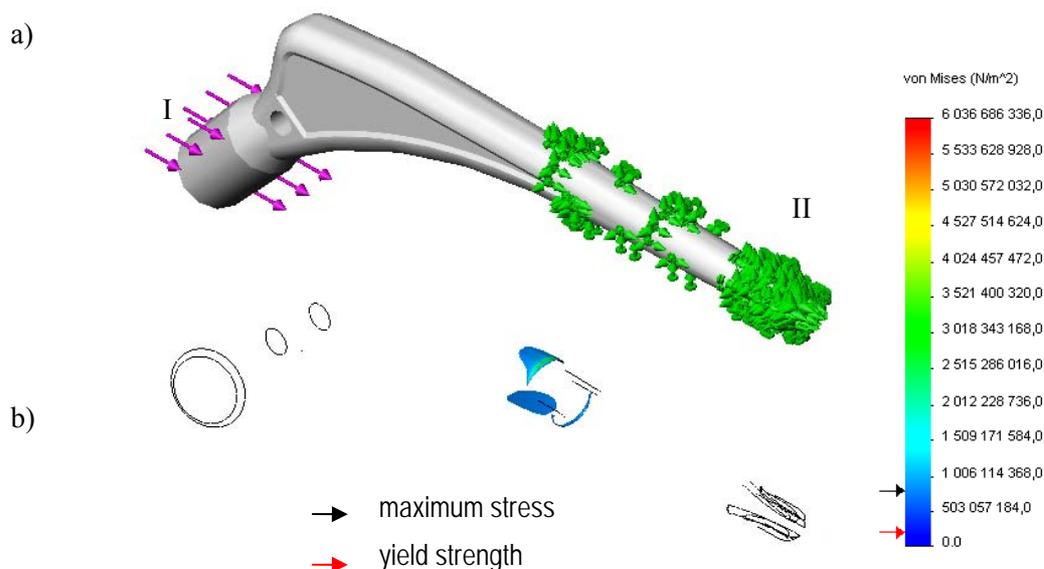
Fig. 6. shows the results of very simple FEM calculations - the stress distribution (according to Huber von Mises hypothesis). Note, that the reduced stress level has different values, but in a place where the stresses are cumulative, the value is sevenfold greater than the yield strength of the material specified. The resultant displacement values are not large - the maximum value of deflection the neck stem under 300 kg load is less than 2 mm.

Fig. 6. 3D stem model with with marked zones of load (I) and attachment (II) (a) and zones of the largest stress tension (b).
