ASSESSMENT OF EVAPORATOR TUBES CORROSION IN LOW-EMISSION STEAM BOILERS

Degradation examinations of outer surface of low-emission steam boiler evaporator tubes are presented in the paper. Metallographic evaluation of scale morphology, its micro sites chemical composition analysis and distribution of elements on cross sections have been performed. Water-wall tubes were exposed in steam boiler for up to two years period. Common tubes made of 16Mo3 steel suffered sulfide and molten salts corrosions. Thermal sprayed tubes with the single layer of 70%Ni 30%Cr alloy show better corrosion resistance, but become also susceptible to sulfide corrosion due to presence of internal voids and cracks. Double layer Al₂O₃/Ni-30Cr coatings withstand corrosion attack for more than one year operation, then failed due to internal heterogeneity and cracks generation.

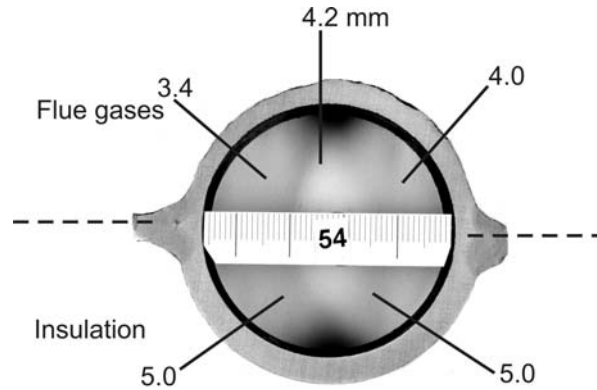
The appearance of cross section of uncoated tube after one year exploitation is shown in Fig.1. Thickness of tube wall was measured at the points indicated in Fig. 1.

The reduction in wall thickness was not uniform on tube perimeter. The front side of the tube facing the combustion radiant heat suffered the worst metal wastage and reaches 68% of its nominal value. Reductions in wall thickness from insulation side of tubes were not recorded.

Fig. 1. Cross section of $\varnothing 57 \times 5.0$ mm evaporator tube after one year exploitation in low-emission boiler

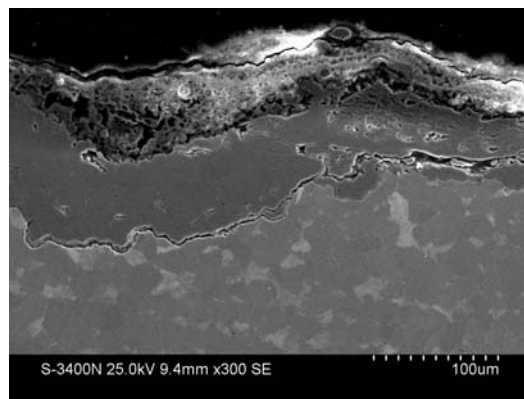
Investigations show that both mechanisms of corrosion (sulfide corrosion and molten salts corrosion) took place on uncoated tubes. Chemical analysis indicated presence of alkaline metals (K, Na, Mg, Ca) and iron sulfides (FeS , FeS_2) in the scales. The morphology of scales consisted of two layers. External, which is porous and weakly connected with the tube surface, and internal, which is dense and adherent to the base metal (Fig. 2 and 3). In these two layers the bands rich in sulphur were detected. Concentration of sulphur in these bands reached 22 wt.%. Outer layers consisted of iron, oxygen, sulphur, silicon, aluminium and alkaline metals. Inner layer consisted mainly of iron oxides and iron sulfides. The traces of chlorine were also detected mainly at the interface of inner layer and base material.

Fig. 2. Cross section of $\varnothing 57 \times 5.0$ mm evaporator tube after one year exploitation. Deposits on the fireside of the tube

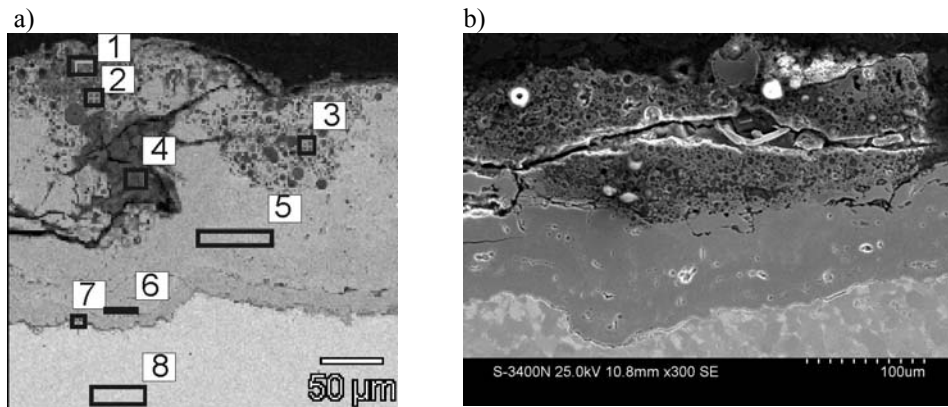
Fig. 3. Cross section of $\varnothing 57 \times 5.0$ mm evaporator tube after one year exploitation; a) places for chemical analysis (EDS), b) general view

Table 1. Chemical analysis at the points indicated in Fig. 3a (wt.%)

Na	Mg	Al	Si	S	K	Ca	Fe
pt1		0.63	20.88	28.86		1.95	0.84	46.06
pt2		2.16	23.27	35.04		4.68		33.77
pt3	1.20	0.44	20.11	24.65	7.88	1.88		43.84
pt4	2.24		1.88	32.16	2.79			60.93
pt5					14.55			85.45
pt6					21.76			77.61
pt7				0.56	4.68			94.76
pt8				0.43				98.91

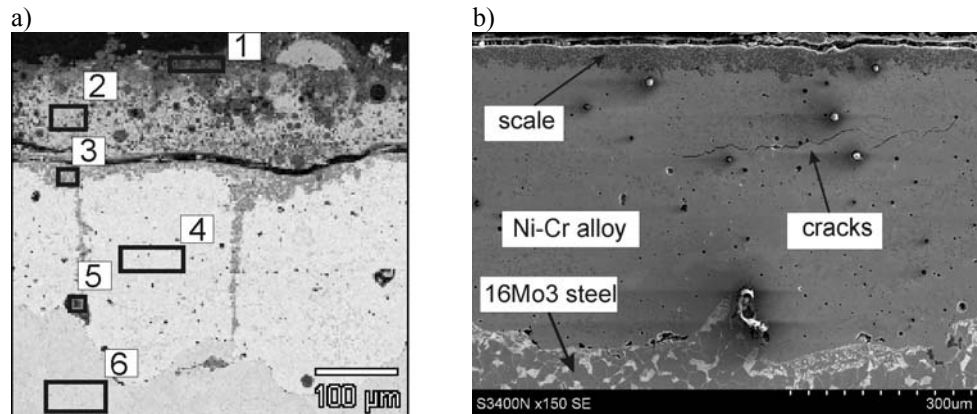
The layer of 50-100 μm in thickness consists of oxides and sulphides of chromium were formed on top of thermal sprayed coating. Other elements originated from combustion process were also detected in the scale (Tabl.2). The dense structure of coating prevents corrosion progress inside material. But it was revealed that coating

were severely cracked (Fig.5b) - probably during exploitation, and this allow the corrosive species to attack the base material through the cracks. Cracks penetrated all the way through the coating. The ways of corrosive attack through the Ni-30Cr coating are visible in Fig. 4 and 5a. Sulphur presence was confirmed along the cracks and on the interface coating-base material.

Fig. 5. Ni-30Cr coating after one year exploitation, a) places for chemical analysis (EDS), b) general view

Table 2. Chemical analysis at the points indicated in Fig. 5a (wt.%)

Na	Mg	Al	Si	S	K	Ca	Cr	Fe	Ni
pt1	1.71	1.24		1.85	5.63	4.06	1.69	59.41	9.39	15.02
pt2		0.58	3.64	2.44	12.28	0.23	0.62	62.89	3.99	13.33
pt3				12.76	6.86			45.07	7.21	28.10
pt4				5.12				21.73	3.83	69.32
pt5		2.21	3.63	3.31	2.60			13.15	38.77	36.33
pt6									98.89

Tubes with single Ni-30Cr arc sprayed surface layer were also susceptible to flue gases reducing environment. The corrosion resistance of Ni-Cr coatings depend on their composition and increases with increasing chromium content [3,4]. Quality of nickel based coatings depends on their structure. Oxides at splat boundaries, cracks and voids can open the way for movement of chemical species and are a reason of corrosion damages. To enhance properties of Ni based coatings, heat treatment or laser melting processes are recommended.
