VERIFICATION OF THE COMPUTED TOMOGRAPHY RESULTS OF ALUMINUM ALLOY WELDED JOINT

Maciej Malicki, Kamil Sobczak

Institute of Aviation, Warsaw, Poland

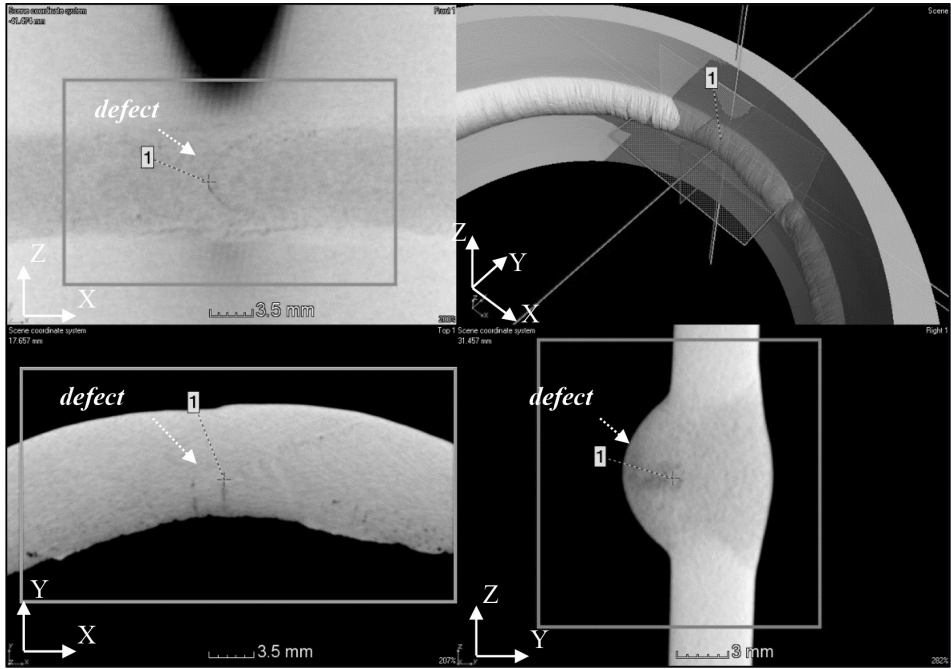
The first CT scan of the whole welded joint (Fig. 3) revealed some defects in the form of linear areas 3mm long with reduced as density compared with the parent material [3]. It was not possible to unequivocally state whether they were cracks or inclusions. To identify these defects the metallographic cross sections were made. It was found that in area containing defects on the CT cross sections, cracks were present (Fig. 4). These cracks ran along the one of the material phase.

Fig. 3. CT Image of defects in tested welded joint

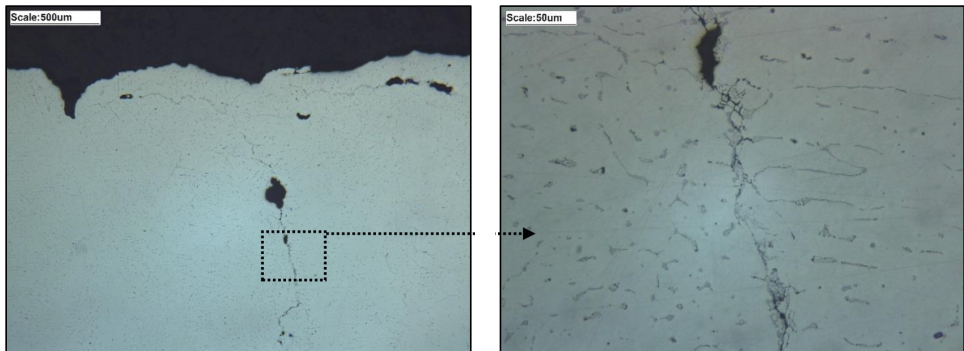
Fig. 4. Metallographic cross section of tested welded joint

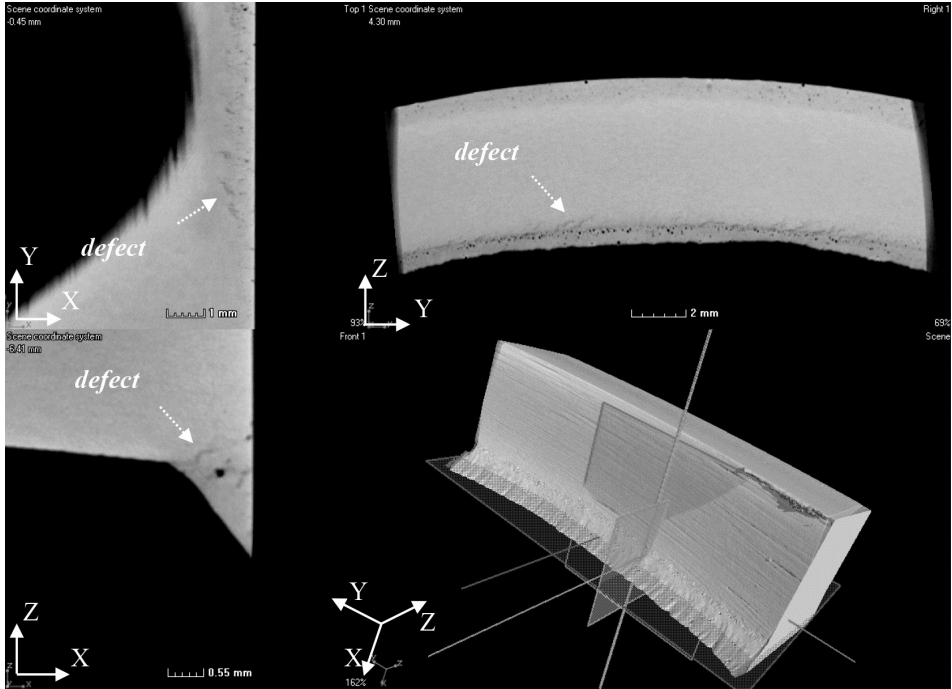
The high resolution CT scan made for the welded specimen showed other defects too. These were less than 1mm long and formed in the HAZ (Fig. 5). Also, the metallographic inspection made in the area corresponding to that defect, showed the present of cracks (Fig. 6, Fig 7).

Fig. 5. CT image of welded joint specimen

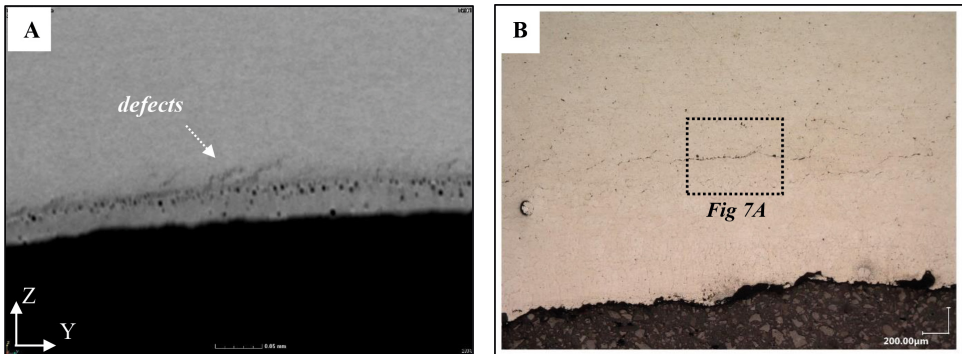
Fig. 6. CT image of defects in welded joint specimen (A) Metallographic inspection made in area correspond to the defects (B)

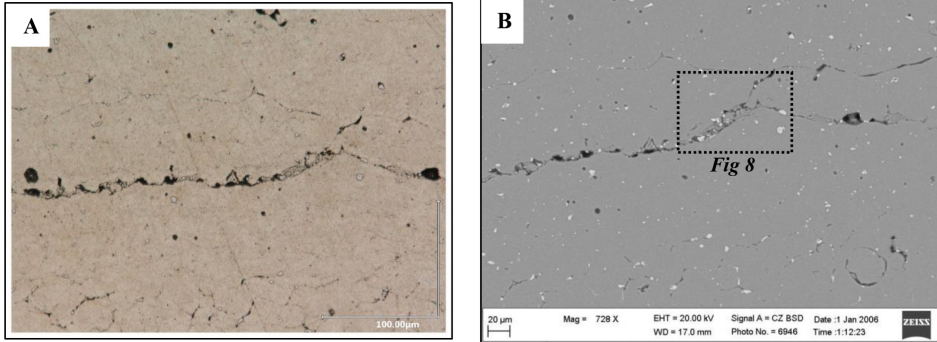
Fig. 7. Metallographic images of crack area. Optical microscope (A), scanning electron microscope using back scattering electron detector

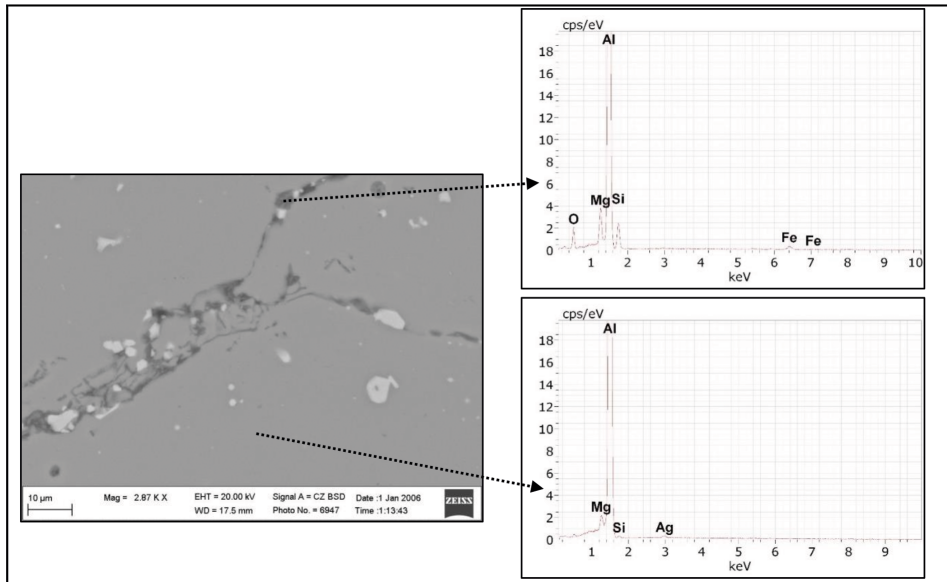
An EDX analysis (Fig. 8) showed that in the crack area there was a material phase rich in iron, magnesium and silica (compared with the parent material). High temperature occurring during welding might well have caused the presence of these phases. The occurrence of precipitates combined with thermal stress could have been the source of the crack formation [4], [5].

Fig.8. EDX analysis in crack area and in parent material
