## Long-term Influence of Concrete Surface and Crack Orientation on Self-healing and Ingress in Cracks – Field Observations

This paper presents results from investigations on the long-term influence of concrete surface and crack orientation on ingress in cracks. Five reinforced concrete structures from Norway exposed to either de-icing salts or seawater have been investigated. Concrete cores were taken with and without cracks from surfaces with vertical and horizontal orientation. Carbonation in cracks was found on all de-iced structures, and a crack on a completely horizontal surface appeared to facilitate chloride ingress. Ingress of substances from seawater was found in all cracks from marine exposure. However, the impact of cracks on chloride ingress was unclear. Horizontal cracks on vertical surfaces appeared to facilitate self-healing.

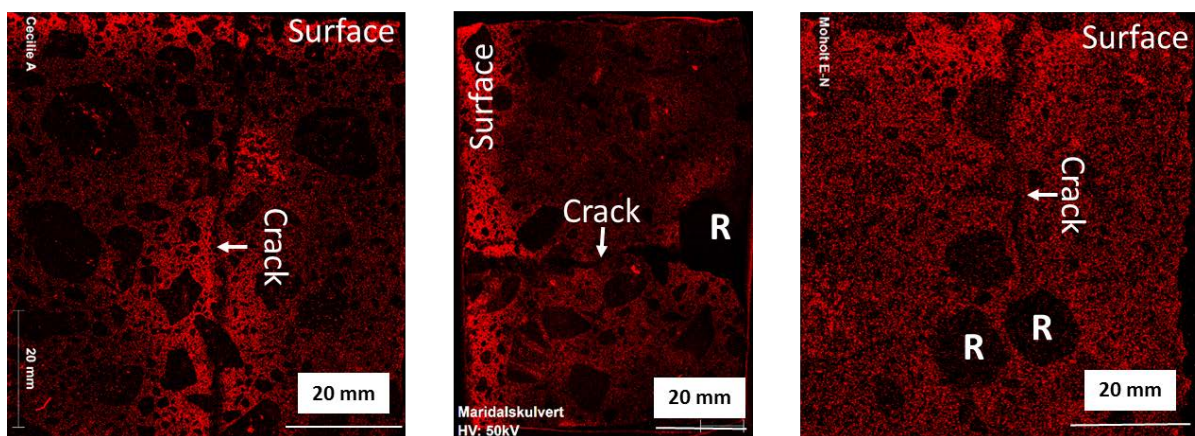
Figure 3 shows the  $\mu$ -XRF chlorine maps of concrete cores taken from Cecilie Bridge, Tåsen Tunnel and Moholt Bridge. The surface crack width of the cracks was 0.45 mm for Cecilie Bridge and Tåsen Tunnel and 0.55 mm for Moholt Bridge. Figure 3 (left) shows the chloride ingress in the cracked concrete core from Cecilie Bridge. An even chloride ingress over the whole width of the concrete core is visible within the first 10 mm. Besides that, chloride ingress is visible along the crack. Chloride ingress from the crack surface into the concrete was observed over the full length of the core, i.e. 100 mm. In contrast to this, the concrete cores from Tåsen Tunnel (Figure 3 middle) and Moholt Bridge (Figure 3 right) did not show an impact of the crack on the chloride ingress.

In the core from Tåsen Tunnel, somewhat higher chlorine intensities were observed around the steel-concrete interface compared to the bulk of the concrete. A possible explanation could be micro-cracking in the steel-concrete interface facilitating the accumulation of chloride. The surface crack width was similar in the core from Cecilie Bridge and Tåsen Tunnel. However, the core from Cecilie Bridge was taken from a horizontal surface, while a crack from a vertical surface was investigated in Tåsen Tunnel. The time of direct exposure is generally longer on a horizontal surface, which can explain the higher ingress into the crack observed in Cecilie Bridge.

In the core from the Moholt Bridge, there seems to be a very low level of chloride ingress in the concrete surface. The measured intensities in the surface near region are not much higher than in

Figure 3 -  $\mu$ -XRF chlorine maps of concrete cores from de-iced structures. Left: Core C\_0.45D from the Cecilie Bridge; Middle: Core T\_0.45D from the Tåsen Tunnel; Right: Core M\_0.55D from the Moholt Bridge. The orientation of the cores represents the surface orientation in the field. R = reinforcement

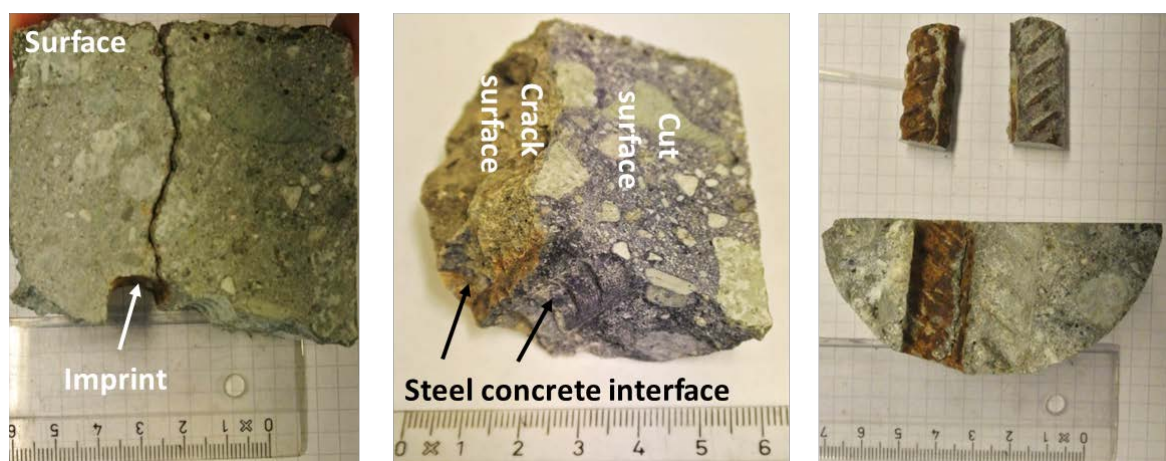
In cores drilled above reinforcement from Moholt Bridge and Tåsen Tunnel general corrosion was found on the surface of the steel in contact with carbonated concrete. However, the extent of corrosion was limited. Carbonation in cracks was observed in all cores taken from de-iced structures regardless of the surface crack width. Figure 4 shows the corrosion imprint in the steel-concrete interface, general corrosion on the reinforcement and the carbonation of the crack surface from the concrete core taken from Moholt Bridge. The example shown is from the concrete core with limited chloride ingress presented in Figure 3 (right).

Figure 4 - Concrete core M\_0.55D from the Moholt Bridge. Left: Cut concrete core; Middle: Carbonated crack surface and steel-concrete interface of the corroded rebar Right: General corrosion on the upper surface of the reinforcement and corrosion imprint in the steel-concrete interface for the reinforcement beneath the crack.

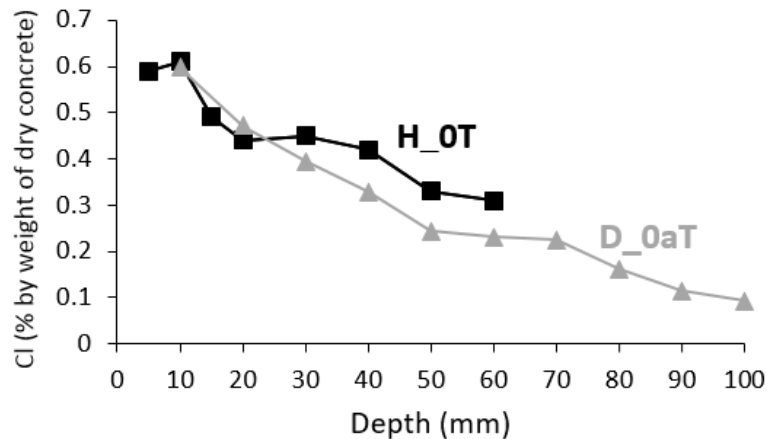
For the marine exposed structures, quantitative chloride profiles of reference cores without crack were taken.  $\mu$ -XRF mapping was performed on concrete cores with and without cracks. Figure 5 shows the chloride profiles of a core from the 33-year-old DNV column (D\_0aT) and the 50-year-old Hafrsfjord Bridge (H\_OT). The chloride profiles look similar with about 0.6 % Cl by weight of concrete in the outer 10 mm of the concrete cores.

Figure 5 - Quantitative chloride profiles of cores H\_OT and D\_0aT from Hafrsfjord Bridge and the DNV column, respectively. Both cores were without crack and from the tidal zone.

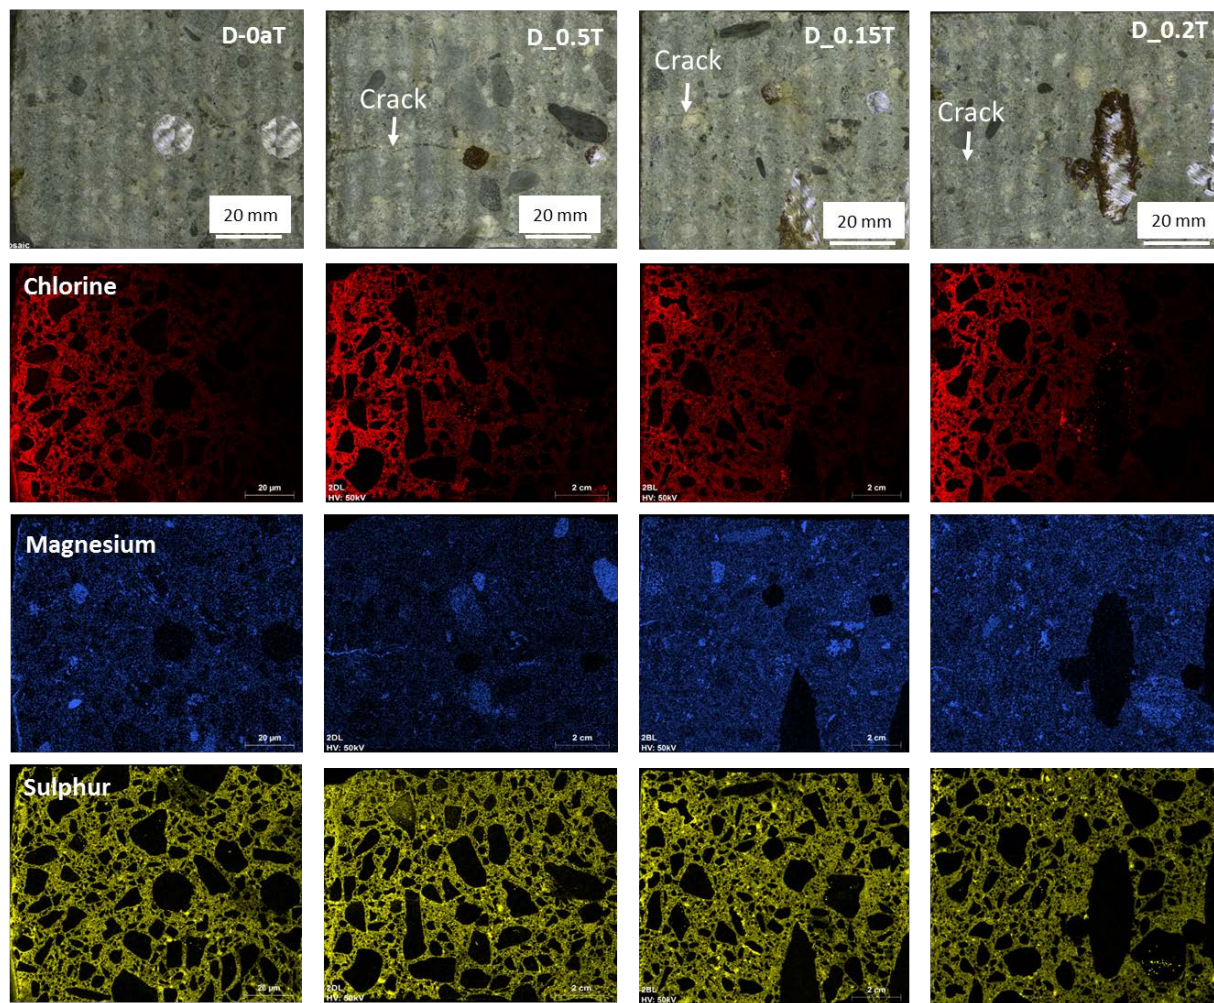
Figure 6 shows the chlorine, magnesium and sulphur maps of four concrete cores from the DNV column. The first core to the left is the reference core with no crack. All four concrete cores show an even chloride ingress from the concrete surfaces. Compared to the reference core there is no apparent deeper chloride ingress in the cracked cores. In the crack of core D\_0.5T, magnesium is visible within the first 20 mm. In cores D\_0.15T and D\_0.2T, the cracks are difficult to see due their small size and the extensive self-healing observed in these cracks. Magnesium and calcium rich products were found in all cracks, which is typical for self-healing of concrete exposed to seawater [9, 11]. Right after cutting and after cleaning the reinforcement with acid, no corrosion was observed. During storage, corrosion developed on the cut steel surfaces in the concrete cores. Corrosion was especially observed on the outer reinforcement, which can be explained by a higher chloride content in this area. Further details on the investigations performed on the DNV column are given in [14].

Figure 6 - Chlorine, magnesium and sulphur maps from cores from the DNV column. **Left:** Core D\_0aT without crack from the tidal zone; **Middle left:** Core D\_0.5T, surface crack width 0.5 mm; **Middle right:** Core D\_0.15, surface crack width 0.15 mm; **Right:** Core D\_0.2, surface crack width 0.2 mm. The cracked concrete cores were located about 0.2 m higher than the reference concrete core without crack. The indicated cracks are partly healed.

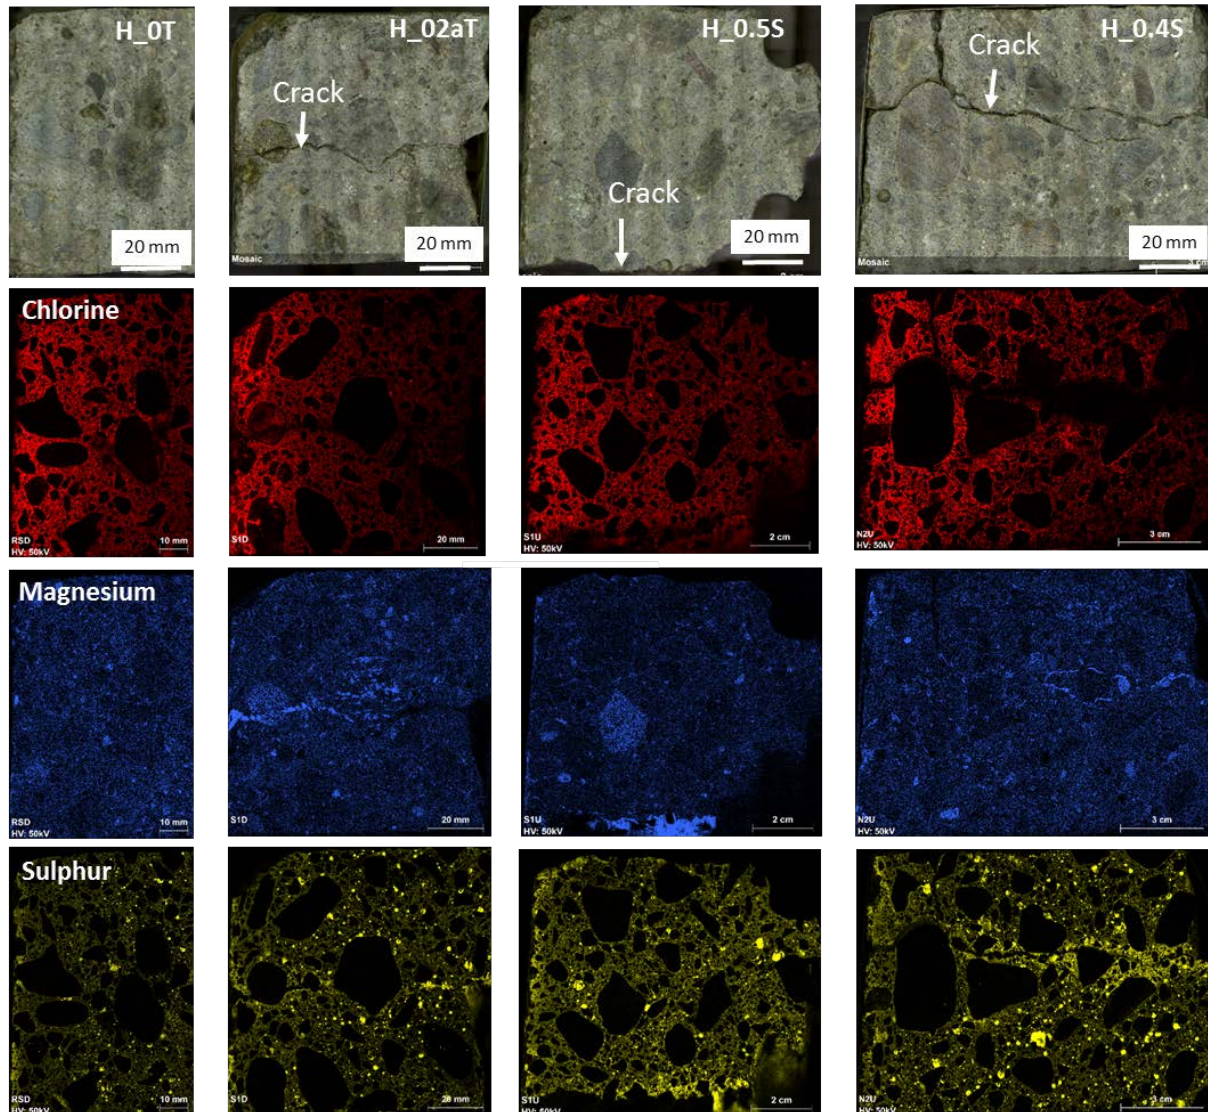
Figure 7 shows the chlorine, magnesium and sulphur maps of four concrete cores from Hafrsfjord Bridge from the tidal and splash zone. The first core to the left is the reference core with no crack. In the field, it was observed that the crack mouth was sealed in the tidal zone. The same cracks but higher up (splash zone) had an open crack mouth. When the concrete cores were extracted, the crack surfaces did not show signs of self-healing, independently of exposure. Most cores fell apart along the crack surface and had to be taped together for  $\mu$ -XRF analysis. The cracks of the concrete cores shown in Figure 7 appear therefore larger than the original size. The sealing of the crack mouths in the tidal zone might be explained by leaching from the cement paste followed by precipitation. Although, no self-healing was observed, magnesium precipitation on the crack surfaces was detected with  $\mu$ -XRF in all cores. Furthermore, ingress of sulphate through the cracks is clearly visible from the sulphate maps. While magnesium seems to precipitate on the crack surfaces, sulphur appears to diffuse into the concrete. Magnesium and sulphate were detected as deep as 100 mm in core H\_0.4S. The very light spots in the sulphur maps are pores, and are also visible in the calcium mapping. This could be explained by potential precipitation of gypsum on the pore walls. Despite, the clear ingress of seawater in to the cracks, an impact of the cracks on chloride ingress was not detectable.

Figure 7 - Chlorine, magnesium and sulphur maps from cores from the Hafrsfjord Bridge. **Left:** Core H\_0T without crack from the tidal zone; **Middle left:** Core H\_0.2aT, surface crack width 0.2 mm, from the tidal zone at the same height as core H\_0T; **Middle right:** Core H\_0.5S, surface crack width 0.5 mm from the splash zone; **Right:** Core H\_0.4S, surface crack width 0.4 mm, from the splash zone.

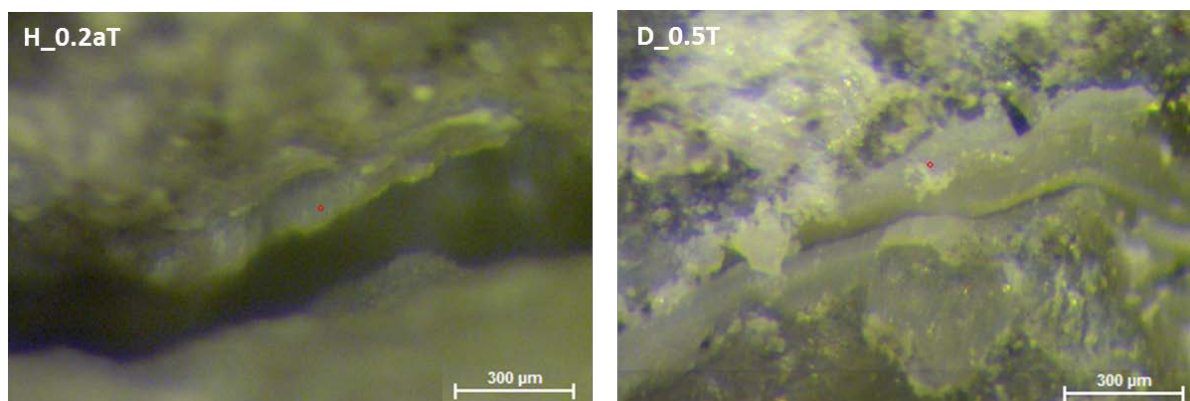
As mentioned before, magnesium precipitation was observed inside cracks for both, the DNV column and Hafrsfjord Bridge. However, self-healing was only observed in cores taken from the DNV column. Figure 8 shows a close up picture of the crack in core H\_0.2aT from Hafrsfjord Bridge and core D\_0.5T from the DNV column. In core H\_0.2aT we can see an open crack with some precipitation on the crack surface. In core D\_0.5T we can see a layer of products closing the crack. In both cases, the phases were rich in calcium and magnesium.

Figure 8 - Left: Open, not self-healed crack of core H\_0.2aT from the Hafrsfjord Bridge; Right: Closed, self-healed crack of core D\_0.5T from the DNV column.
