In-Situ and Laboratory Investigation on Leaching and Effects of Early Curing of Shotcrete

During the construction of a rock tunnel in Stockholm, several sections with leaching shotcrete (sprayed concrete) were found one year after the spraying was completed. An investigation was therefore conducted, and its results are presented in this paper. The amount of leaching after such a short time indicated that a one-sided water pressure existed in combination with a permeable shotcrete. The reason for the water pressure was likely a partly unsuccessful grouting that created sections with leaking water. The permeable shotcrete could be a combined result of insufficient curing and the use of accelerators, and the effect of in-situ curing was therefore investigated. A total of six slabs were sprayed and cured under different conditions in the tunnel. Test results according to standards indicated that curing has no significant effect on the development of mechanical strength or water penetration through the shotcrete. However, this is believed to be a

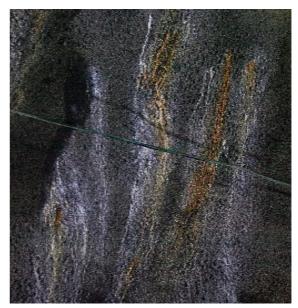
During the construction of a motorway tunnel in Stockholm, sections with leaching shotcrete were found one year after completing spraying, see examples in Figure 1. The extent of the leaching was more severe in these sections compared to the rest of the tunnel. Leaching is a deterioration process in which the calcium hydroxide (CH) in the concrete is dissolved in water and transported to the surface. This occurs through cracks or through a very porous concrete and is characterized by a white precipitation on the surface [5, 6]. Due to the extent of leaching at such an early age, it was believed that this had occurred through cracks in the shotcrete and that insufficient curing of the shotcrete was the reason for the formation of cracks. An investigation was conducted to determine: *i)* the presence and size of cracks in the leached areas, *ii)* the cause of leaching and *iii)* if curing of young shotcrete effects its mechanical strength and bond strength to the rock.

Figure 1 - Examples of leaching in shotcrete one year after completion.

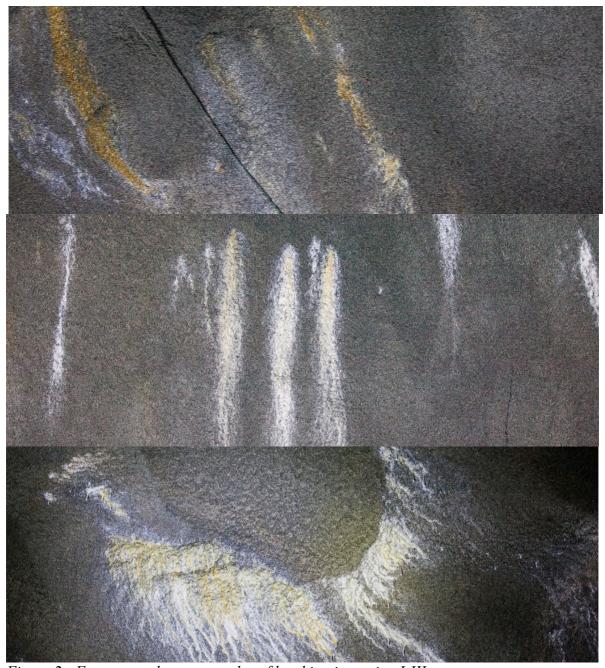
Based on photos and a preliminary in-situ inspection of the shotcrete, some sections were selected for a detailed inspection. The primary theory was that leaching had occurred through cracks in the shotcrete and that this could have caused damage to the interface between shotcrete and rock. A skylift was used to get close to the surface. The bond was tested by striking the surface with a hammer and a crowbar and observing the sound. In all tested sections, no signs of bond failure could be detected. However, the utmost quality of the shotcrete was on many locations poor and broke on impact. On most locations this corresponded to a couple of millimetres of shotcrete. The shotcrete was visually inspected at hand-close range, but no cracks were found. This indicates that if crack exists, their length and width should be limited. Some of the sections with precipitation were still wet which indicates that the leaching process had not stopped. On these locations, the source of leaching seemed to be circular holes with a corresponding size to large aggregates. In the sections where the surface was dry, leaching could have occurred through cracks that where healed and closed during the process.

In Figure 2, three examples of leaching from three different sections (I to III) in the tunnel are shown. These sections are supported with 50 to 75 mm FRS in combination with systematic bolting with a bolt distance of 2.0 m. In section I, the precipitation has a rusty/brown colour. According to the geotechnical investigation of the rock for section I, water was leaking from two grouting holes in the area and from several joints in the rock which contained iron. This iron content is the most likely explanation for the colour of the precipitation. For section II, a 0.5 to 10 mm wide and clay filled joint crosses the entire tunnel. Water leaks from joints which seems to coincide with the section of leaching. In section III, a large area of leaching is visible in the roof of the tunnel. According to the geotechnical investigation, a 0.5 to 2.0 mm wide and dry rock joint runs along the roof of the tunnel.

Figure 2 - From up to down, examples of leaching in section I-III.

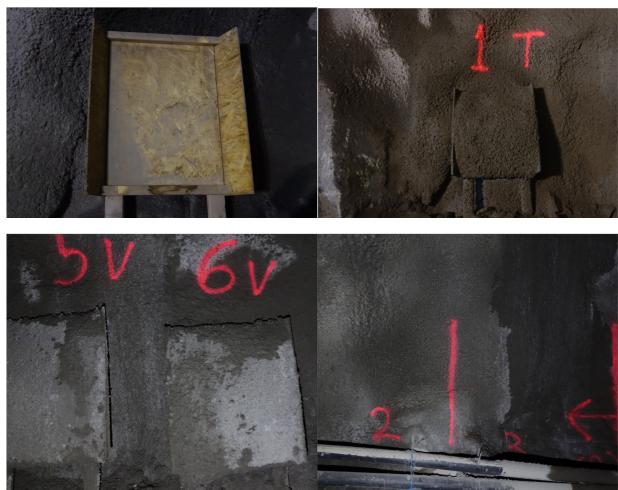
Figure 3 - From top to bottom, left to right i) mould for test samples, ii) marking after finished spraying, iii) drying process and iv) shotcrete sprayed on rock for bond test and extent of wet area at the third section.

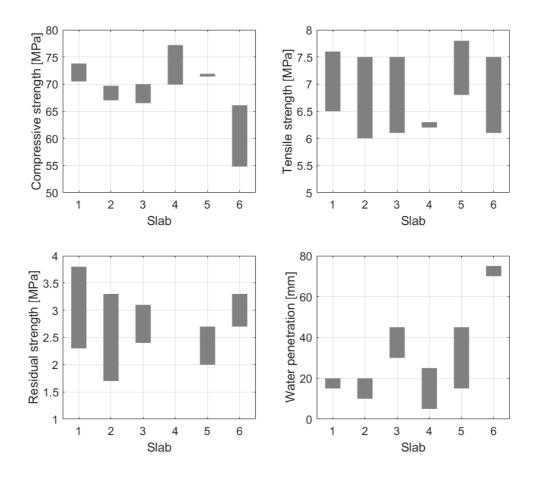
Results for compressive strength, water penetration, flexural and residual strength (for a deformation of 2 mm) are shown in Figure 5. The results are presented for each slab and each bar represents the range of three results. For compressive strength and water penetration, there is a clear difference between the results for Slab 6 compared to the other five slabs. Water was added to this slab during the first 48 hours and in contrast to what is expected, the compressive strength is lower and the water penetration higher compared to the other slabs. However, for flexural and residual strength no unexpected difference exist between the slabs.

Figure 5 - Test results for compressive strength, water penetration, flexural strength and residual strength at a deformation of 2 mm. Each bar represents the range of results for one slab.

The anticipated results from the experiment was an improved strength and a decreased water penetration for the samples that were water cured. Clearly, no such improvement can be seen based on the results presented in Figure 4. This could indicate four things:

- The thickness of the specimen should be the same as the thickness of the rock support.
- Tests could be performed on beams sawn from slabs [20] or on round panels [23].
- After spraying, the top surface of slabs and panels should be smoothed to decrease the effects of stress concentrations implied by the irregular surface.
- Slabs and panels are cured under desired conditions.
- Beams or panels are tested by putting the top surface which is most affected by curing in tension.
