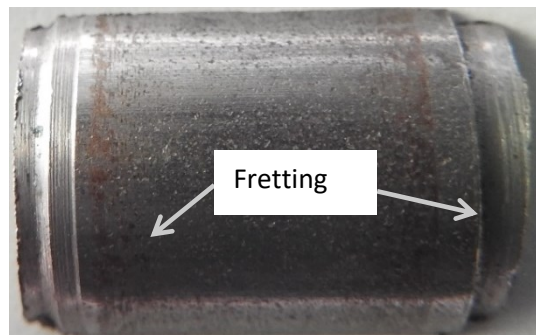
Fig. 4. Signs of fretting wear on the surface of the wheelset axle

Signs of fretting wear appear on both sides of the wheel seat in form of a 3.5 mm wide ring around the entire wheel seat perimeter. Wear signs are brown, which indicates oxidising of wear products present in that area. The literature contains research works in which authors describe the wear mechanism and explain the characteristic brown colour. The areas with wear signs were observed using a scanning electron microscope. Sample results are presented in Fig. 5.

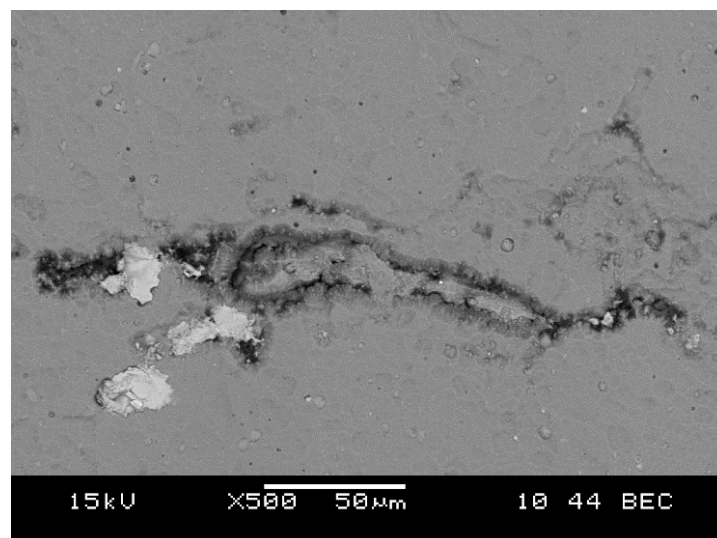
Fig. 5. Microscopic image showing the cracks on the surface and accumulations

The presented scanning images of shaft wheel seats indicate that fretting wear appears mostly in form of accumulation of materials that are subject to plastic deformations and oxidising. The observation of the surface also indicated local abrasion and micropits. The observed surface abrasion is the result of the microcutting process.
