# PRODUCTION ENGINEERING ARCHIVES

## An analysis of the causes of track twist at high speed of driving

Andrzej Pacana<sup>1</sup>, Dominika Siwiec<sup>2</sup>

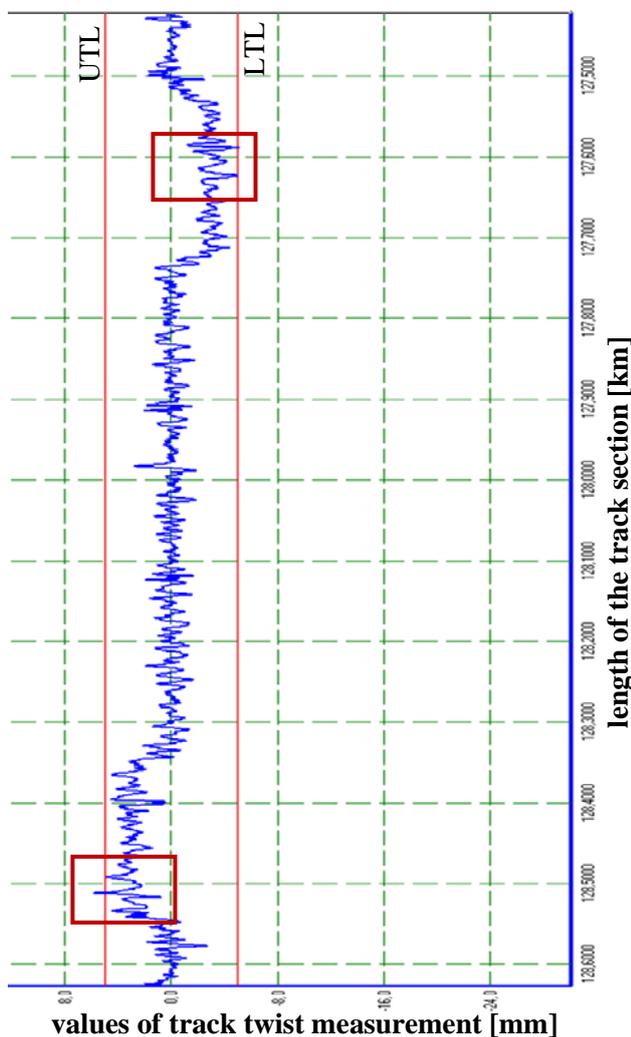
After analyzing the results from the geometric measurement of the track in the case of achieving the possible speed of 180 km/h the track twist was identified (fig. 3). Three values occurred that were not within the tolerance limit of the admissible deviation of track twist. The first value, which was not within the upper tolerance limit (UTL) amounted 6,25 mm and it occurred on the measuring section at the point of 127,5120 km. The second and third value, which was not within the lower tolerance limit (LTL) of the admissible deviation of track twist amounted respectively -6,05 mm and - 6,09 mm and they occurred on the measuring section of, respectively 127,6240 km and 127,5900 km.

Fig. 3. An example of a chart for twisted track at a rail vehicle speed of 180 km/h for the total measurement performed on a 1,1270 km section. Own study

The first of the track (from 128,5470 km to 128,3400 km) was characterized by the values of track twist significantly close to the upper tolerance limit of the admissible deviation of track twist (6 mm). While the second section of the track

(from 127,7130 km to 127,5350 km) was characterized by the values of track twist significantly close to the lower tolerance limit of the admissible deviation of track twist (-6 mm). It was concluded that in the case of achieving the possible speed of 180 km/h on the section track which was analyzed, the track twist occurred and it could be problem in the view of safety and the comfort of driving a rail vehicle. In order to identify the potential causes of the problem (the track twist) the Ishikawa diagram was drawn up (fig. 4).

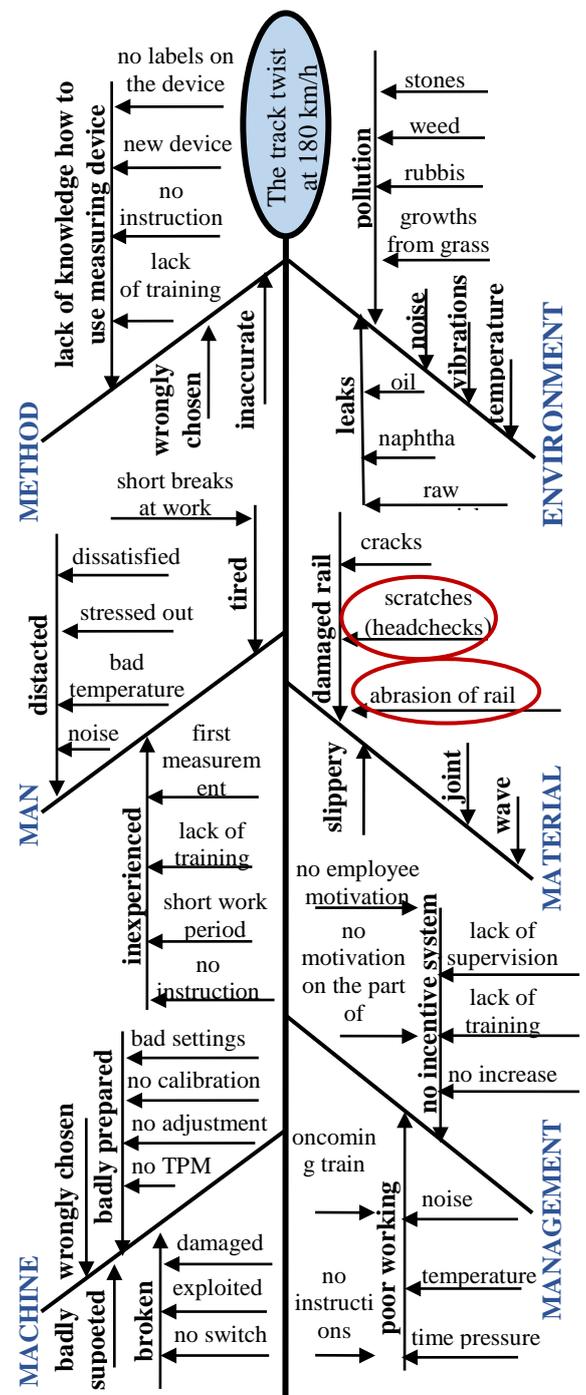
Fig. 4. An example of Ishikawa diagram for the analyzed problem. Own study

After analyzing the problem (the track twist at the speed of 180 km/h occurred) by using the Ishikawa diagram it was concluded that the main causes of the problem are scratches (the so-called headchecks) and abrasion of rail. These inconsistencies occurred locally on the rolling surface and both side surfaces of the head of the rails (Guide, 2017). The scratches, or headchecks, developed mainly in the arches with radius of 600 – 1000 m. The abrasion of rail appeared as local wipe-down of rails, which resulted from start of heavy trains. These faults occurred at the depths ranging from a fraction to a few millimeters from the surface of the rail (Bałuch, 2009; Grulkowski, 2014; Stencel, 2016). In order to identify the source cause of the problem (the track twist) the 5Why method was applied (fig. 5).

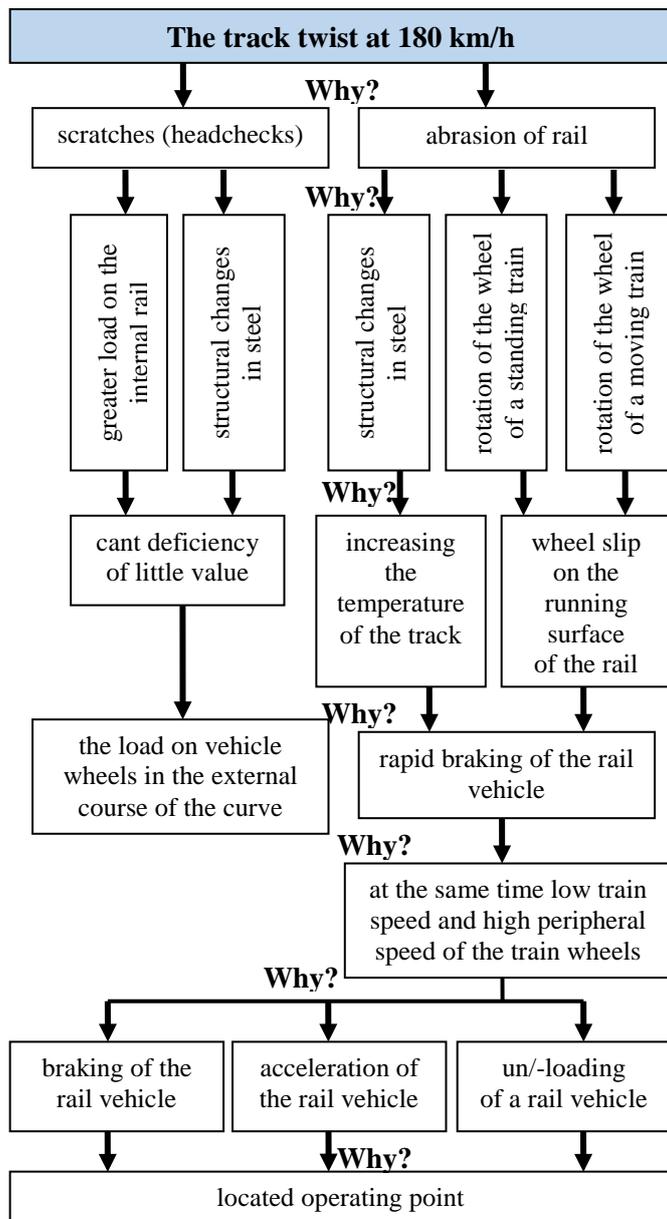
Fig. 5. An example of 5Why diagram for the analyzed problem. Own study

Analysis of the problem of track twist at possible speed of 180 km/h of a rail vehicle using the 5Why method allowed to identify the source cause of the problem which was a located operating point, i.e. railway station or level crossing.
