PRODUCTION ENGINEERING ARCHIVES

An analysis of the causes of track twist at high speed of driving

Andrzej Pacana¹, Dominika Siwiec²

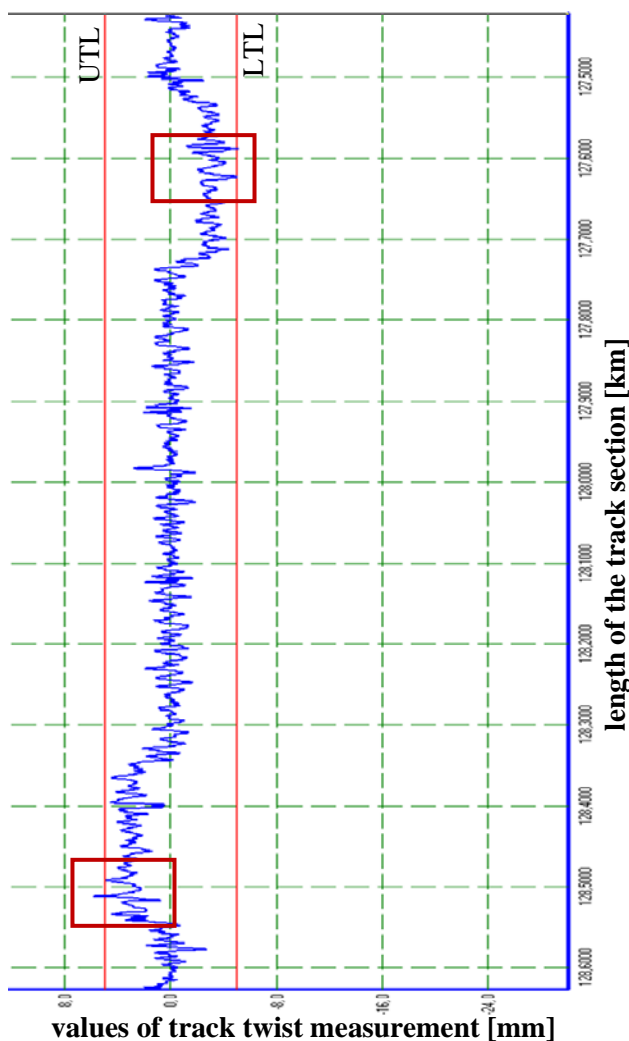
After analyzing the results from the geometric measurement of the track in the case of achieving the possible speed of 180 km/h the track twist was identified (fig. 3). Three values occurred that were not within the tolerance limit of the admissible deviation of track twist. The first value, which was not within the upper tolerance limit (UTL) amounted 6,25 mm and it occurred on the measuring section at the point of 127,5120 km. The second and third value, which was not within the lower tolerance limit (LTL) of the admissible deviation of track twist amounted respectively -6,05 mm and - 6,09 mm and they occurred on the measuring section of, respectively 127,6240 km and 127,5900 km.

Fig. 3. An example of a chart for twisted track at a rail vehicle speed of 180 km/h for the total measurement performed on a 1,1270 km section. Own study

The first of the track (from 128,5470 km to 128,3400 km) was characterized by the values of track twist significantly close to the upper tolerance limit of the admissible deviation of track twist (6 mm). While the second section of the track

(from 127,7130 km to 127,5350 km) was characterized by the values of track twist significantly close to the lower tolerance limit of the admissible deviation of track twist (-6 mm). It was concluded that in the case of achieving the possible speed of 180 km/h on the section track which was analyzed, the track twist occurred and it could be problem in the view of safety and the comfort of driving a rail vehicle. In order to identify the potential causes of the problem (the track twist) the Ishikawa diagram was drawn up (fig. 4).

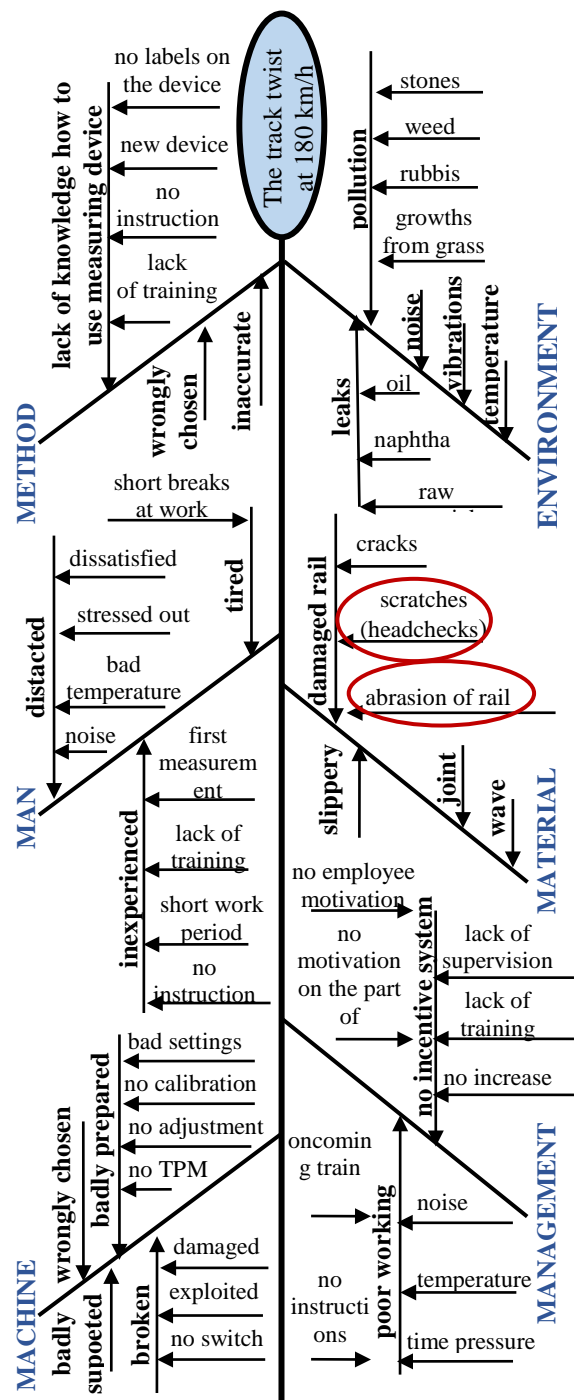
Fig. 4. An example of Ishikawa diagram for the analyzed problem. Own study

After analyzing the problem (the track twist at the speed of 180 km/h occurred) by using the Ishikawa diagram it was concluded that the main causes of the problem are scratches (the so-called headchecks) and abrasion of rail. These inconsistencies occurred locally on the rolling surface and both side surfaces of the head of the rails (Guide, 2017). The scratches, or headchecks, developed mainly in the arches with radius of 600 – 1000 m. The abrasion of rail appeared as local wipe-down of rails, which resulted from start of heavy trains. These faults occurred at the depths ranging from a fraction to a few millimeters from the surface of the rail (Bałuch, 2009; Grulkowski, 2014; Stencel, 2016). In order to identify the source cause of the problem (the track twist) the 5Why method was applied (fig. 5).
