PESD, VOL. 11, no. 2, 2017

ANALYSIS OF THE HYDROCLIMATIC RISK PARAMETERS AT THE HIGH LEVEL OF THE TAZLĂUL SĂRAT RIVER IN 2016 YEAR

Mihail Luca¹, Mihaela Avram²

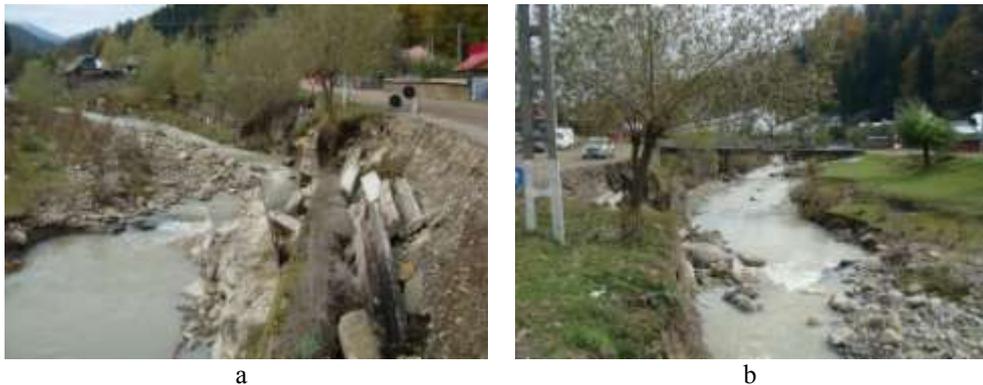
Zone 1 - "Toderaş". The shore defence is executed from a simple concrete wall to the road elevation. The shore defence was degraded by 40-90% over a length of 60 m. The flood waves have morphologically modified the Tazlăul Salt Riverbed in the "Toderaş" curvature area, causing the bedding to be dampened and the tallo descended, which influenced the shore defence behaviour and the degradation over time. The defence of the wall of a support wall made of simple concrete, located on the left bank in the curvature area, was completely destroyed in the central section (Fig. 4). The river also acts on small water on the bank, resulting in the continuous degradation of the structural components of the defence and further on the foundation layer of the communal road.

Fig. 4. General view of the morphology of the Tazlăul Sărat riverbed and the state of degradation of shore defence and DC 180A in Zone 1 "Toderaş": a - general view from downstream with highlighting the erosion of the road; b - upstream view (Oct 2016)

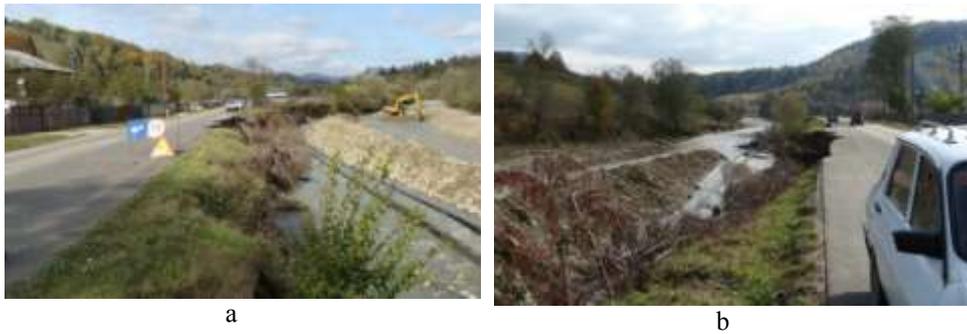
Zone 3. "Chiosa". The Tazlăul Sărat River has a right curve in this area, after which it maintains a linear downstream (Fig. 5a). At the end of the curve, the riverbed and the left bank lie near the DC 180A communal road.

Fig. 5. The degradation phenomena of the riverbed in Zone 3, "Chiosa" after the flood in June 2016 on the Tazlăul Sărat River: a - upstream view of the river bed change and erosion; b - downstream view, highlighting oil piping and breaking the DC180A (photo Oct 2016)

shoreline and shoreline construction. The unprotected bank of the Tazlăul Sărat River was eroded on a length of 80 m and an entrance to the shore of 0.5-5.0 m.

The erosion phenomenon has caused road breakage and traffic constraint. Crude oil pipelines and electric cables are located (buried) in the shore area. The erosion of the shore caused the pipes to be cut off and suspended (Fig. 5.b). The field analysis did not reveal the presence of shore defence.

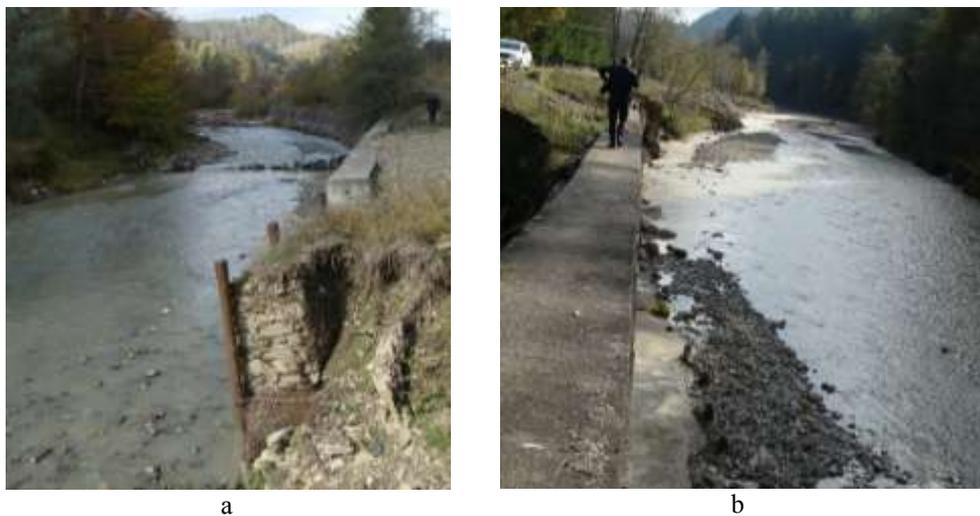
Fig. 6 - General view of the evolution bed of the Tazlăul Sărat River in area 4 "The Forest Canton Maxim": a - upstream view of the erosion area; b - downward view (photo Oct 2016)

Zone 4. "Forest Canton Maxim". The Tazlăul Sărat River bed has an approximately trapezoidal shape in this area, with a bottom width of about 16.0 m and a height up to the crown of the shore defence of 4.0 m. The left bank is vertical, being made by shore defence, and the right bank shows a slop slope 1: 0.5-0.8.

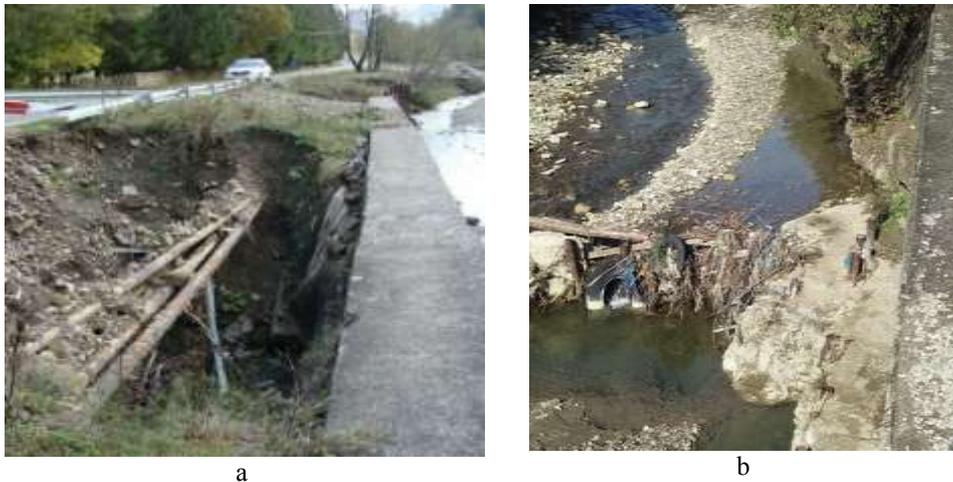
The first sub-area is located at the entrance to the analyzed riverbed sector, where the shore defence consists of a support wall made of plain concrete (foundation height - 1.00 m, elevation height 3.00 m, crown thickness 0.80 m). The water flow in the curvature area has a high velocity, causing an erosion phenomenon of the thalweg and the left bank.

The lowering of the thalweg has influenced the stability of the support wall foundation. The foundation has been scattered over its entire length over a relatively long time (Fig. 7.b). The water penetrated under the foundation and made several flow paths in the massive bed of cohesive material of the bed. Through these voids, an infiltration stream or pressurized water jet was formed, which

Fig. 7. Erosion phenomenon of the left bank after the flood in June 2016 on the Tazlăul Sărat River in Zone 4 "Forest Canton of Maxim": a - general view of the erosion zone behind the shore defence at the DC 180A limit; b - fencing phenomenon in the shore defence foundation area (Oct. 2016)

washed the filler material behind the support wall (Figure 7.a). The erosion phenomenon of the water jet continued to the ground (Fig 7). The erosion pit

behind the supporting wall reached a width of 4.80 m, out of which 1.90 - 2.00 m have developed in the structure of the road (Luca M., 2016).

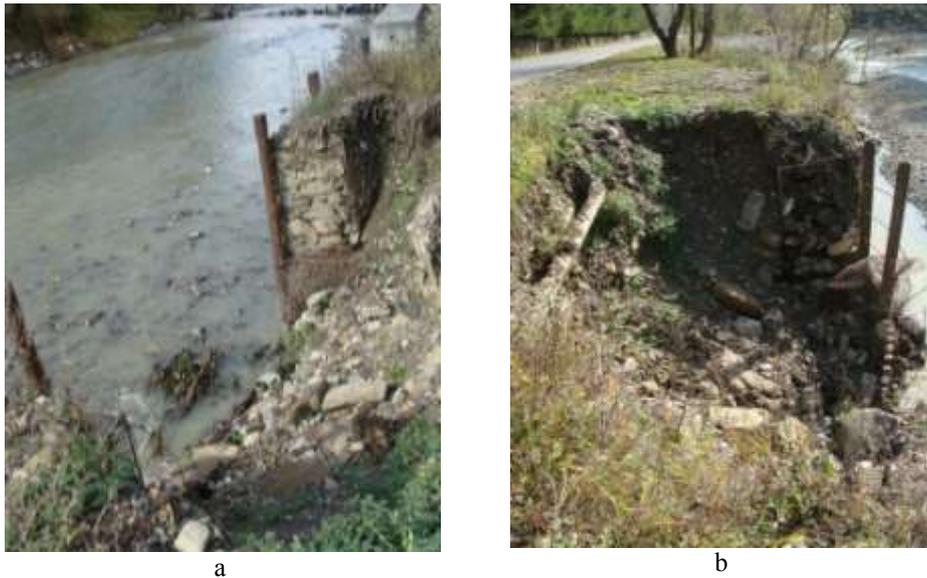
Fig. 8. Degradation of shore defence and erosion of the left bank of the Tazlăul Sărat River, the second erosion section, zone 4 "The Forest Canton Maxim": a - destruction of shore defence; b - upstream view (downstream river bed and unpacking of oil pipelines, Oct. 2016)

The second sub-area is located downstream to about 25.0 m from the first. The shore defence consists of a support wall made of gabion boxes. The water flow in the curvature area, guided by the simple concrete support wall, has created a strong erosion phenomenon here. The effect materialized through the destruction of the shore defence (gabion box support wall) on a length of about 15.0 m (Fig. 8). The erosion phenomenon continued until the road foundation (Luca M., 2016).

The degradation phenomenon of the left bank is influenced by the stable shape of the riverbed towards the right bank and by the limitation of the development of a meander to the left by the river. The hydraulic energy of the water stream turns into a mechanical deformation of the left bank in the curvature area. At the end of the road and on the bank of the river oil pipelines are buried. The erosion phenomenon of the bank and further on the road caused the pipes to be cut off and suspended. Pipeline degradation can lead to a strong oil pollution phenomenon on the Tazlăul Sărat River (Luca M., 2016).
