The influence of mining activities on the Church of St. Cross in Bytom–Miechowice

Tomasz Lipecki^{1*}, Hanna Ligarska¹ and Małgorzata Zawadzka¹

Abstract

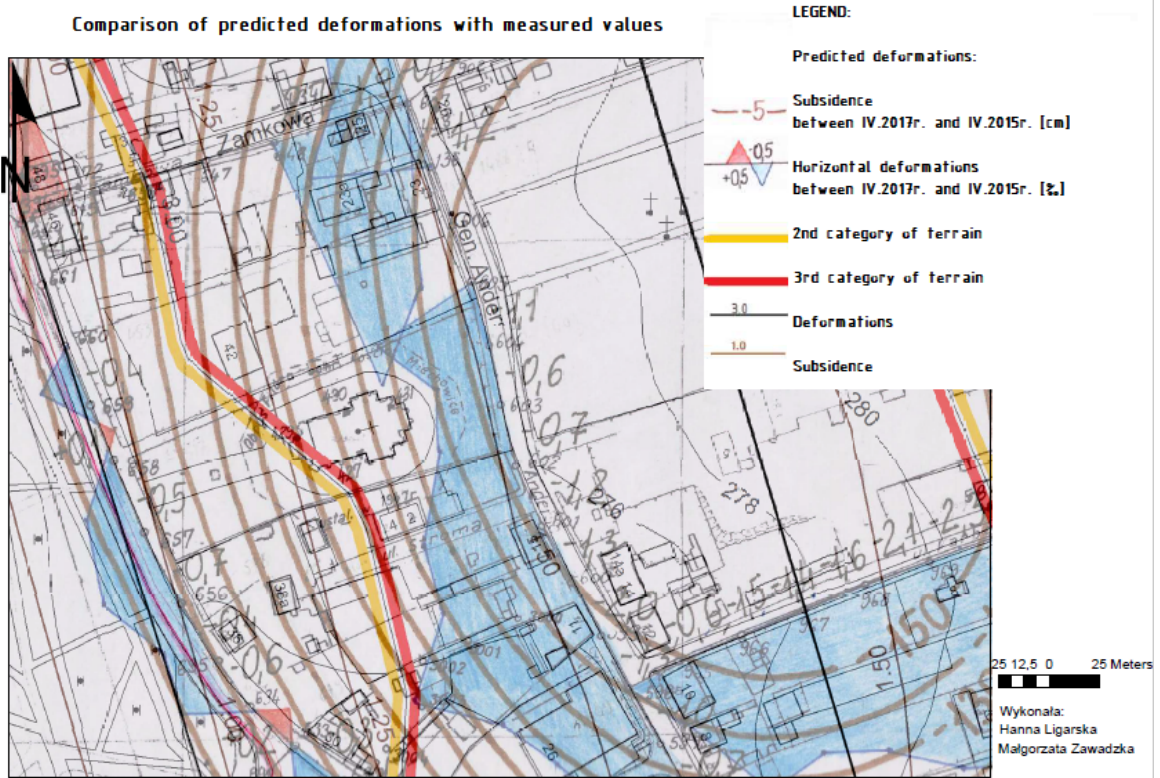
Under the church building, the expected falls were in the range of $0.9 \div 1.4$ m, rising to the north-east (Fig. 2). The compressive deformation should not exceed 11 mm/m. By comparing the measured values, it can be seen that subsidence roughly overlap with the forecasts and are contained in values of $1.0 \div 1.5$ m, rising in the same directions. In contrast, the maximum subsidence of the measured benchmarks, described in subsection 4.2, exceeds the predicted values and reaches 1.6 m. The deformations at the site beneath the church are in the II category of the mining area (strains 1.5 to 3.0 mm/m), and therefore are much smaller than the predicted (IV and V category – strains above 6 mm/m).

Figure 2. Comparison of predicted deformations with measured values [Own elaboration based on maps received from mine]

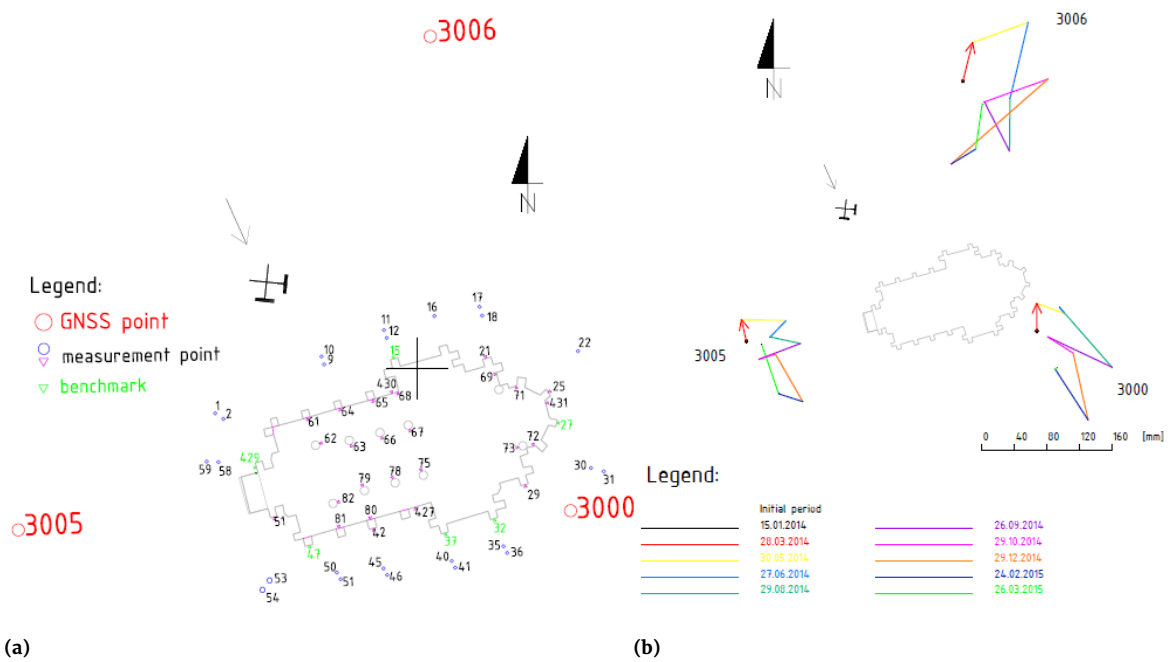
As of January 2014, the GNSS measurements (Lipecki, 2009, 2011) were performed at 3 points (Fig. 3a), near the church, monthly or every 2 months. From the third period (from 30.05.2014), the displacement of the points became different (the moment of the front of the wall under the object) in both the direction and the displacement value. The largest periodic displacement (per two months) was at point 3006. The change in the position of all points relative to the initial measurement was up to approximately 10–12 cm (Dec. 2014), decreasing successively in the following months. The overall tendency to change the position of the points has remained the same: north, then south-east and finally north again, aiming for a starting position. This was due to the development of the settlement basin and the location of the fronts of the walls in relation to the monitored points.

Figure 3. Location of test points (a) and displacement of GNSS points (b)

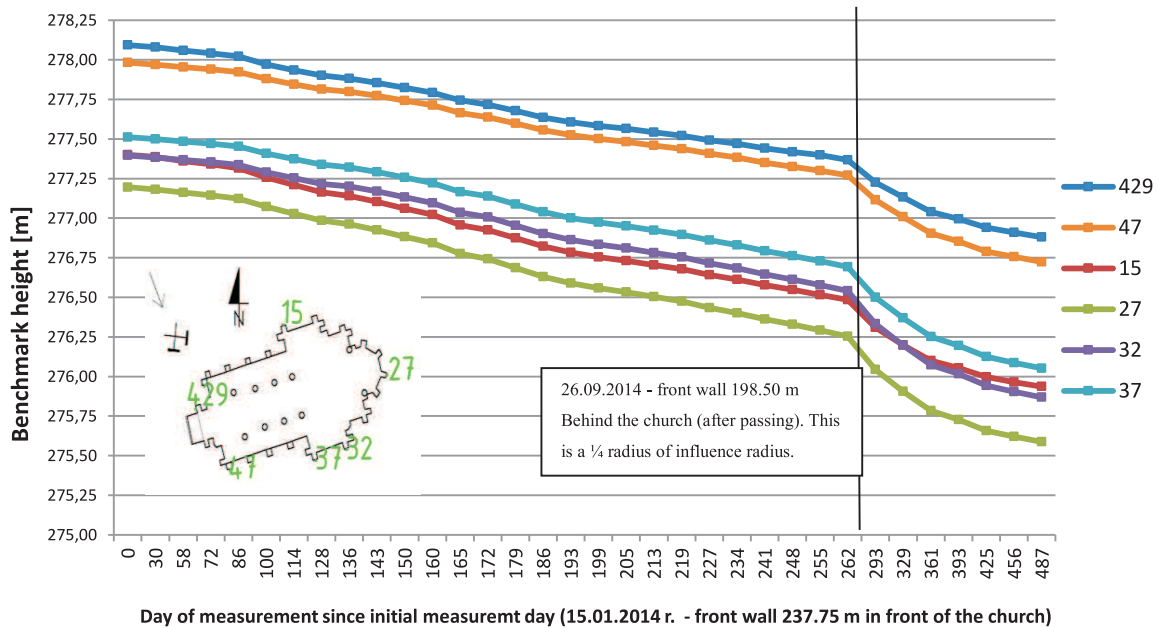
Figure 4. Summary of benchmarks subsidence from 01.2014 to 04.2015

In the initial period of running, all controlled elevation points were evenly distributed. After about 180 days (11.07.2014), when the operation was directly under the church, the values of the benchmarks were not homogeneous (the repertoire on the eastern side of the church settled more than on its western side). In analyzing the diagrams of the individual repairs (Fig. 4), it has been observed that approximately 260 days after the beginning of the operation there was a sudden decrease in elevation points (26.09.2014 when the front wall was about 200m behind the church after passing under the object) 0.3 m to 1.5 ÷ 2.0 m. In the period from 23.05.2014 (the front of exploitation was 100 m behind the object from the north) to 26.09.2014 (front of exploitation was 200 m behind the object from the south) the most intense changes took place. Approximately 260 days after the start of measurements (September 2014), a clear break is visible on the graphs of each benchmark, indicating that the subsidence process has accelerated during this time. All repercussions decreased by at least 1.2 m. The repercussion number 27 decreased the most – the reduction value is 1.6 m, that is 0.4 m more than the repertoire value of 429. These points are located on two opposite sides of the church. Benchmark # 27 is located in the eastern part of the entrance, while benchmark # 429 is in the western part of the building. This means that the object does not settle evenly, but the direction of settling of the object is consistent with the depression trough system (Figure 2). Benchmarks 32, 37, 15 and 27 are located on the eastern side of the Church and they have reached the highest settlement values, which means a higher inclination of the church building toward E – NE.

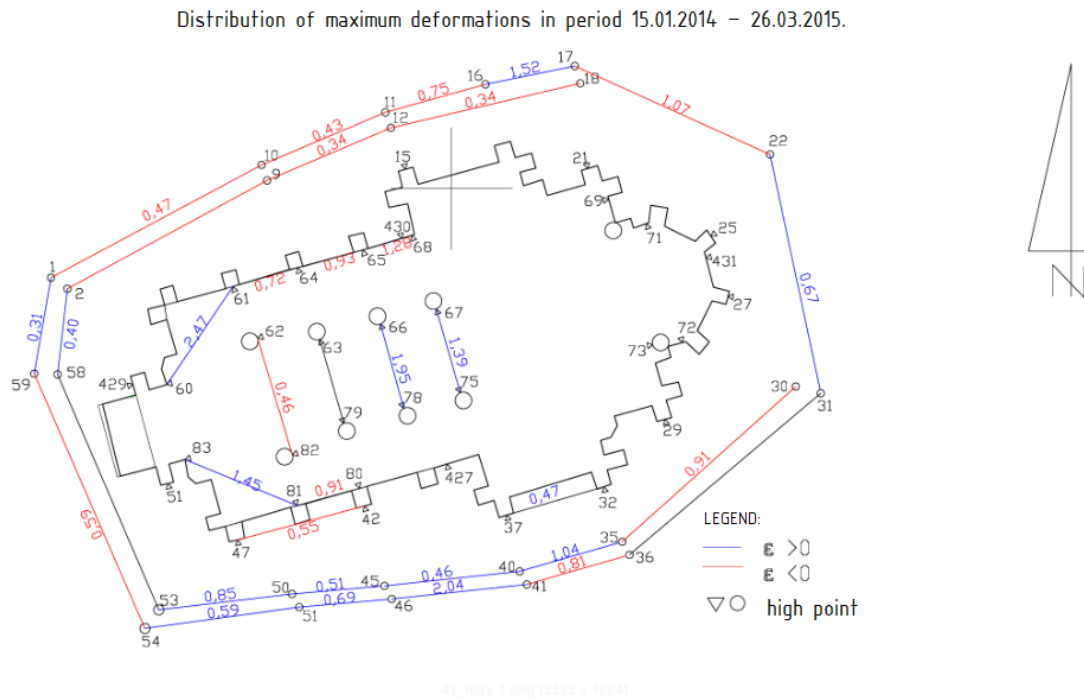
The period from 14.08 to 29.08.2014 brought the greatest deformations for the construction of the church – at that time the tensile values measured on the sections located inside the building on its western side were up to $+2.47$ mm/m. It was the time when the exploitation was already under the facility and it was about 150 m on its south side. The observed phenomenon is not consistent with the theory of behavior of the building during the transition of the basin, because at this moment the object should be affected by compressive forces, resulting from the formation of the basin after the front of the exploitation. Impact on this result can be related to exploitation of the second wall (30a) which timing is not known by the authors. When analyzing the values of deformation in time when the wall was behind the church, an analogy to the initial

Figure 5. Distribution of maximum deformations in period 15.01.2014 – 26.03.2015

It turns out that the deformations occurring in the church area mostly consist of 0 and 1 terrain categories. The exception is the strain value at length 41–46 in period 9 and 60–61 in periods 27–29 (X–XII 2014) and do not exceed the second category of terrain – reaching a maximum of +2.47 mm/m. Comparing this to the deformation forecast described in point 3, they are more than four times less than the predicted maximum values.

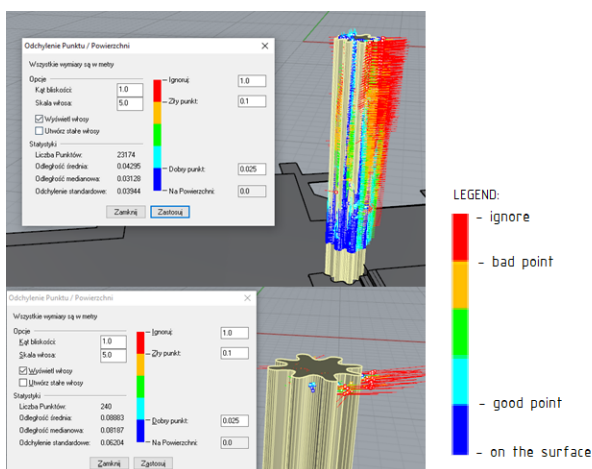
Rhinoceros software allows to determine the limit distance vectors of a given point from the reference model. For tested pillars, the value for the so-called the “good” point was taken 2.5 cm, and for the so-called “wrong” 10 cm. As a result of the analysis, three values are obtained: mean distance – the arithmetic mean of all points distances from the model, median distance – the center distance for the entire set of points and standard deviation – the distance distribution of the points from the model to the average distance. In the first place, the distance of the pillar points from the reference models (Fig. 10)

Figure 10. Declination of set points from model – pillar 1

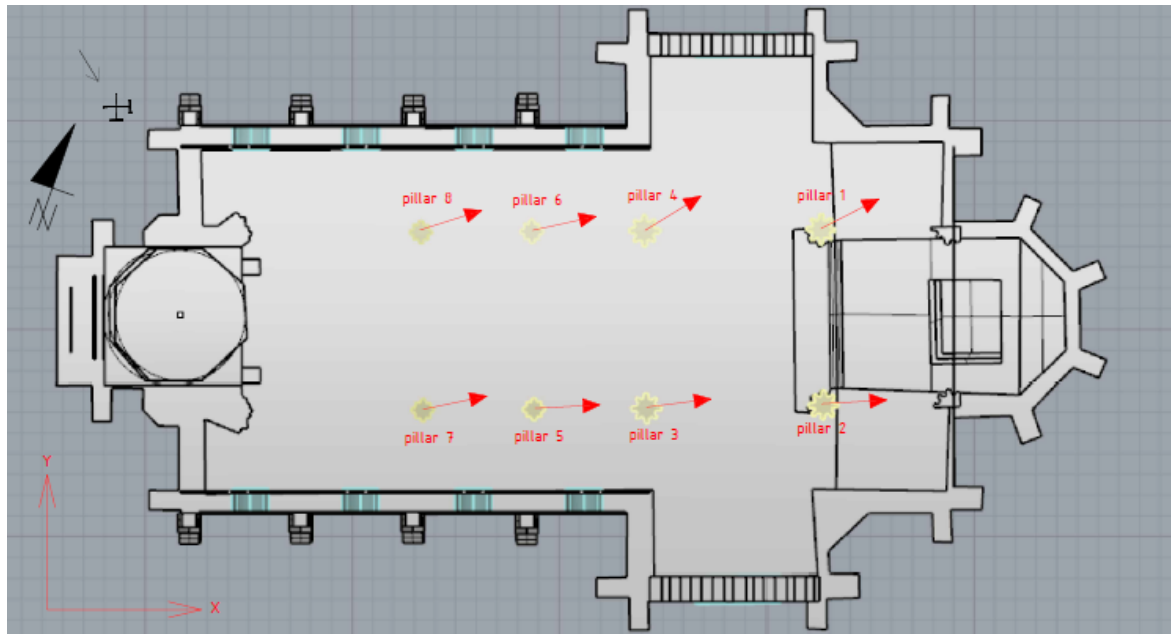
Figure 12. Direction of pillars declination in the church

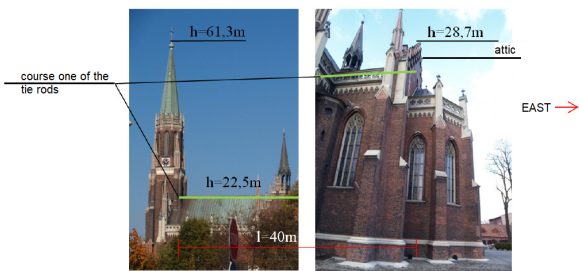
The next element analyzed was the attic (Fig. 13), which due to earlier exploitation was significantly stressed (December 2004 – 38.2‰). Measurement carried out during the last exploitation showed that its declination raised to 44.4‰ in March 2013 and to 55.4‰ in November 2014 (Kawulok et al., 2015). Analysis conducted in the Rhinoceros program showed that in June 2015 the incidence of this element was 41.8‰ (Fig. 14, Tab. 4). This means that the slope of the terrain and consequently the inclination of the attic decreased after the end of exploitation.

Figure 13. Church tower and analyzed attic – view from the south

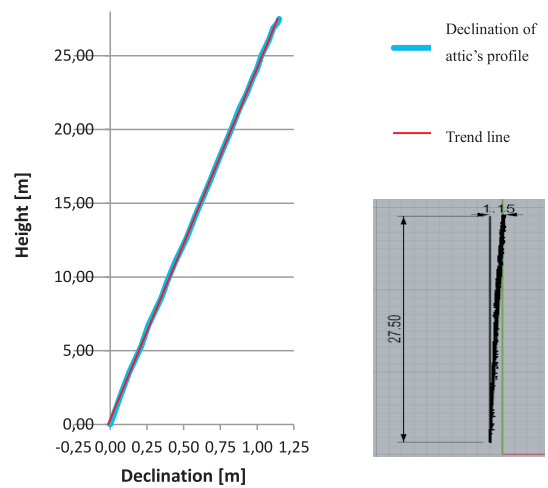
Declination's linearity was also checked by reading the value of declination on levels lower than 1 m. On this basis, the coefficients of the linear regression equation were calculated. The coordinates in the Rhinoceros program did not differ by more than 1 cm from the expected values determined from the regression equation (Fig. 15), therefore it has been found that attic's declination is linear.

Figure 15. Checking the straightness of declination of the attic from the vertical line

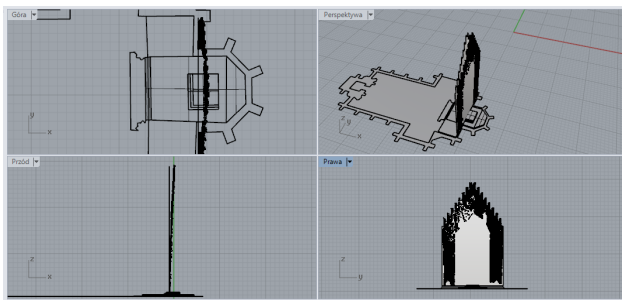
Figure 14. Declination of the attic cross-section from the vertical plane

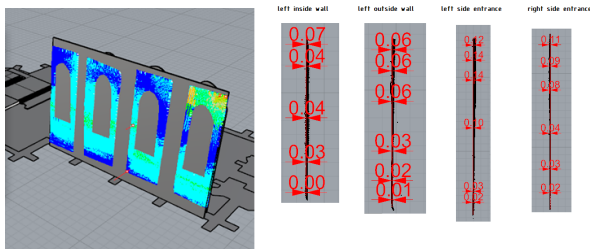
The verticality of the side walls of the church, as expected, was not significantly altered in the transverse direction of the church (Fig. 17).

Figure 17. Declination vectors of the side walls from the vertical line [m]

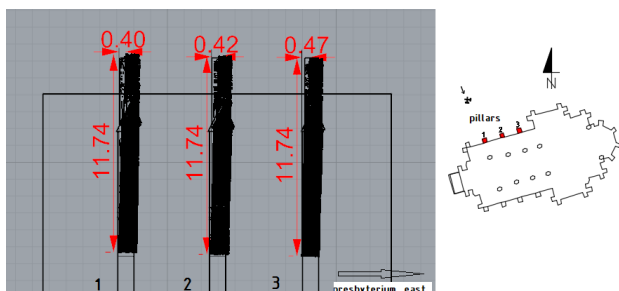
To determine the declination in longitudinal direction, declinations of window openings (Fig. 19) and the outer pillars (Fig. 18) were determined. The opening of the window openings was about 26‰, while the declination of the pillars was much higher and was 34 ÷ 40‰ (Tab. 5). Influence on such large pivoting of the pillars can have inaccurate fit in the model and complicated construction of the pillars (probable narrowing of the object up).

Figure 18. Vectors of the edge of the outer pillars from the vertical [m]

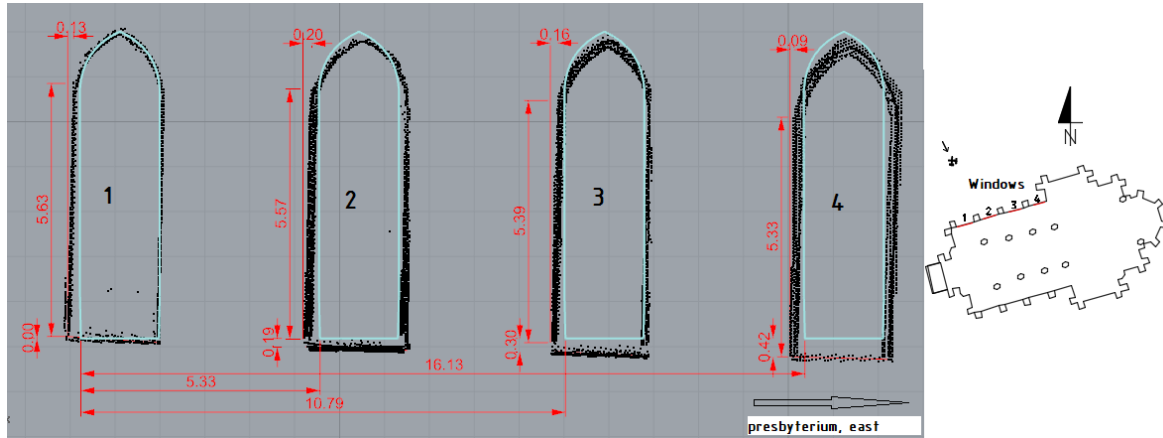
Figure 19. Declination vectors of window opening edges [m]

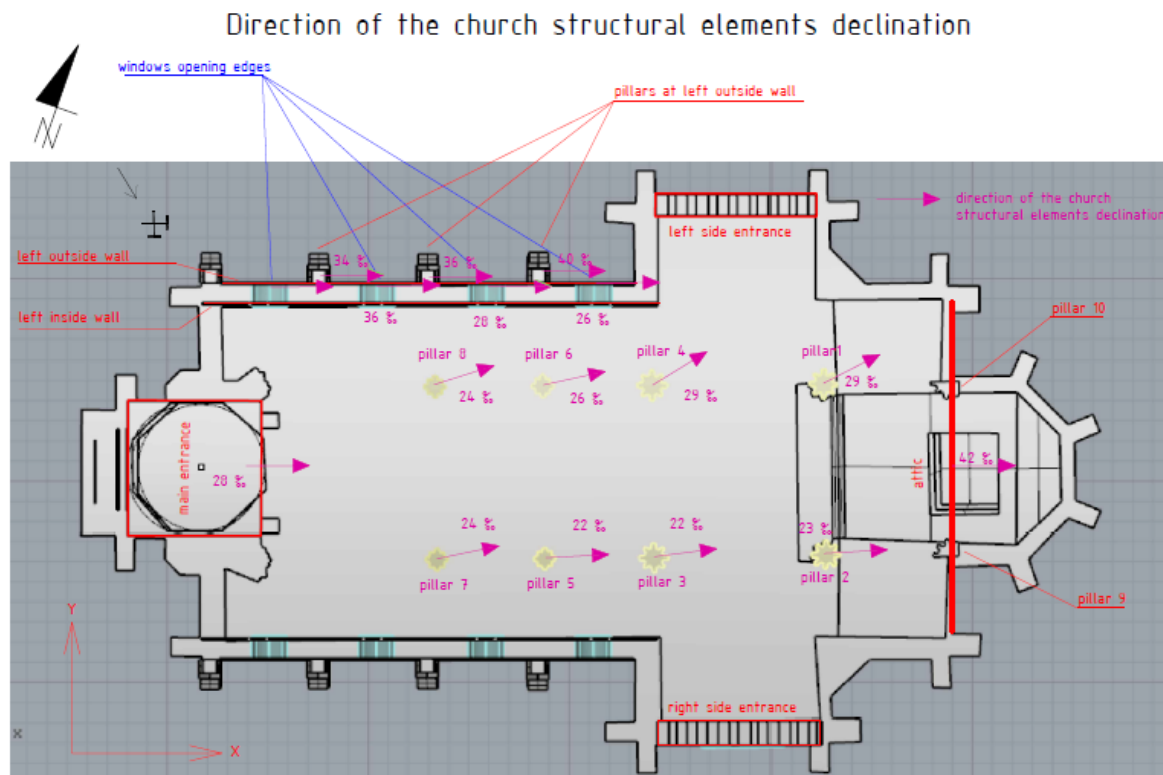
As described above, all analyzed elements tends to decline towards the church presbytery (approximately to the east direction, Fig. 20). The results below (Tab. 6) show that the declination of the church’s construction elements is approximately 28 ‰, with the exception of the attic which has been much heavier (41‰) and external pillars whose declination values is not accurate enough and it cannot be considered as reliable to determine the declination of the external pillars.

Based on the results obtained, it can be stated that church structure behaves monolithically and undergoes the same deformations (Fig. 20). The direction of these deformation is consistent with the direction of formation of the depression trough, both predicted and measured (Fig. 2). It should be noted that the calculated value of the terrain around the church, based on leveling measurement obtained from the mine, is about 13.8‰ which is much lower than analyzed elements. It should be remembered, however, that the declinations that occurred during 2014 exploitation and the previous ones have resulted in overexert of the object construction, prolonged deformation, and retention of structural elements. All the above-mentioned values of object’s elements declination belong to 5th category of mining areas which is more than ten times greater for large-space historical object. At the moment there is no coal exploitation planned in this area, and existing damage has been repaired or under repair. The reinforcements and preservations of the church’s construction applied so far have increased their safety, however ongoing building control and abandonment of coal exploitation under the church is strongly advised.

Figure 20. Direction of the church structural elements declination

- v. Periodic verification of applied protection of the church by control measurement of construction elements declination is strongly advised.
- vi. Thanks to applied protections and on-going repairs, despite the alarming results of church’s elements tilts, the objects does not show any additional structural changes.
