TECHNICAL NOTE

EXAMPLE OF THE APPLICATION OF JET GROUTING TO THE NEUTRALISATION OF GEOTECHNICAL HAZARD IN SHAFT STRUCTURES

PIOTR DYBĘŁ, DANIEL WAŁACH, JUSTYNA JASKOWSKA-LEMAŃSKA

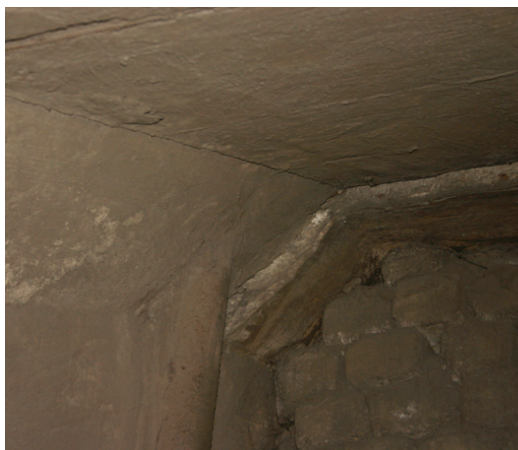
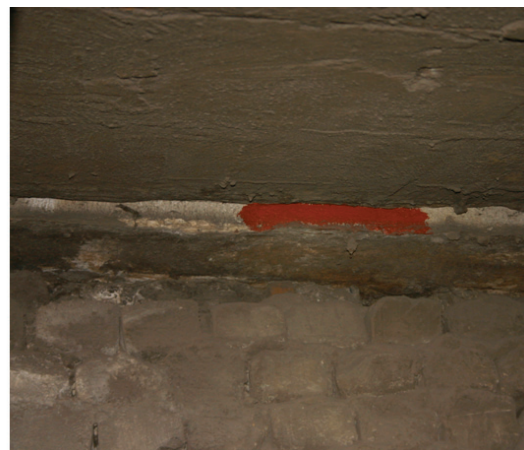
After the dislocation of the ventilation duct, a site inspection was performed, including the immediate area around the shaft, ventilation duct and the shaft top building. As a result of the displacement of the first segment of the ventilation duct in relation to the shaft collar, a possibility of additional loads affecting the shaft lining was found. These loads were not taken into account in the initial design. The research conducted by the authors included the analysis of the current condition as well as control static and strength calculations helped to assess the real hazard to shaft structures and infrastructure. It was shown that further subsidence of the ventilation duct may lead to damaging the shaft structures. Immediate protection of the

Fig. 2. Vertical displacement on the joint of the L-1 segment of the ventilation duct with shaft collar, from the shaft's side

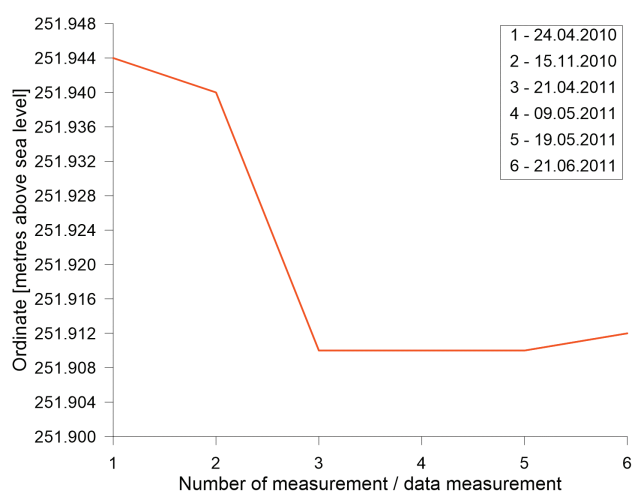
Fig. 3. Measurement point levels in the L-1 segment of the ventilation duct

placement in the period from November 2010 to April 2011 was 3.1 cm. The analysis of the surveys also shows that the subsidence process was most intensive in the spring of 2010 (Fig. 3).

The results of geodetic surveys show that the factors contributing to the displacement of the segments of the ventilation duct have stabilised. However, due to the geotechnical conditions, further subsidence cannot be excluded.

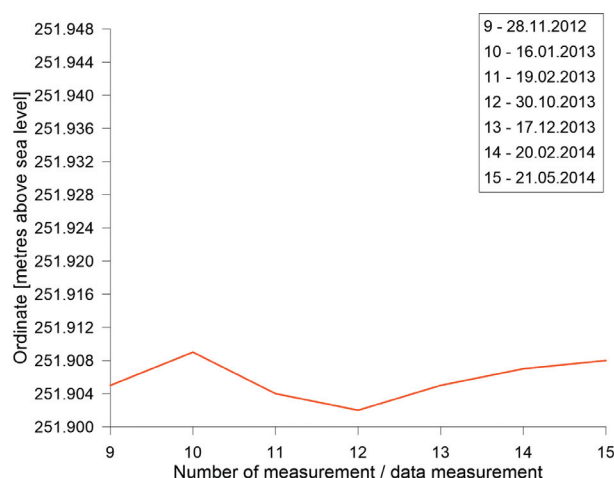
the ventilation duct. Similar dependences were found for the remaining measurement points.

Fig. 5. Measurement point levels in the L-I segment of the ventilation duct after the reinforcement of the foundation soil
