# THE IMPACT OF THE LOW THROW FAULT ON THE STABILITY OF ROADWAYS IN A HARD COAL MINE

PIOTR MAŁKOWSKI

**Abstract:** Ensuring roadways stability in hard coal mines is one of the main challenges faced by engineers. A changeable geological structure have caused the roadway's conditions to vary, thus influencing its stability. One of the causes of those changes is the presence of a previously undiscovered fault zone (small faults crossed the roadway) within which a significant convergence or support deformation may occur.

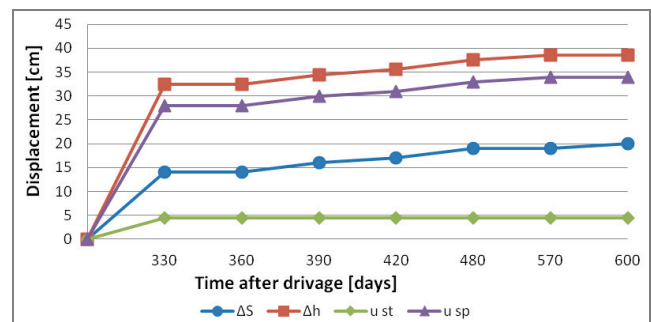
Convergence measurements in the measurement base located at 930 m of the D-2 maingate, located outside geological disturbance zones, have been carried out for 270 days. During this period, low values of roadway convergence have been noted. They were, respectively: roadway width change ( $\Delta S_w$ ) – 20 cm, roadway height change in the opening ( $\Delta h_w$ ) – 38.5 cm, average floor heaving ( $u_{sp}$ ) – 25.8 cm, and the cross section change ( $\Delta P_w$ ) – 2.87 m<sup>2</sup>. The dynamics of those changes is shown in Fig. 3, and the values obtained are presented in Table 2. After ca. 600 days from roadway drivage, its height was 384 cm, which constituted ca. 91% of the nominal height of the opening. The width of the roadway, in July 2016, constituted 96.7% of the nominal width  $S$ , which was 610 cm.

Fig. 3. Maingate D-2 convergence – base on 930 m ( $\Delta S$  – roadway width change,  $\Delta h$  – roadway height change,  $u_{st}$  – roof displacement,  $u_{sp}$  – floor heaving)

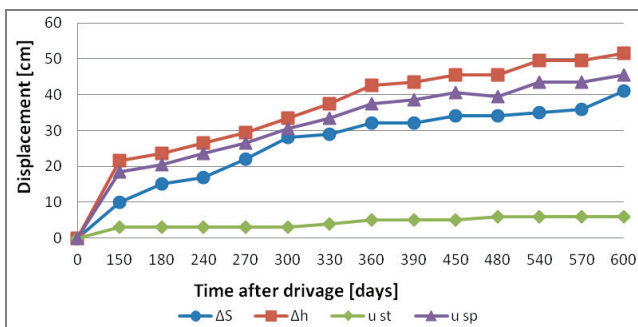
The measurement base in the fault area was installed at 790 m of the D-2 maingate. The roadway support, in this area, was additionally reinforced with a V29 steel beams. Research conducted in this base lasted 16 months; 13 measurements were taken. Results are shown in Table 3. During 450 days of observations, the width of the roadway was reduced by 41 cm, which constitutes around 7% of the original width. The roadway height, in the cross-sectional area of working, as a result of the influence of a single fault, was reduced by 12% (52 cm). Reduction of both the width and the height of the roadway in the impact zone of the fault caused the roadway cross section to decrease. As a result of steel yielding support convergence, the cross section of the roadway, after 600 days from drivage in the above-mentioned area, was at 17.5 m<sup>2</sup> (ca. 81% of the original value), which caused the ventilation conditions and the roadway functionality to deteriorate. Floor heaving, compared to the 930 m base located on the section free of geological disturbance, technically rose 1.5 times (Table 3) on its entire width. The average value of

floor heaving is 34 cm. The rate of those changes is presented in Fig. 4.

Fig. 4. Maingate D-2 convergence – base on 790 m ( $\Delta S$  – roadway width change,  $\Delta h$  – roadway height change,  $u_{st}$  – roof displacement,  $u_{sp}$  – floor heaving)

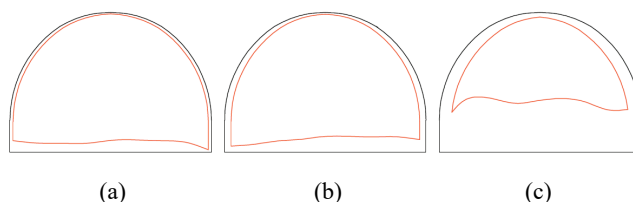
On the basis of mining research conducted during a long period (450 days), it may be observed that vertical convergence has the strongest influence on relocation in the vicinity of the roadway. Floor heaving constitutes around 90% of vertical convergence, both for bases located in fault zones and for the base located outside that zone, which was also proved in other studies [11]–[13]. The value of roadway roof lowering, in each case, is from a few to around a dozen centimeters. For the base installed under the impact zone of a single fault or a fault zone, the vertical convergence does not exceed 40 cm. For the base located at the 0.7 fault, the value of vertical convergence is ca. 52 cm – 30% higher than at the base outside the impact zone of the fault. Vertical convergence occurs evenly, almost linearly. Meanwhile, the roadway located in the fault zone is characterized by an increase in vertical convergence that is close to linear, but with a lower correlation coefficient. The value is ca. 167.5 cm and is more than 4 times higher than in the case of roadway section free of the impact of the fault. A comparison of cross section sizes of roadways in different sections is shown in Fig. 6.

Fig. 6. Maingate D-2 convergence: (a) base on 930 m, (b) base on 790 m, (c) base on 757 m

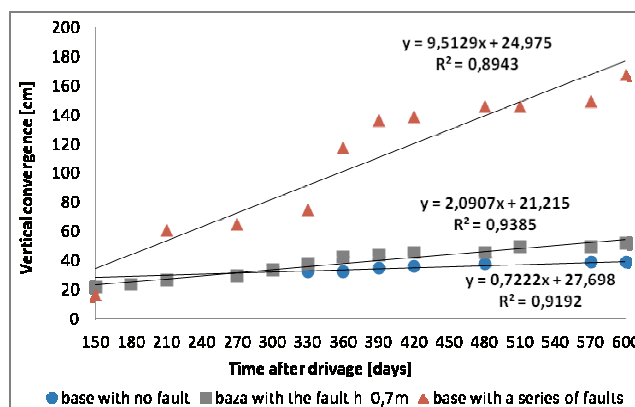
A comparison of the results of vertical convergence measurements is presented in the chart in Fig. 7. Although the roadway in the area of measurement bases located at 930 m and 790 m sections may be

considered stable, the D-2 maingate located in the fault zone at 757 m loses its stability. It is also worth mentioning that, after each floor brushing, a periodic relaxation occurs, and the increase rate of deformations slows down for 150–200 days (Fig. 7).

Fig. 7. Vertical convergence for the measurement bases
