## Bird mortality on medium-voltage power lines in the Czech Republic

Vlasta ŠKORPÍKOVÁ, Václav HLAVÁČ & Milan KRÁPEK

**Abstract:** In 2015–2016, 6,429 km medium-voltage power lines with 76,430 pylons were checked for bird mortality in the Czech Republic. 1,326 bird victims of power lines were found, 156 of which died after collisions, and 1,170 birds were electrocuted. They belonged to 60 species from 12 orders, and birds of prey made up almost half of all victims. Steel pylons bearing several cross-arms including upper and crosswise jumpers were identified as most dangerous from the electrocution point of view. On the other hand, pylons in straight lines with Pařát cross-arms (triangular arrangement of conductors without any horizontal bar) were among the least dangerous, and when they had a simple perch fitted below the cross-arm, no mortality was recorded. But these pylons are new in practice and despite becoming widely used recently, they form less than one tenth of all pylons in the Czech Republic. On other pylons various types of mitigation measures have been installed. Commonly used plastic covers and plastic strips have proved to be especially effective, but only in case

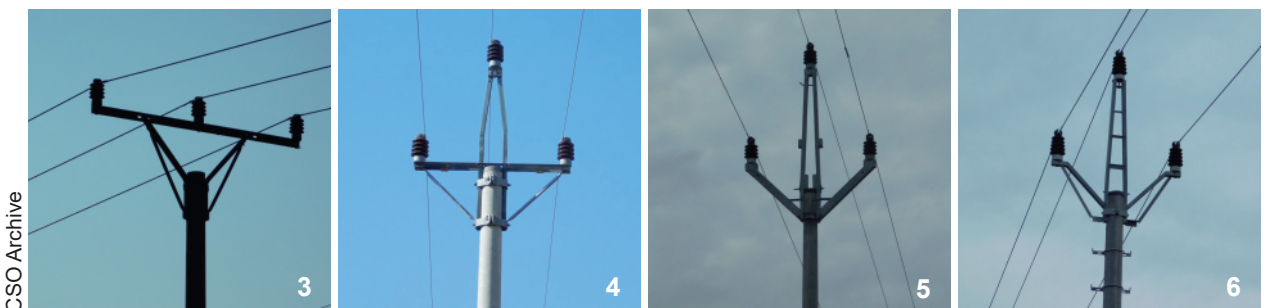
**Fig. 3–6.** Four basic cross-arm types used for medium-voltage electrical lines in the Czech Republic: a horizontal console with upright insulators (“killer pylon”; 3), Delta (4), Pařát (5) and Delta variant (6).

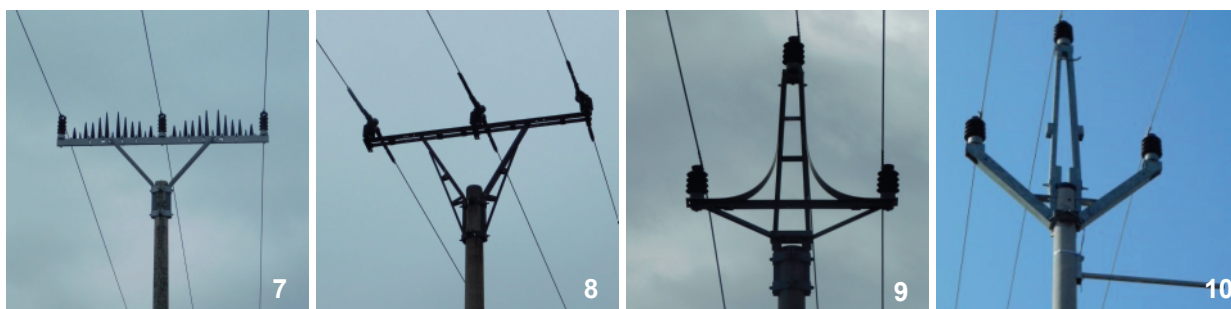
**Fig. 7–11.** Correctly installed and undamaged components used as mitigation measures on basic cross-arms: racks (7) or plastic covers (on horizontal cross-arms and upright insulators; 8), plastic strips (on Delta cross-arm; 9) or simple perch (used with Pařát, 10, and Delta variant cross-arms, 11).

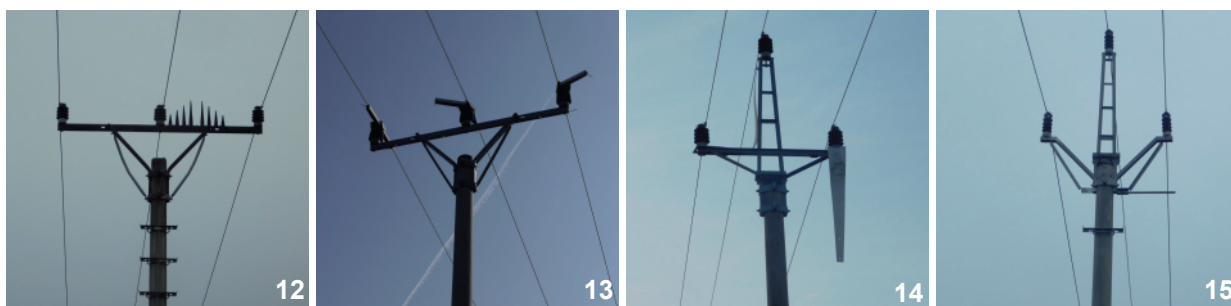
**Fig. 12–15.** Incorrectly installed or damaged components used as mitigation measures on/with basic cross-arms: racks with broken teeth or missing parts, plastic covers partly free of cables, a loose plastic strip, a perch installed too high.
