H. Smoleńska, W. Kończewicz¹

FAILURE ANALYSIS OF THE EXHAUST VALVE FACE IN DIESEL MARINE ENGINE

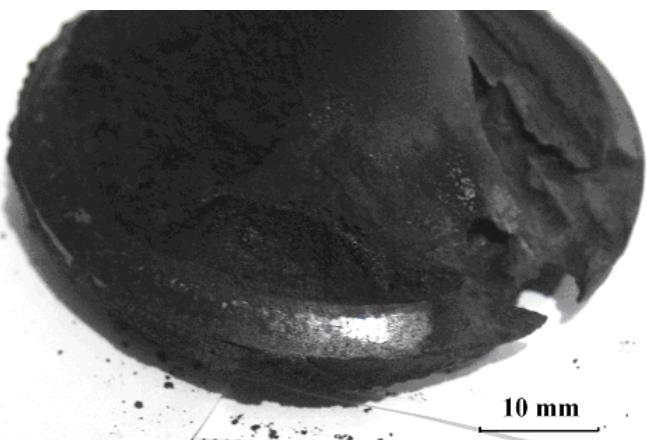
The failed valve head was presented on fig.1. The part of the face and valve disk was completely destroyed while the rest of the valve head had no visible damages. Even the valve face was still shinning in the great deal.

Fig. 1. Macro photograph of the failed valve head

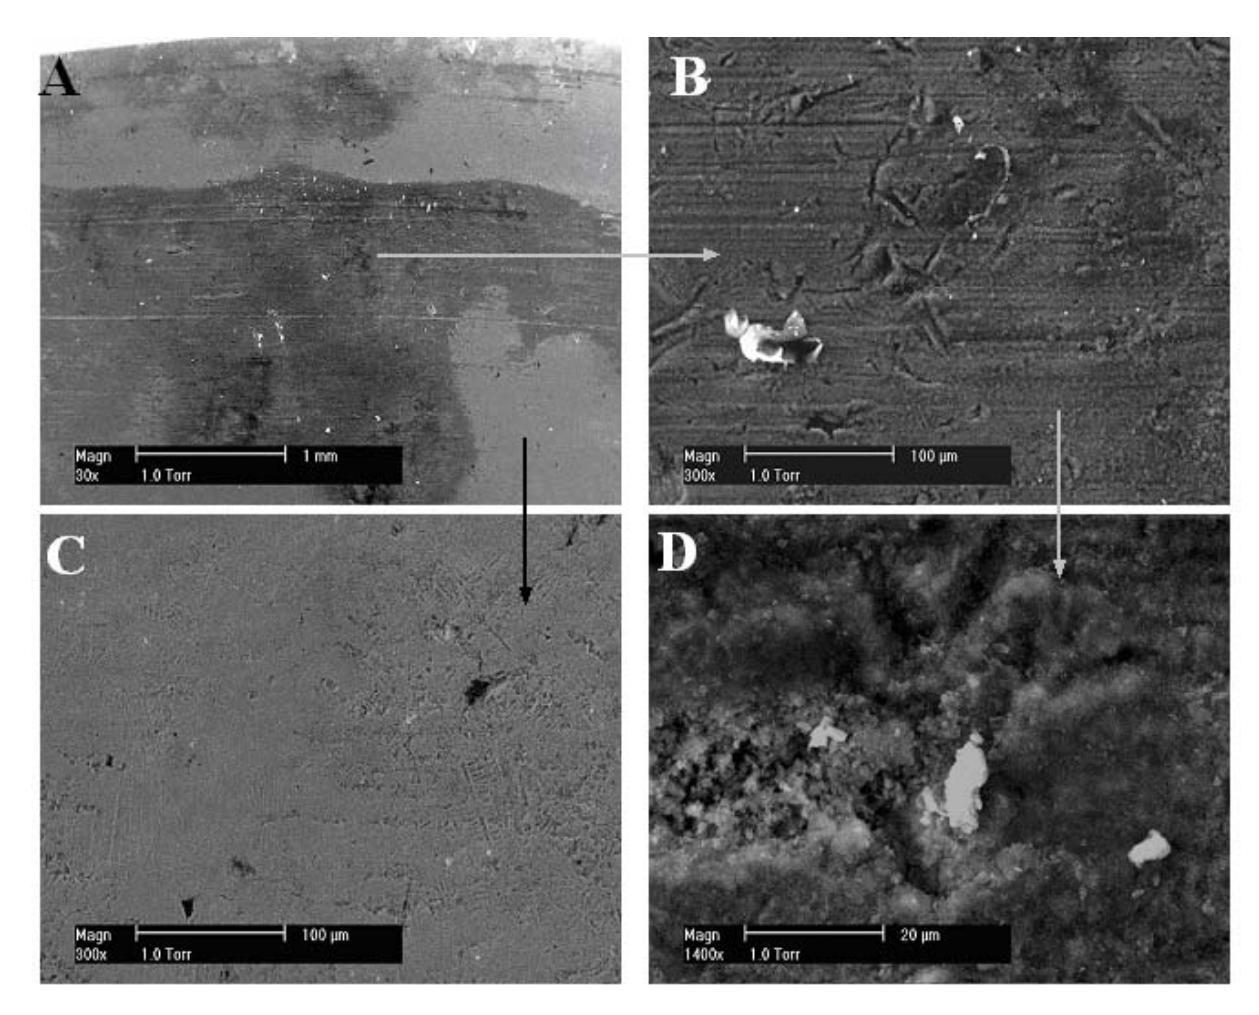
The results of the observation of the undamaged face were presented in Fig.2. The "dark" and "white" regions were noticed. The higher magnification of these "white" (Fig.2B) and "dark" places (Fig. 2C) allowed to state that the "dark" region were more intensive worn, even plastic deformed, than the "white" regions. Additionally the remains of the corrosion products were noticed in the "dark" region (Fig.2 D).

Fig. 2. SEM pictures of the undamaged face surface: A- the whole surface; B- higher magnification of the "dark" region; C- higher magnification of the "white" region; D- high magnification of the "dark" region

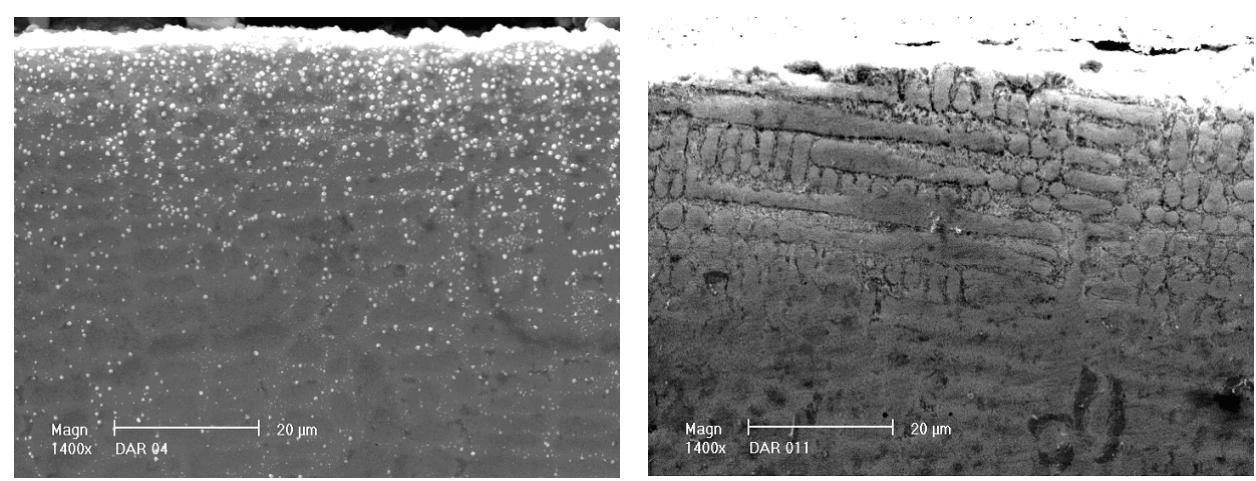
The radial cross-section, prepared through the valve face surface, were ground and polished according to standard metallographic practise. Fig. 3 shows the microstructure of the clad surface for the both samples. The photographs present typical dendritic structures however for the Fig. 3a additionally the undefined white precipitates are visible. Chemical analyses reviled differences in the composition of the clad layer. The results of EDS analyses are presented on fig. 4. The "damaged" region is enriched in most of the alloying elements (especially in molybdenum and nickel) while higher amounts of cobalt and silicon is noticed in undamaged region. Such a chemical composition is not conformable with the powder which should be applied according with the design.

Fig. 3a. SEM cross-section micrograph of the clad layer surface, close to the damaged region (A)

Fig. 3b. SEM cross-section micrograph of the clad layer surface from undamaged region (B)

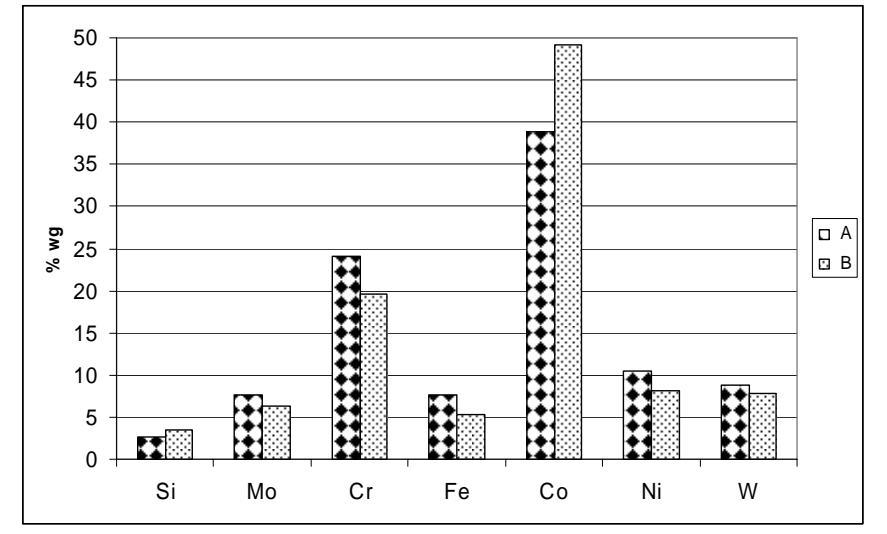
Fig. 4. Chemical analysis from the micro region situated close to the surface, on the cross-section of the clad, after service; A – close to the damaged region of the valve face, B – undamaged region of the valve face

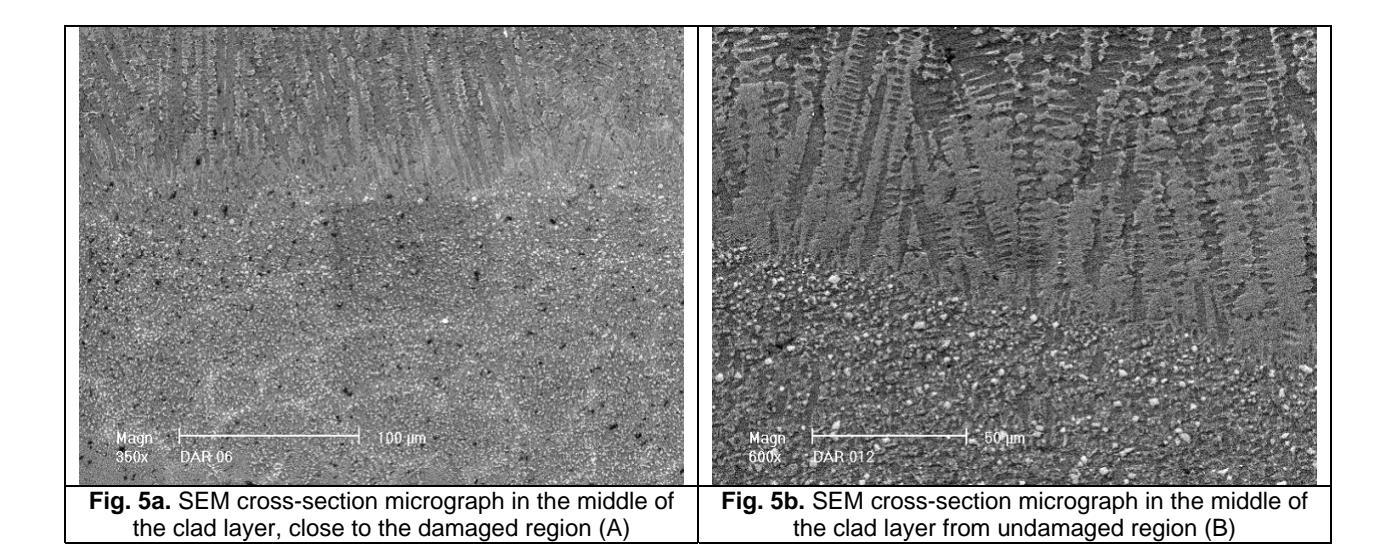
Metalographical observation of the part of the clad situated deeper from the surface provided rather surprised picture of the microstructure. In the middle region of the clad both dendritic and globular structures are observed. Such a dual microstructure was similar for all region of the valve (Fig. 5a and 5b). Also chemical composition of these regions is different how ever for undamaged part of the valve those differences aere less dramatic. Fig. 6 and 7 presents the results of the analysis.

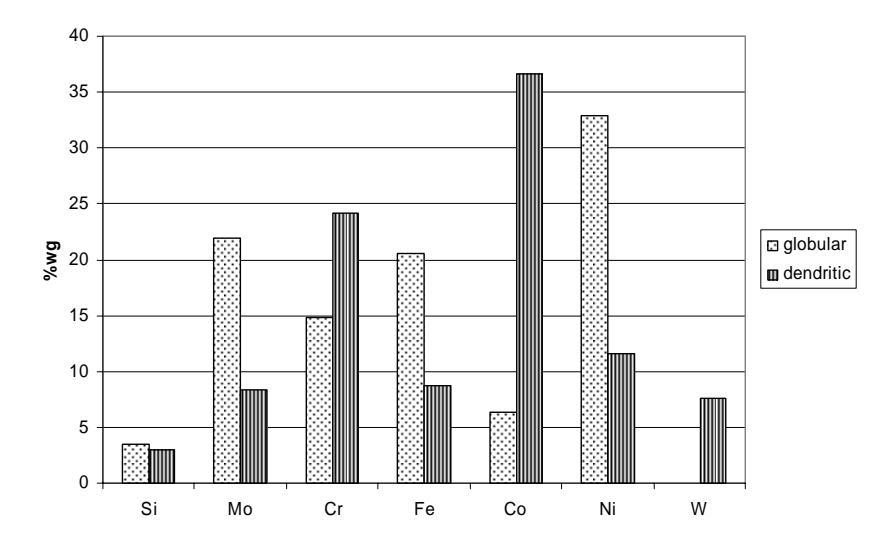
Fig. 6. Chemical analysis from the micro region situated in the middle of the clad, close to the damaged part (A) of the valve face, for globular and dendritic regions from the fig. 5a

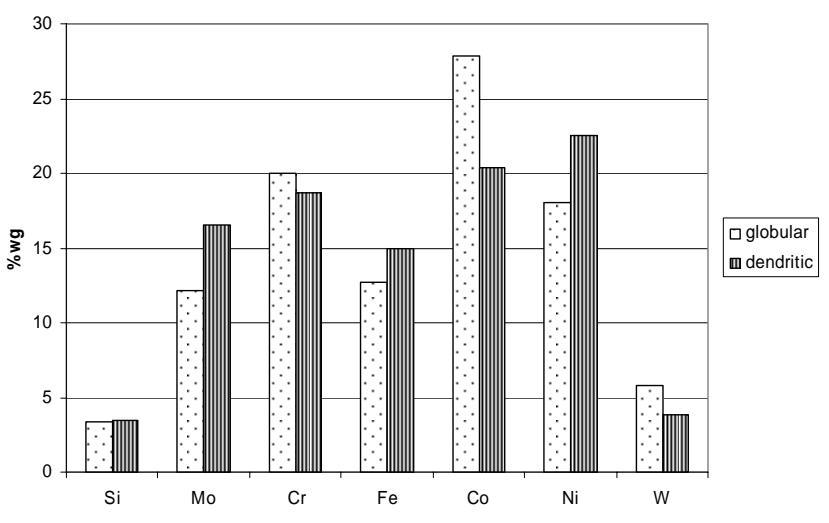
Fig. 7. Chemical analysis from the micro region situated in the middle of the clad, undamaged part (B) of the valve face for globular and dendritic regions from the fig. 5b

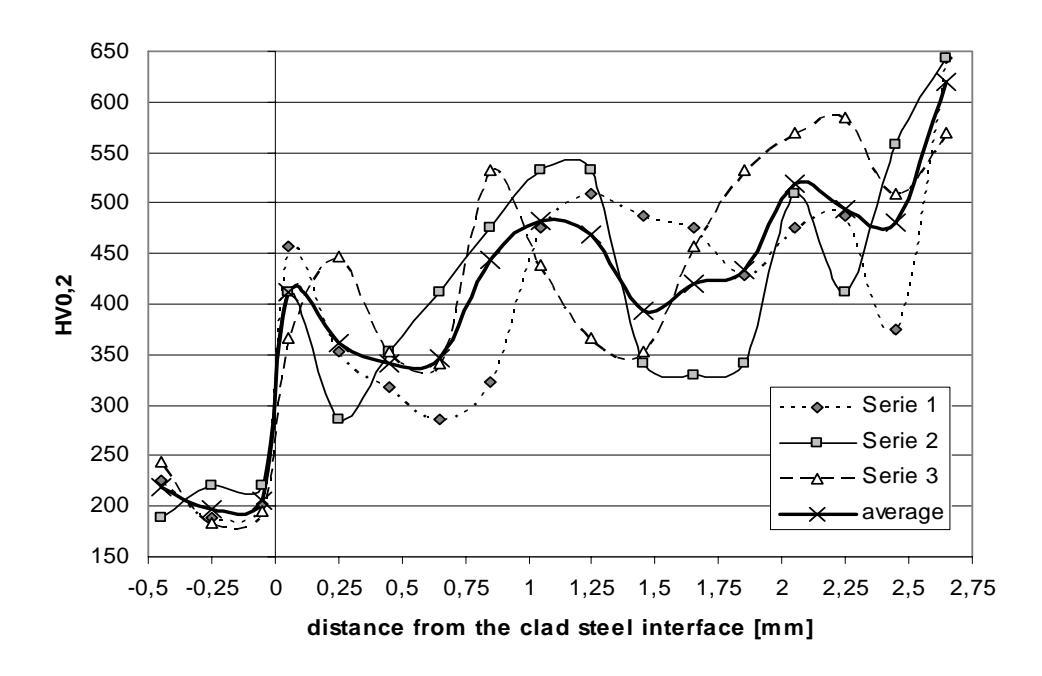
Fig. 8. Average hardness numbers for sample A (damaged region)

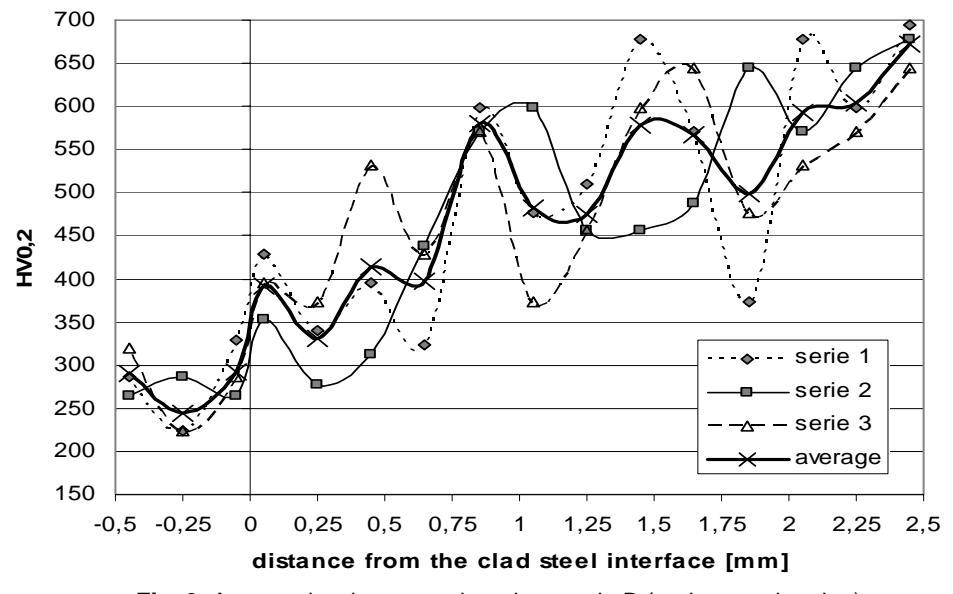
Fig. 9. Average hardness numbers in sample B (undamaged region)

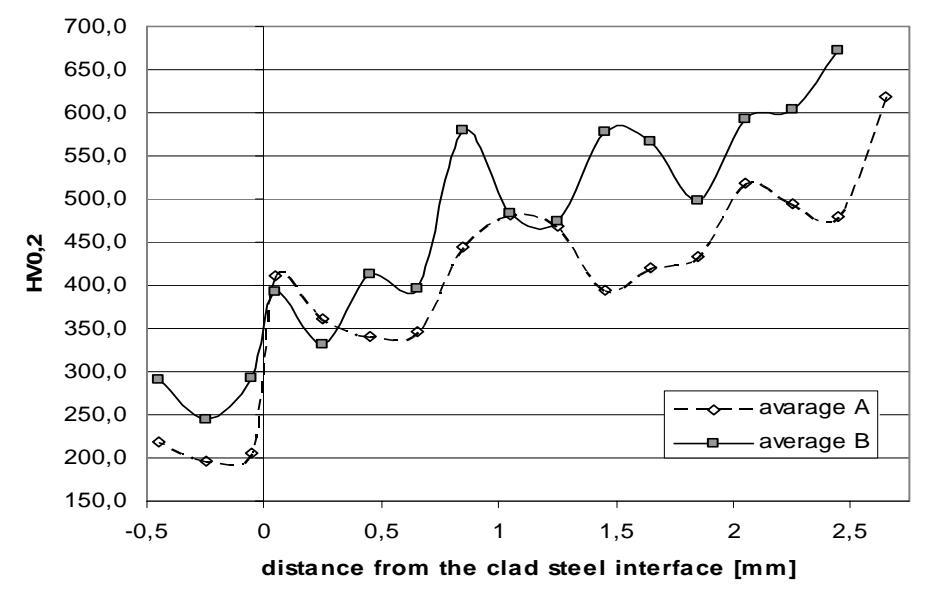
Fig. 10. Comparison of average numbers for A (damaged) and B (undamaged) region

Undamaged region presents higher hardness especially in the outer area of clad layer. It may result with the higher wear resistance and service time for this part of the valve face. How ever such huge differences in chemical composition, microstructure and mechanical properties are unacceptable for the safe reasons. Probably there were any disturbances during the cladding process which resulted with improper chemical composition (mixed powders) and improper microstructure (improper cladding parameters?). Generally producer did not keep regimes of the product engineering.
