## A self-destroying mechanism generated when functional parameters of paint system layers are improved in a non-suitable manner

*Mindoš L., Paráková M.* **SVÚOM, s.r.o.** E-mail: mindos@svuom.cz

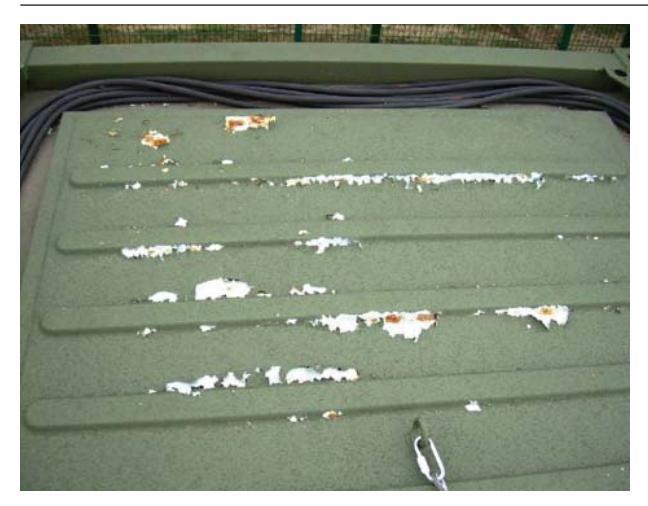
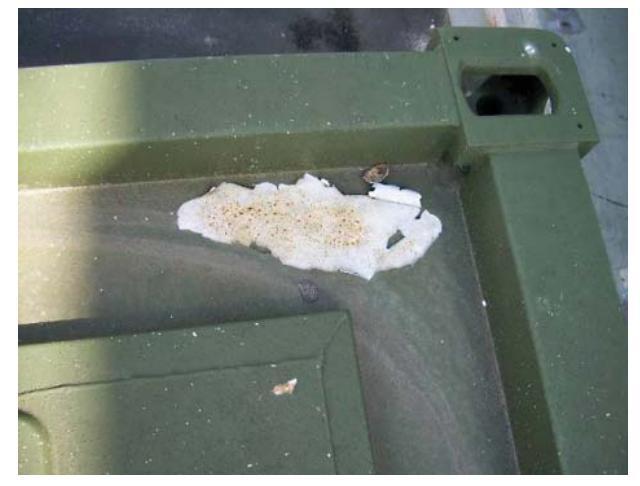
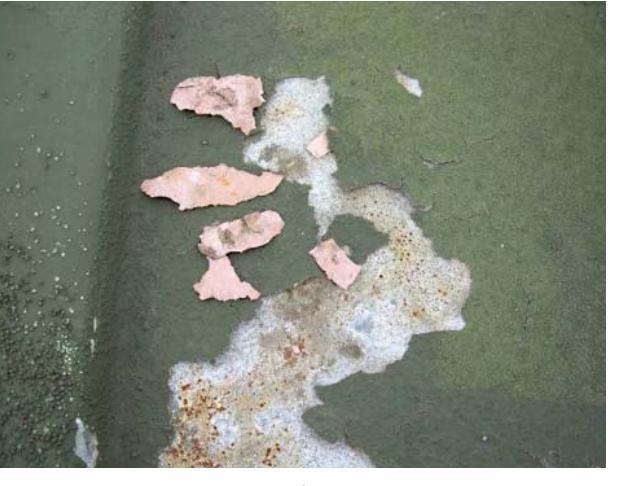
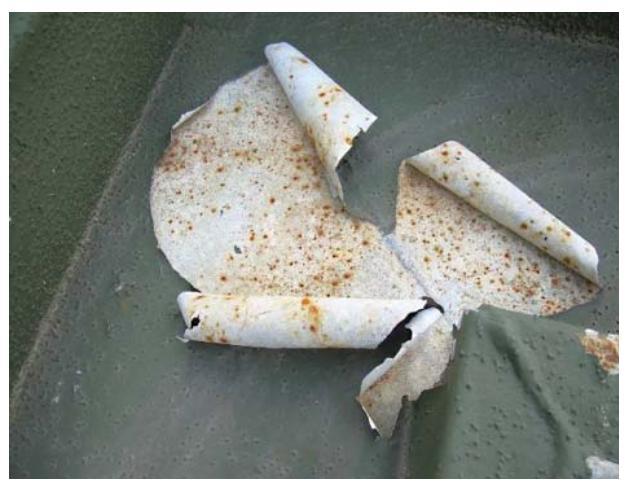
paint system peeled off, the zinc coating corroded, and the steel substrate also corroded intensively – see Fig. 1.

Fig. 1. Roof panel – defects of the surface treatment Obr. 1. Střešní panel - defekty v povrchové úpravě

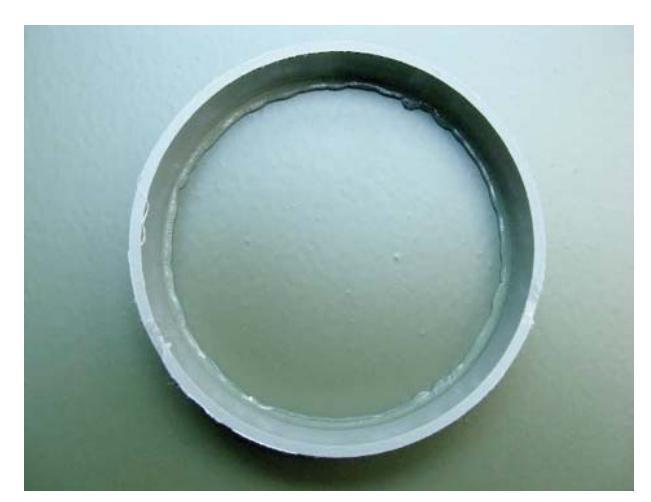
Fig. 2. Original paint system on glass Obr. 2. Původní nátěrový systém nanesený na skle

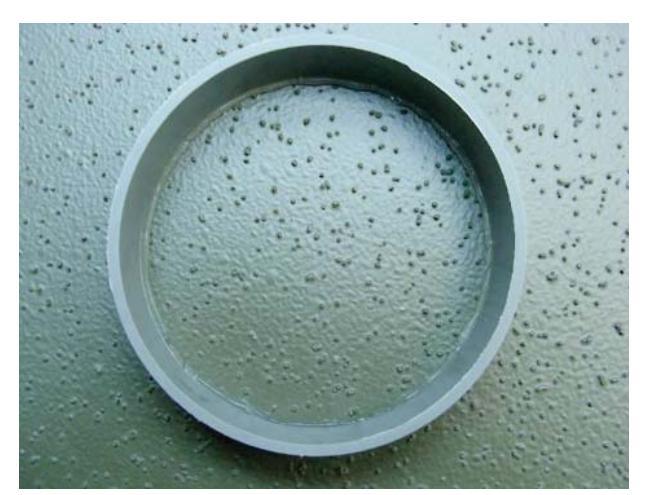
Fig. 3. Modified paint system on glass *Obr. 3. Upravený nátěrový systém nanesený na skle*

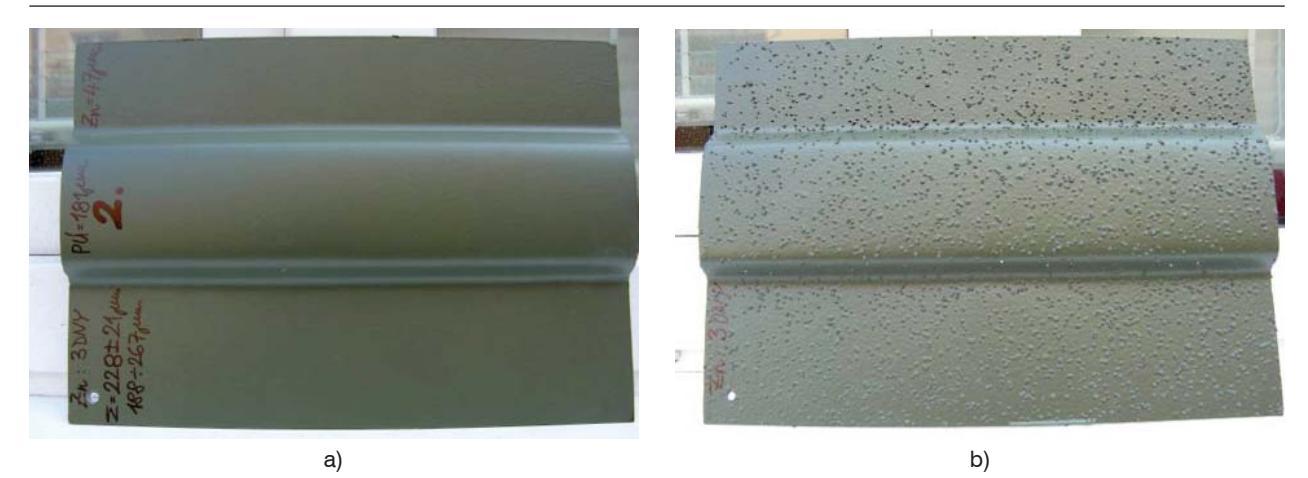
Fig. 4. The original and modified paint systems applied on steel sheets *Obr. 4. Původní a upravený nátěrový systém nanesený na ocelovém plechu*

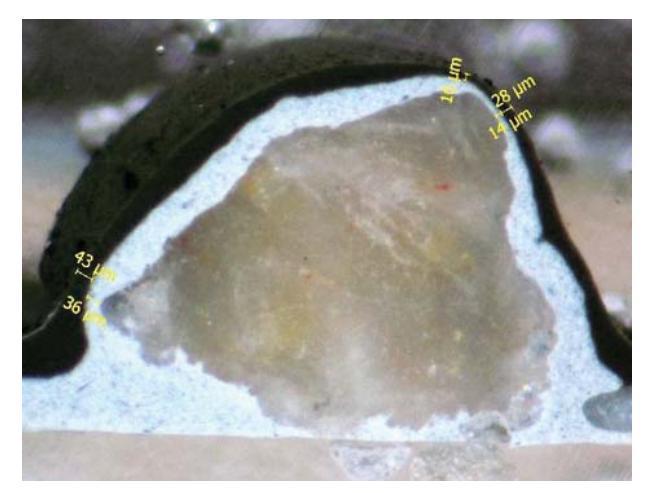
Fig. 5. Non-uniform distribution of the paint system layer thickness near to a sand grain

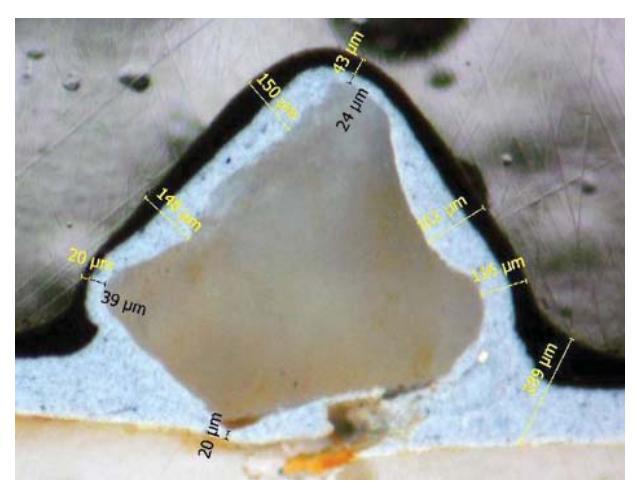
Fig. 6. A layer thickness of 39+20 μm on the upper part of a sand grain protruding above the substrate sheet Obr. 6. Vrstva s tloušťkou 39+20 μm na vrchní části zrna písku vystupující nad podkladovou ocel

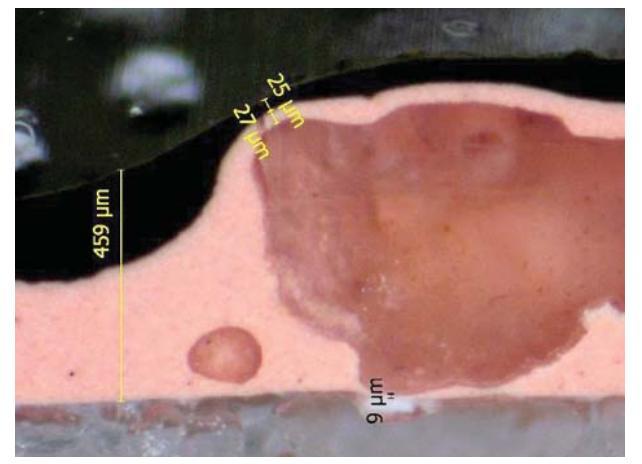
It was found that the most intensive changes in the thickness of a paint system occurred on the top of sand grains, alongside with the lowest values of the thickness of a coating layer, and on the contrary, the higher thickness of a coating layer was found on the lower parts of sand grains, near to the galvanised steel sheet (Figs. 5-8). The paint system thickness varies between approx 500 to 700  $\mu$ m on a metal surface and approx 50  $\mu$ m on the upper part of sand grains. Application of sand grains into a wet paint layer caused a decrease in the thickness of the paint layer under the sand grains nearing to zero.

Fig. 7. A layer thickness of 27 + 25  $\mu$ m on the upper part of a sand grain Obr. 7. Vrstva s tloušťkou 27 + 25  $\mu$ m na vrchní části zrna

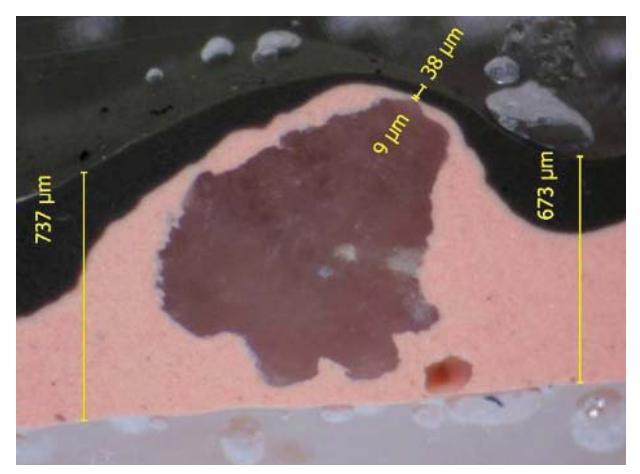
Fig. 8. A layer thickness of 9 + 38 μm on the upper part of a sand grain *Obr. 8. Vrstva s tloušťkou 9 + 38 μm na vrchní části zrna písku*

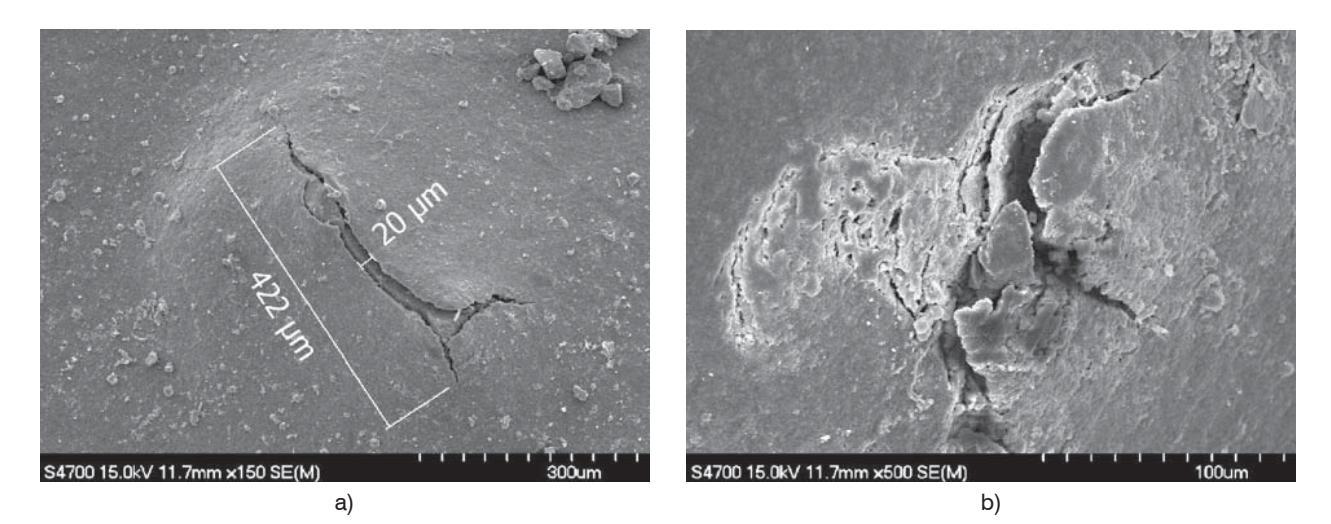
More detailed images with a higher magnitude and significantly higher harshness proved the negative effect of high non-uniformity of thickness of layers of 2K paints with pasted sand grains. There were found highly developed cracks in the paint systems, on the upper parts of sand grains, and also the cracks in the initial stage (Fig. 9).

Fig. 9. Cracks development in the paint system layer on the side and the top of a sand grain, 150x and 500x magnitude *Obr. 9. Praskliny vytvořené ve vrstvě nátěrového systému vedle a nad zrny písku, 150x a 500x zvětšeno*

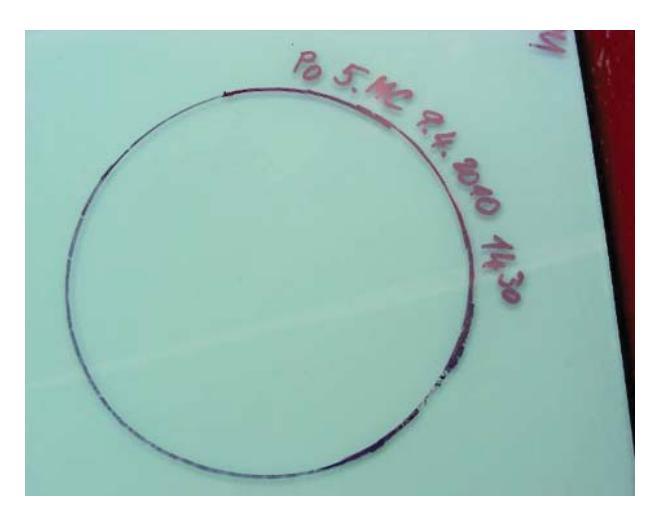
Fig. 10. No paint system delamination after 5 cycles Obr. 10. Nátěrový systém bez delaminace po 5 cyklech

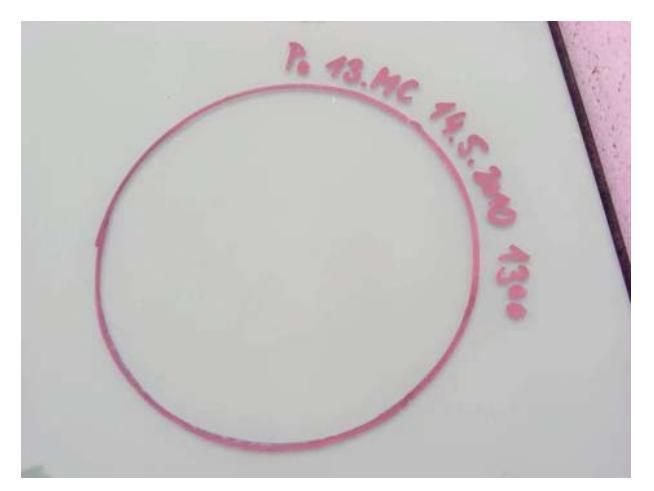
Fig. 12. No paint system delamination after 13 cycles Obr. 12. Nátěrový systém bez delaminace po 13 cyklech

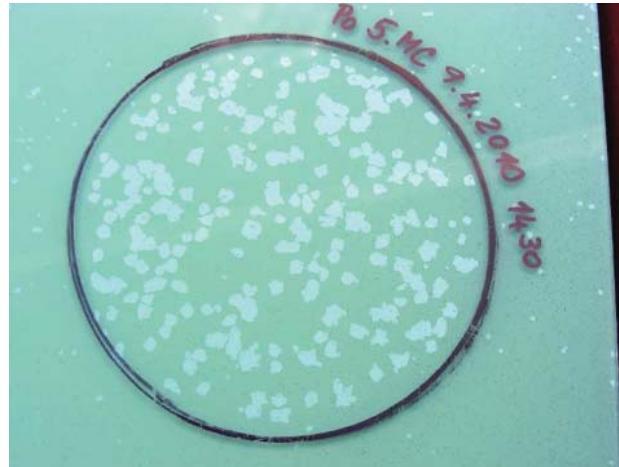
change in paint layer thickness on durability of a paint system. Significant pain system delamination was found around sand grains after 5 test cycles (Fig. 11) and a paint system layer got delamined in approx 75% of the area after 13 test cycles (Fig.13). The reference paint without any anti-sliding modification did not show any delamination after the test (Figs. 10 and 12).

Fig. 11. Significant paint system delamination after 5 cycles Obr. 11. Významná delaminace nátěrového systému po 5 cyklech

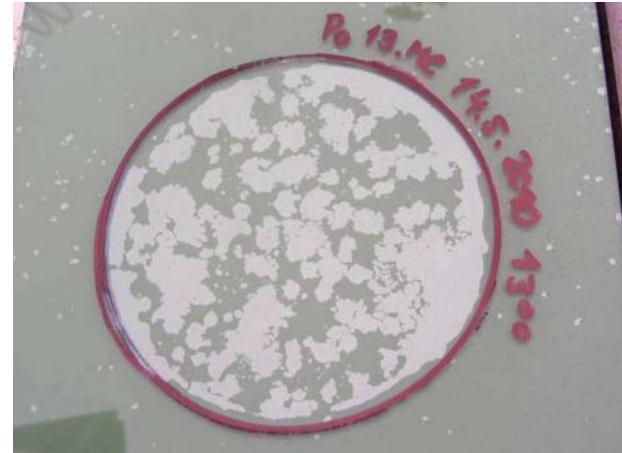
Fig. 13. Non-acceptable paint system delamination after 13 cycles

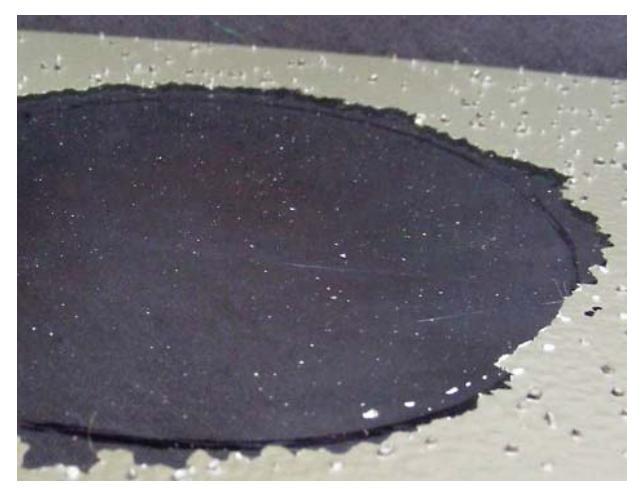
The glass surface covered with a modified antisliding layer was constantly damaged by relative deep scratches caused by sand grains pasted into the paint layers (Figs. 14 and 16). There were not found any defects on the glass surface covered by the original paint system after its removal (Fig. 15). This fact helps to fully clarify and understand the cause leading to occurrence of the self-destructive mechanism which had been accidentally but really formed in the modified anti-sliding paint system.

Fig. 14. No paint system delamination after 5 cycles *Obr. 14. Nátěrový systém bez delaminace po 5 cyklech*

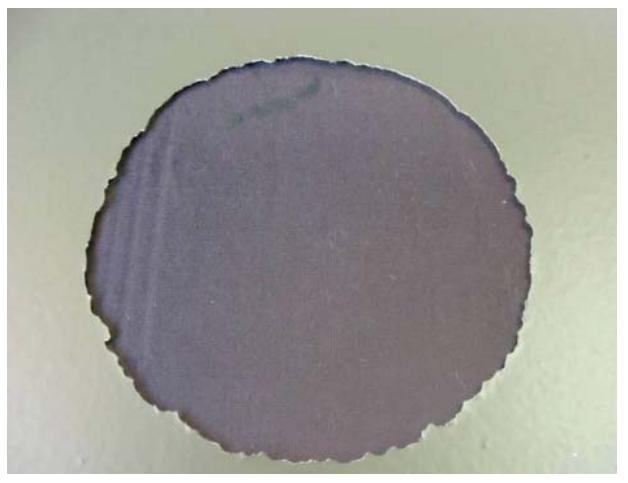
Fig. 15. Significant paint system delamination after 5 cycles Obr. 15. Významná delaminace nátěrového systému po 5 cyklech

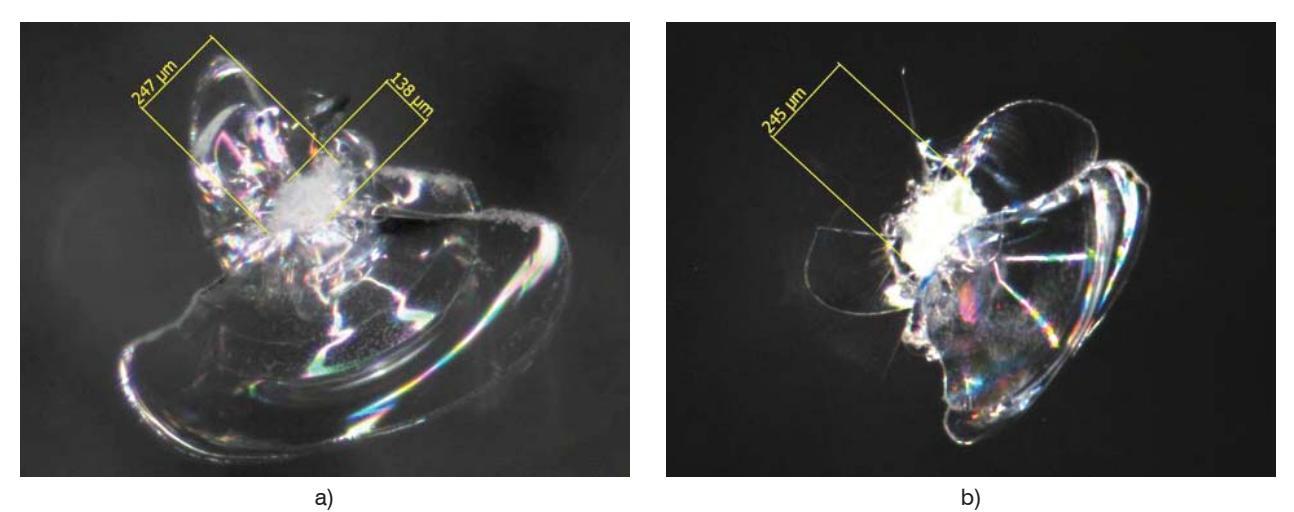
Fig. 16. Measuring of the fragmentation scratch of glass caused by the pressure of a sand grain pasted into the paint system *Obr. 16. Měření tříštivého vrypu ve skle vlivem tlaku pískového zrna zapracovaného do NS*

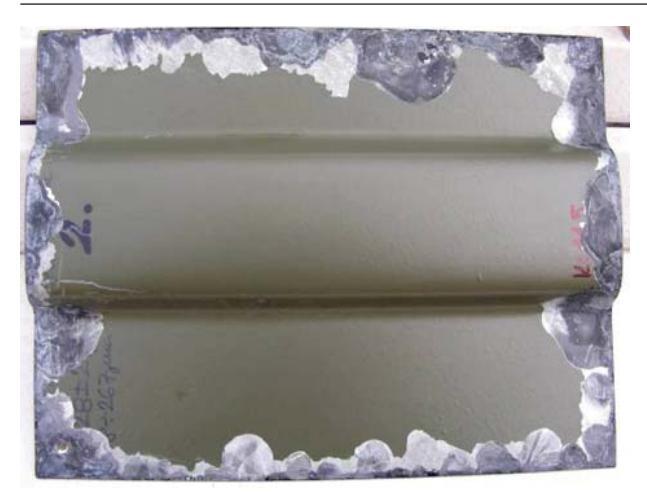
Fig. 17. 1 200 hrs at NSS, no corrosion or delamination in the area Obr. 17. 1200 h ve zkoušce NSS. bez korozního napadení a

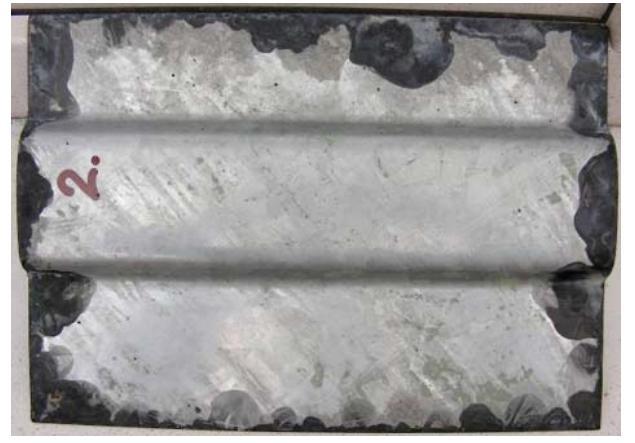
Fig. 19. The zinc layer without corrosion in the area under the paint

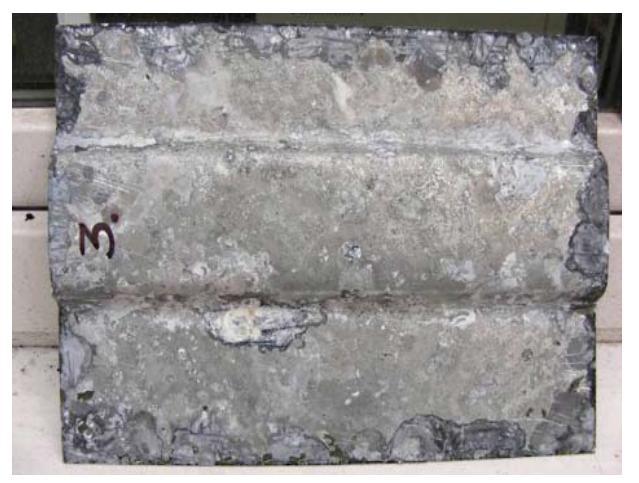
The sheet sample with anti-sliding modification shows total delamination of a paint system layer after its exposure to an accelerated corrosion test according to ISO 9227. The modified anti-sliding paint system showed an intensive corrosion attack on the zinc layer, which locally led to red steel corrosion product occurrence (Figs. 17-20). Sharp sand grains create defects in a relatively thin zinc coating. The paint layer was removed from the non-modified painted sheet by means of an organic thinner after the accelerated test. The zinc layer

Fig. 18. 1 200 hrs at NSS, total delamination of the paint system, a corrosion attack on the zinc layer *Obr. 18. 1200 h ve zkoušce NSS, úplná delaminace nátěrového systému, korozní napadení zinkového povlaku*

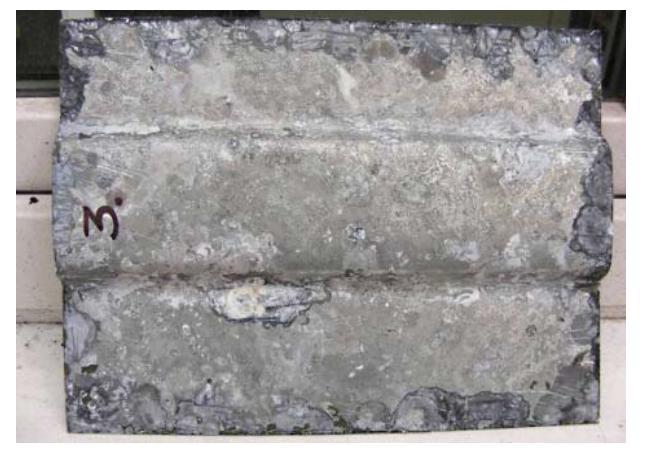
Fig. 20. Intensive corrosion of the zinc layer in the area under the paint
