Remedial Method against Moisture Problems – Church of St. Abdon and Sennen in Gemersky Jablonec

Ladislav Ťažký, Anna Sedláková

Technical University of Košice Civil Engineering Faculty, Institute of Architectural Engineering e-mail: ladislav.tazky@tuke.sk, anna.sedlakova@tuke.sk

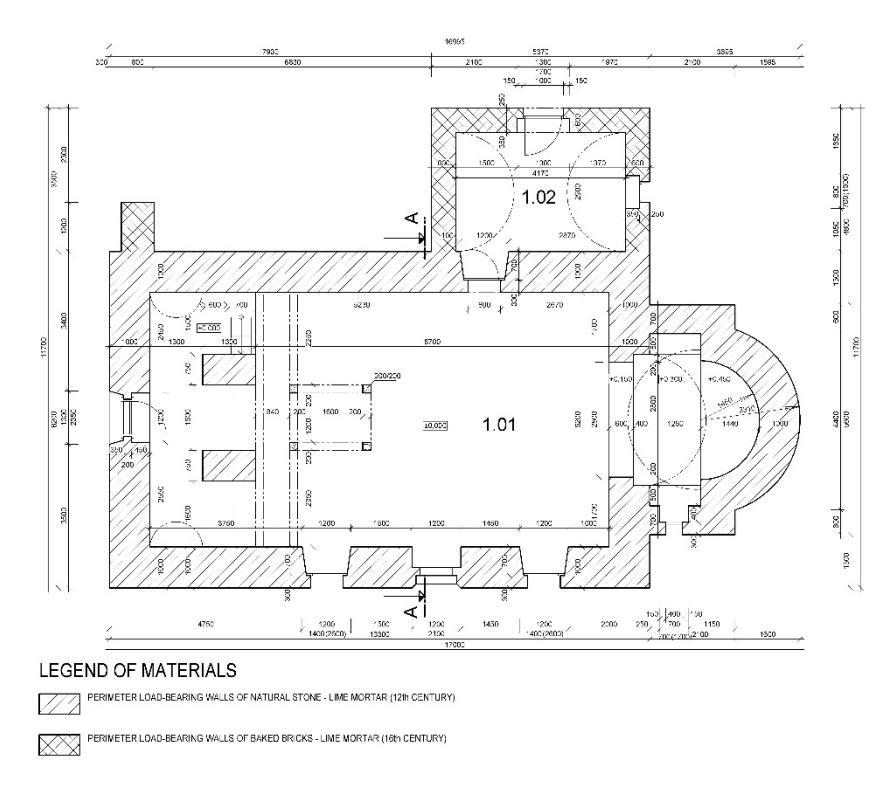
Figure 3: Floor plan of the church

During the visual survey it was found that the moisture content of the internal masonry pillars reaches up to the height at around 1700-1900mm. The situation was the worst at the apse of the east side of the church. On the inner surface of the plaster there was visible efflorescence and mildew occurrences especially in the higher parts of the plinth. On the outside of the walls there are still visible lichens, mosses and algae. During the reconstruction of the 80es a gutter walkway was built around the church which only worsened the situation. The biggest problem is the concrete sidewalk on the west side of the church, which compresses the water towards the walls and concentrate at the foundations.

- The increased surrounding terrain, which increase the concentration of the moisture on the outer walls;
- The waterproof PVC covering which was laid in the 80es on the original ceramic tiles;
- The waterproof plinth which is formed of the synthetic color on the walls;
- No roof drainage system. Rain is driven by the wind on the perimeter walls and the water runs down the surface;
- The moisture regime of the church is inappropriate, the worst of all is the unsystematic and almost no ventilation;
- The removed concrete gutter pavement in 2008 which was replaced with a drainage pipe in the gravel embankment, which was only effective for 2 years and thus does not fulfill its function.

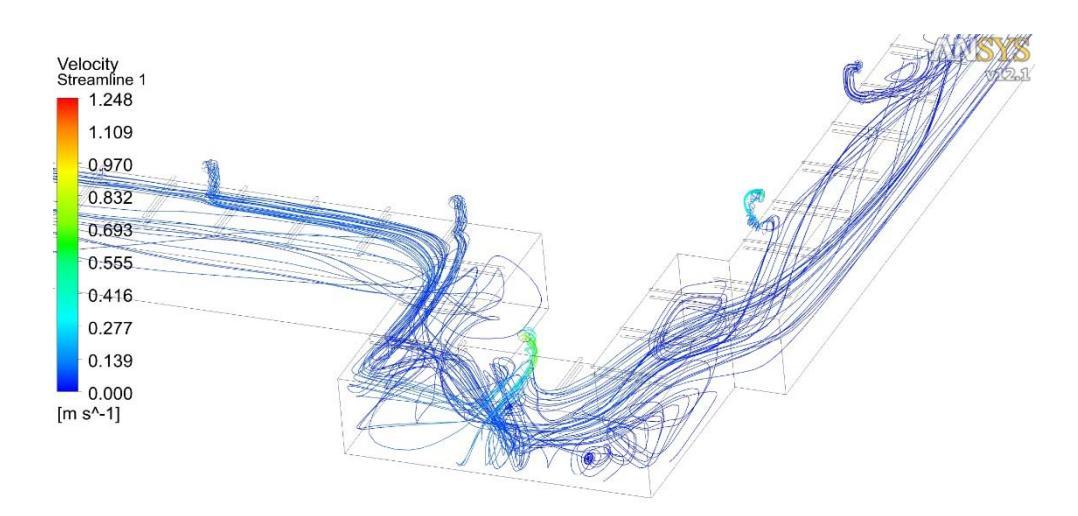
Figure 8: Streamlines air in the air channel around the pillar

The Fig. 8 displayed streamlines air in the air channel around the pillar of church. The streamlines air is colored according to air velocity. In this part of the church is the worst situation, because water content in the masonry is around 9%. The tested samples have been collected from the bottom part of the masonry wall. Results obtained from the numerical simulation in the software ANSYS CFX are satisfactory in the complicated parts of the church as well as at the apse.
