Stanislav Smugala, Darja Kubečková*, František Indra The impact of changes in the geological conditions of road bedrock layers while the road was in use

DOI 10.2478/otmcj-2019-0008 Received May 13, 2019; accepted September 27, 2019

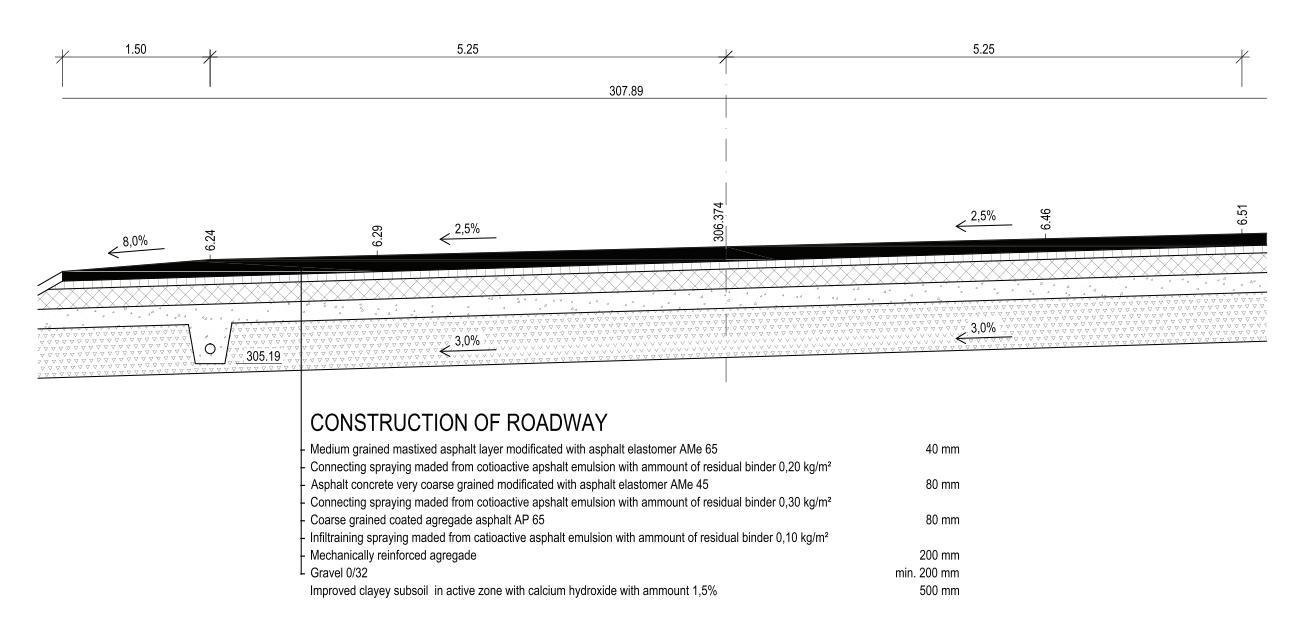
Fig. 1: Road cross-section with the original reconstruction measurements.

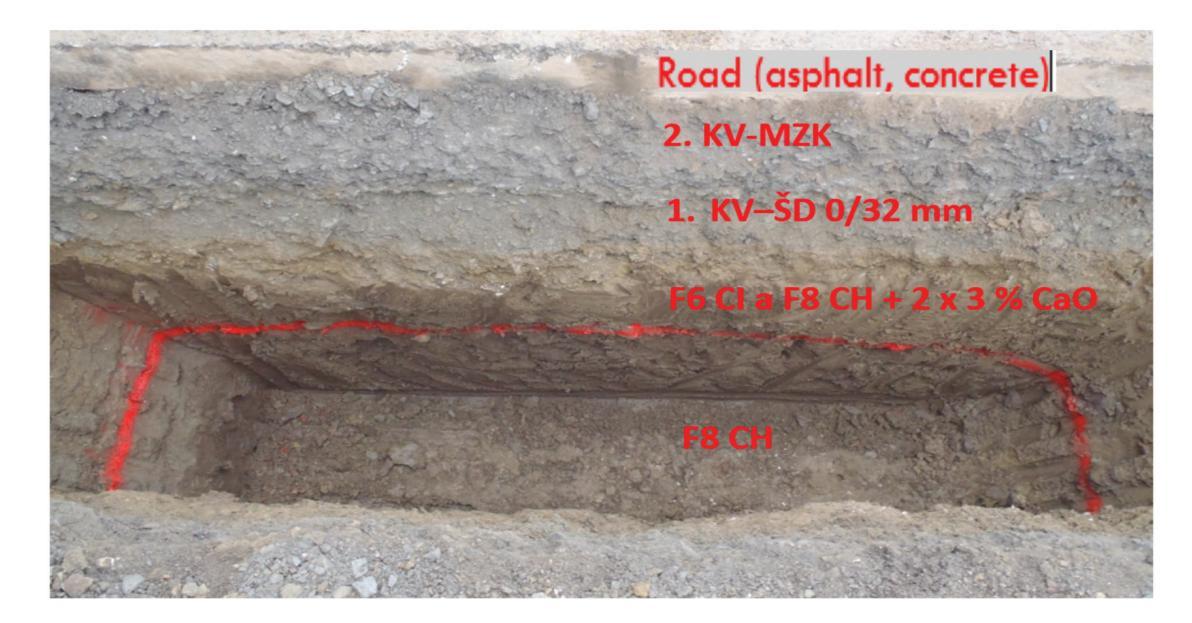
Fig. 3: Profile of the excavated survey probe showing the deformation of the underbase layer.

The surveys revealed two road structural layers beneath the asphalt and asphalt-concrete road surface. These layers were 0.5–0.6 m deep, with the following composition (from top): second structural layer = MZK, first structural layer = ŠD fraction 0-32 mm.

Their base contained a lime-treated $(2 \times 3\%$ CaO) active zone (Figure 3). The bedrock consisted of eolic loess sediments of class F6 CI and eluvial, highly plastic claystone and siltstone with a class FB CH soil character. The depth of the treated soils was approximately 0.5 m. The bedrock of the lime-treated soils included untreated eluvial claystone F8 CH. The probes exposed volcanic Těšín basalts with a class S4 SM soil character.

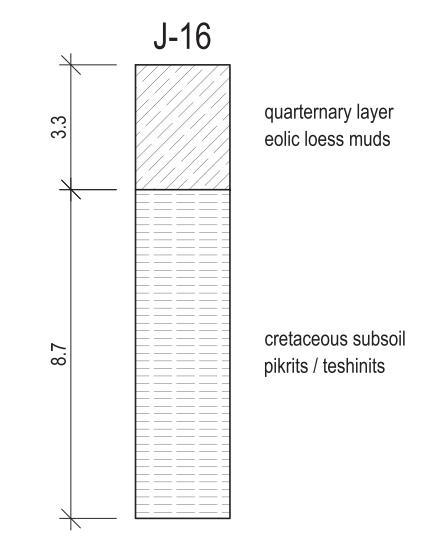
Fig. 4: Diagram of a geological borehole at the location of deformations.

Several geological boreholes were excavated along the given road section. The borehole designated J 16 penetrated the road where the deformations occurred when the road had been in use (Figure 4). Fine-granular soils at the construction site were initially treated using burnt lime [calcium oxide (CaO)], which was mixed with the soil using a ground cutter.

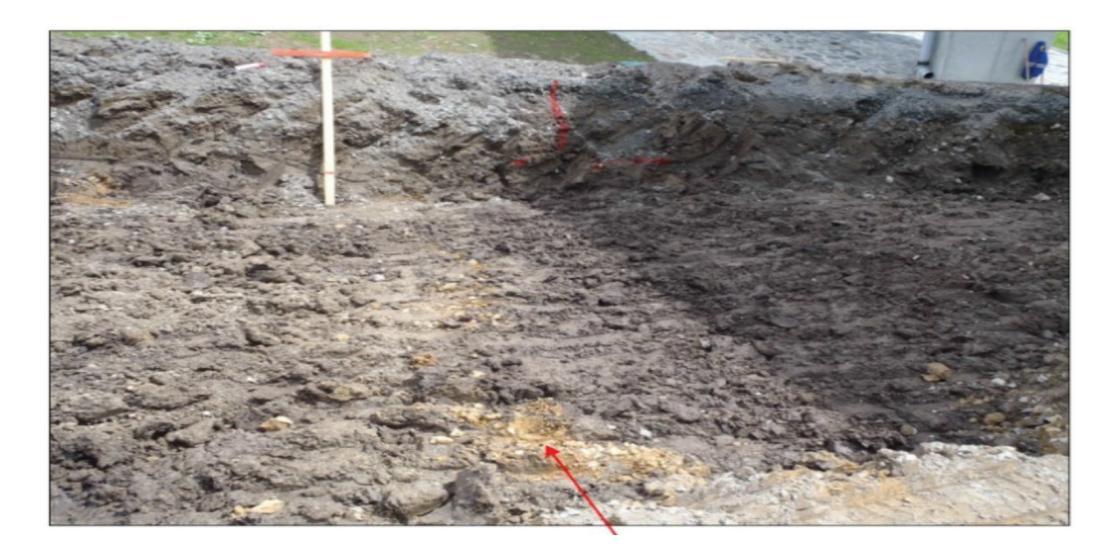
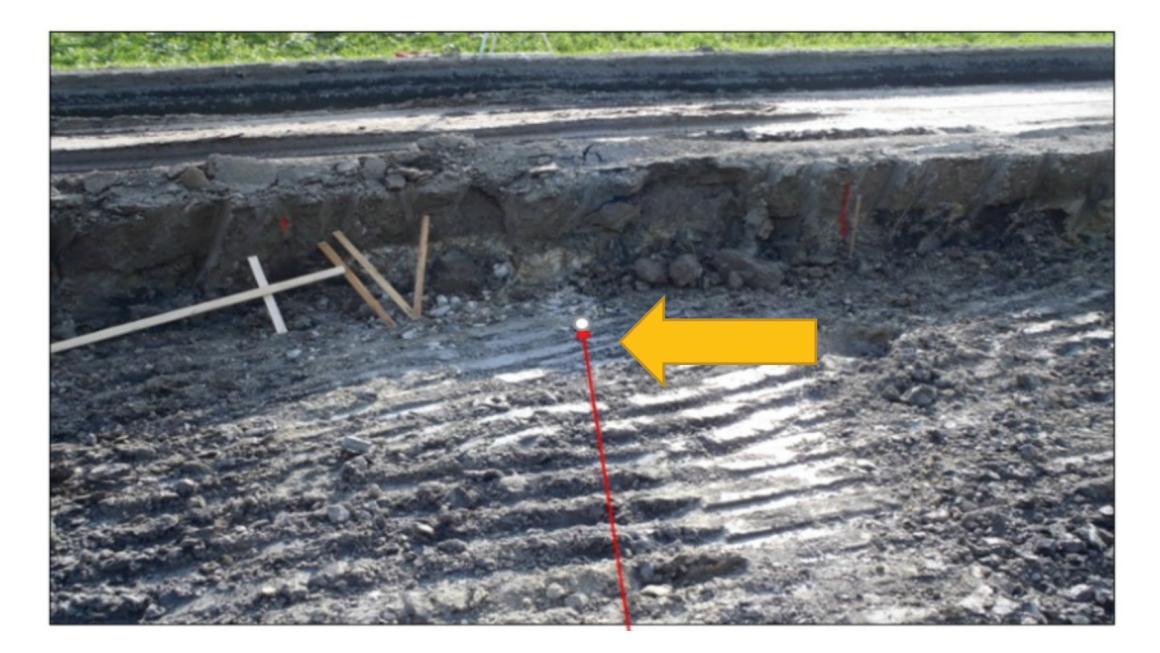
Fig. 5: Location of highly permeable rocks in the contact aureole in the active zone's bedrock.

Fig. 6: Location of highly permeable rocks (limestone) in the active zone's bedrock.

The macroscopic assessment of the surface of the excavated bedrock identified significant inhomogeneity with permeating groundwater, due to which areas of eluvial clays (approximately 90–95% of the excavated soil) alternated with areas of highly permeable rock (Figures 5 and 6). The locally moist rocks were part of a contact aureole (Těšín

sediments) with a shelf of marlite and limestone in the layer of eroded claystone. These rocks were not discovered by any of the survey probes, which is why their presence at the reconstructed section was unexpected. As moisture content increased, i.e. $w_n > 20\%$, which was very probable according to the conditions identified after removing the structural layers and active zone, the mechanical and physical characteristics of the treated bedrock could be changed. For this reason, the proposed reconstruction process was modified according to the proposal included in the reconstruction method modifications.

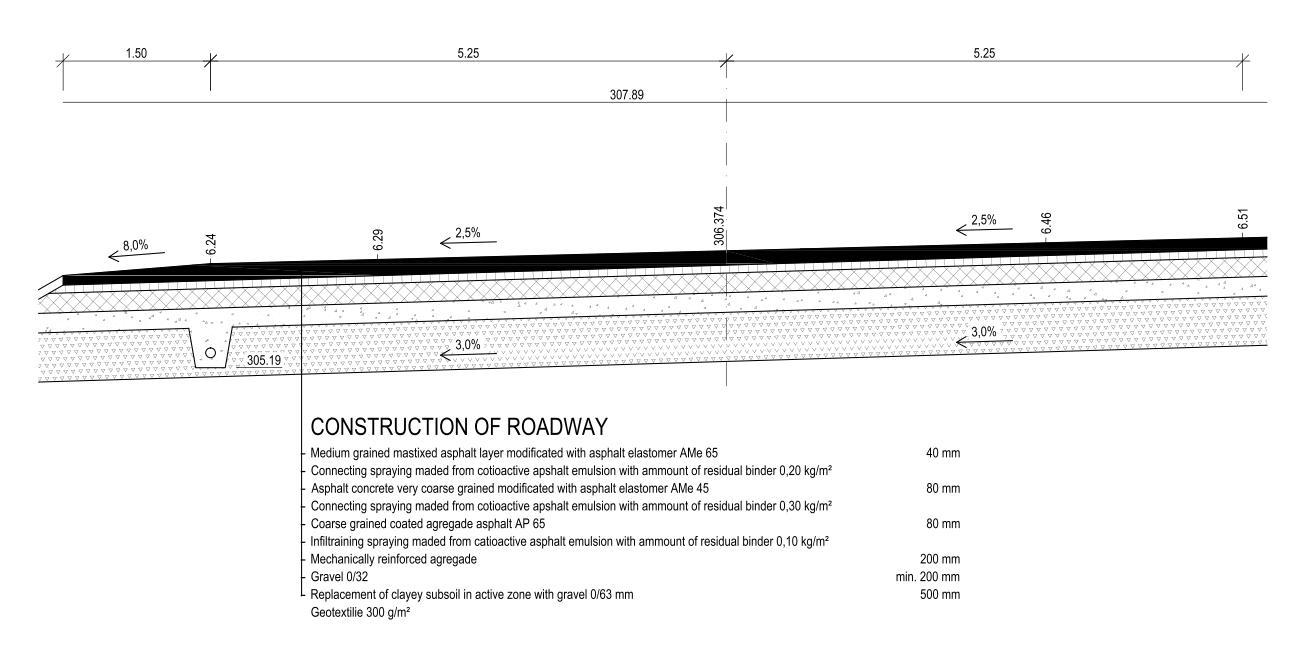
Fig. 8: Cross-section of the road according to the new reconstruction procedures.

In relation to the survey results mentioned above, which are exclusive to the problematic location, the occurrence of permeable rocks and permeating underground water flowing to the bedrock at the reconstructed area through local, isolated and randomly occurring fissure structures could not be considered in the original reconstruction proposal procedures. Based on the altered geological conditions discovered at the location after excavating the reconstructed layers, the geotechnician prepared new reconstruction procedures (Figure 8):

- Installation of a filtration geotextile was recommended at the surface of the inhomogeneous bedrock described above with a gradient of 3% at a depth of approximately 1 m below the level of the projected underbase in accordance with the Construction Geology of Geotechnika, a.s., TP 97 (2008), aiming to achieve the requirements of the geotextile filtration function (O90 \leq 0.1 mm, where O90 is the apparent opening size).
- Two drainage layers were recommended for the geotextile, each being 0.2 m thick. The first layer consisting of crushed stone with a fraction of 11–22 or 4–16 mm, and the second layer consisting of crushed stone with a fraction of 0–32 mm.
- Replacement of the remaining deficient material was also recommended up to the level of the projected underbase with a frost-resistant, sufficiently permeable and well compactable material such as crushed

stone with a fraction of 0-63 or 0-125 mm. All material must be correctly compacted in accordance with ČSN 72 1006 (2015) on soil and stone compaction control.
