Preliminary geophysical investigation for road construction using integrated methods

Joel Olayide Amosun¹*, Gbenga Moses Olayanju², Oluseun Adetola Sanuade¹, Tokunbo Faqbemigun¹

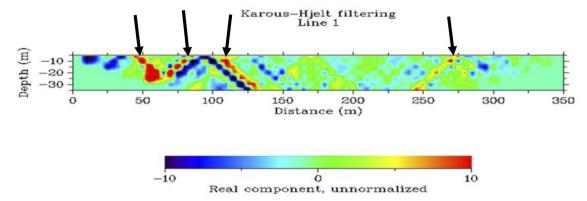
Figure 3: 2-D VLF-EM subsurface conductivity image for traverse 1.

Figure 3 shows suspected geologic features such as fault or fracture having varying degrees of conductivity as indicated by arrows on the section. Between distance 40 and 80 m, the resistivity is low, depicting a conductive body to a depth of about 10 m. Similarly, between distance 125–132 m and 180–200 m, a conductive body that orientate towards the northern part of the section at a depth exceeding 12 m is observed. In adddition, towards the northern part of the section is a conductive body at a distance between 240 and 250 m. However, two prominent high conductive zones were found at different points between 50–100 m and 250–275 m as shown in Figure 3.

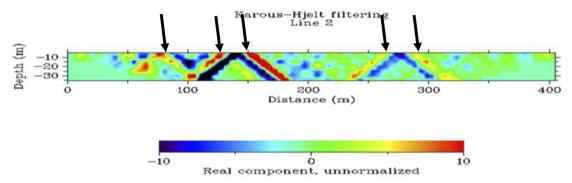
Figure 4: 2-D VLF-EM subsurface conductivity image for traverse 2.

Figure 4 shows similar structures such as fault or fracture along traverse 2. There are features of different degrees of conductivities on the section, while at distance between 150 and 200 m, a conductive zone is observed (low resistivity).

At a distance between 5 and 35 m, a resistive body is observed, which may be as a result of an outcrop closer to the location. There is a presence of a highly conductive body between station distance 220 and 240 m, indicative of an incompetent layer across the road segment.

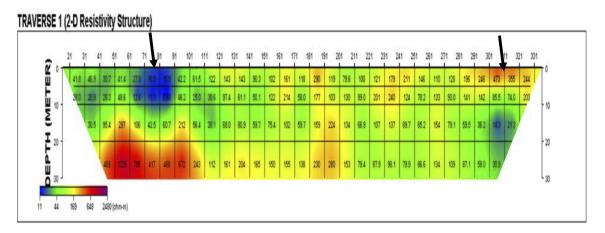
Figure 5: The inverse model resistivity section for traverse 1.

The inverted section in Figure 5 shows that between stations 32 and 111, there is a layer of low resistivity (having values ranging from 11 to 35 Ohm-m) at depth of 1–10 m. The shape of the material suggests the presence of pocket of clay materials at these locations. There is also a resistive layer between stations 115 and 217, which is about 1–8 m thick. At stations 21–51 of the section, there is a layer of relatively thin resistive material as the topsoil, which may be an indication of the topsoil compaction along the road segment. At stations 301–321, the resistivity value is between 14 and 21 Ohm-m, indicating clayey materials. This region also shows high conductive layers between stations 111–121

and 301–321 along the profile due to their relative low resistivity, indicating high saturation in the region [19]. The relatively high-resistivity anomalies observed at the depth of about 4 m at the southern part of the section between stations 41 and 105 show that the subsurface materials in this region are highly resistive. The topsoil is conductive between stations 1 and 91, depicting clayey material, although there is decrease in clay material between stations 101 and 331 with thick overburden. The correla-

Therefore, proper drainage pattern should be constructed between traverses 1 and 2 in order to discourage the accumulation of runoff and thereby expose the subsurface material to erosion and lead to incompetency of the investigated area, and the excavation of the clay material established should be carried out at a depth of about 4 m and be replaced by more competent geologic material before the construction of road.

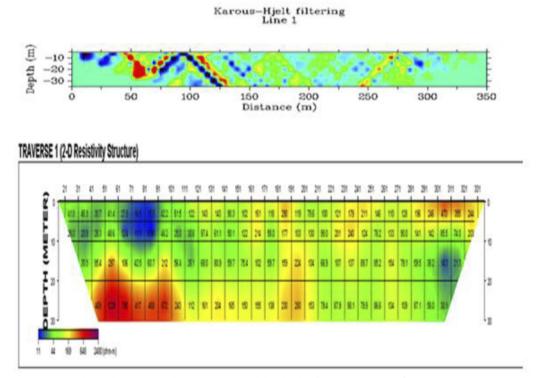
Figure 6: Correlation between conductive VLF-EM and dipole–dipole resistivity survey for traverse 1.

tion between VLF profile and pseudosection resistivity for traverse 1 (Figure 6) shows that the principal geologic features that could pose a threat to the road construction in the study area is found at distance between 40 and 80 m in traverse 1 and stations 60 and 91 in the inverse model resistivity section, which could be a pocket of clay material.
