A. Zieliński, A. Dziadon¹, W. Serbiński, M. Jazdżewska

SURFACE CRACKING OF LASER MELTED Ti-6Al-4V ALLOY

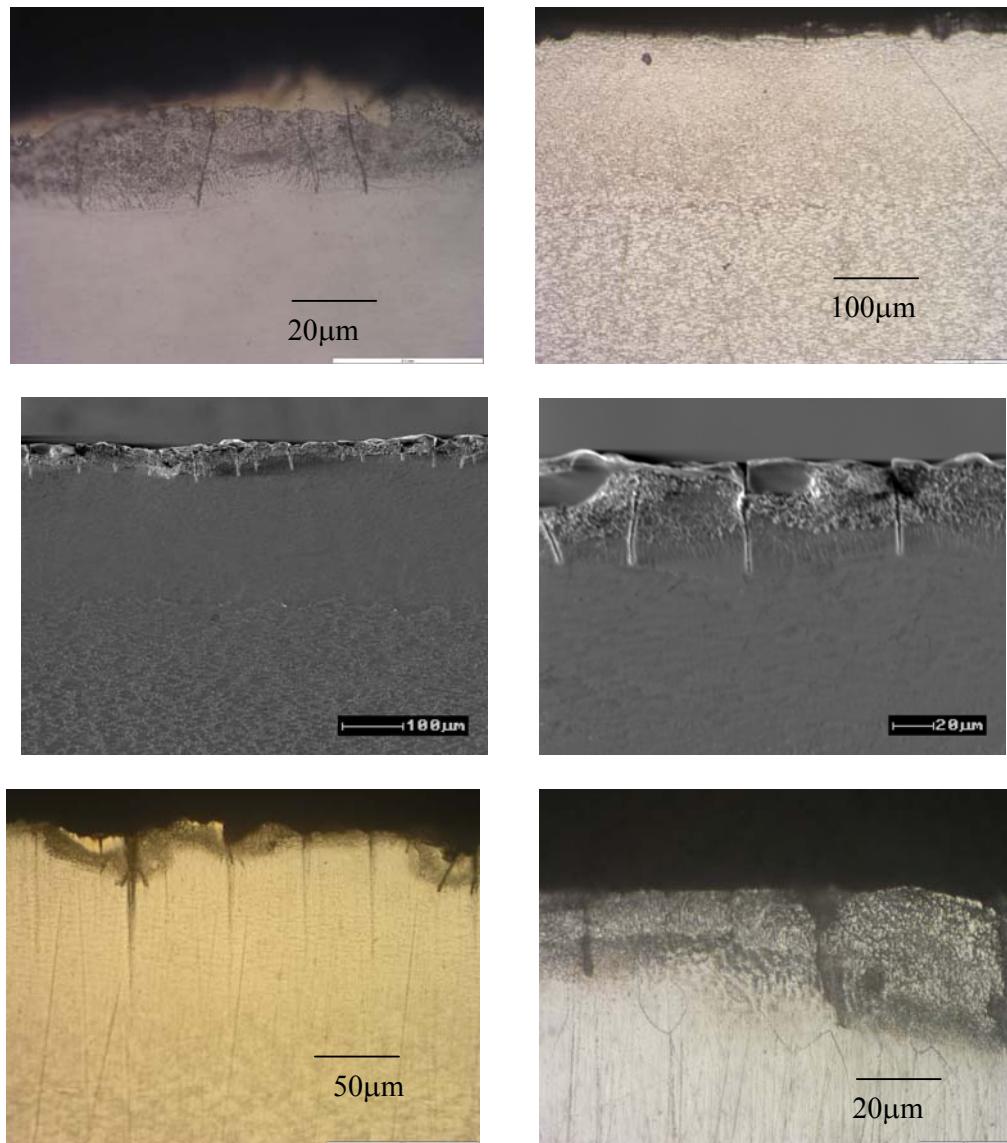
Fig. 1. Cracking of surface layers for specimens laser melted with CO₂ laser in liquid nitrogen at scan rate 1 m/min at power input (from top to the bottom): 3 kW, 4 kW, 5 kW and 6 kW

The results of performed tests are shown in Figs. 1-4. For every combination of tests parameters the view of the melted surface and cross-section are put together.

The cracks are evident to form at each condition. The depth of the crack is dependent on all variables. Generally, the higher power input and the lower scan rate, the longer cracks. The environment has also an effect: cracks are more significant during laser treatment in air and water. Pre-heating diminishes the cracking. The depth of the crack is always a significant portion of the melted zone and from this point of view, the laser melting in liquid nitrogen seems the most appropriate. The quantitative data are estimated and will be published in future.

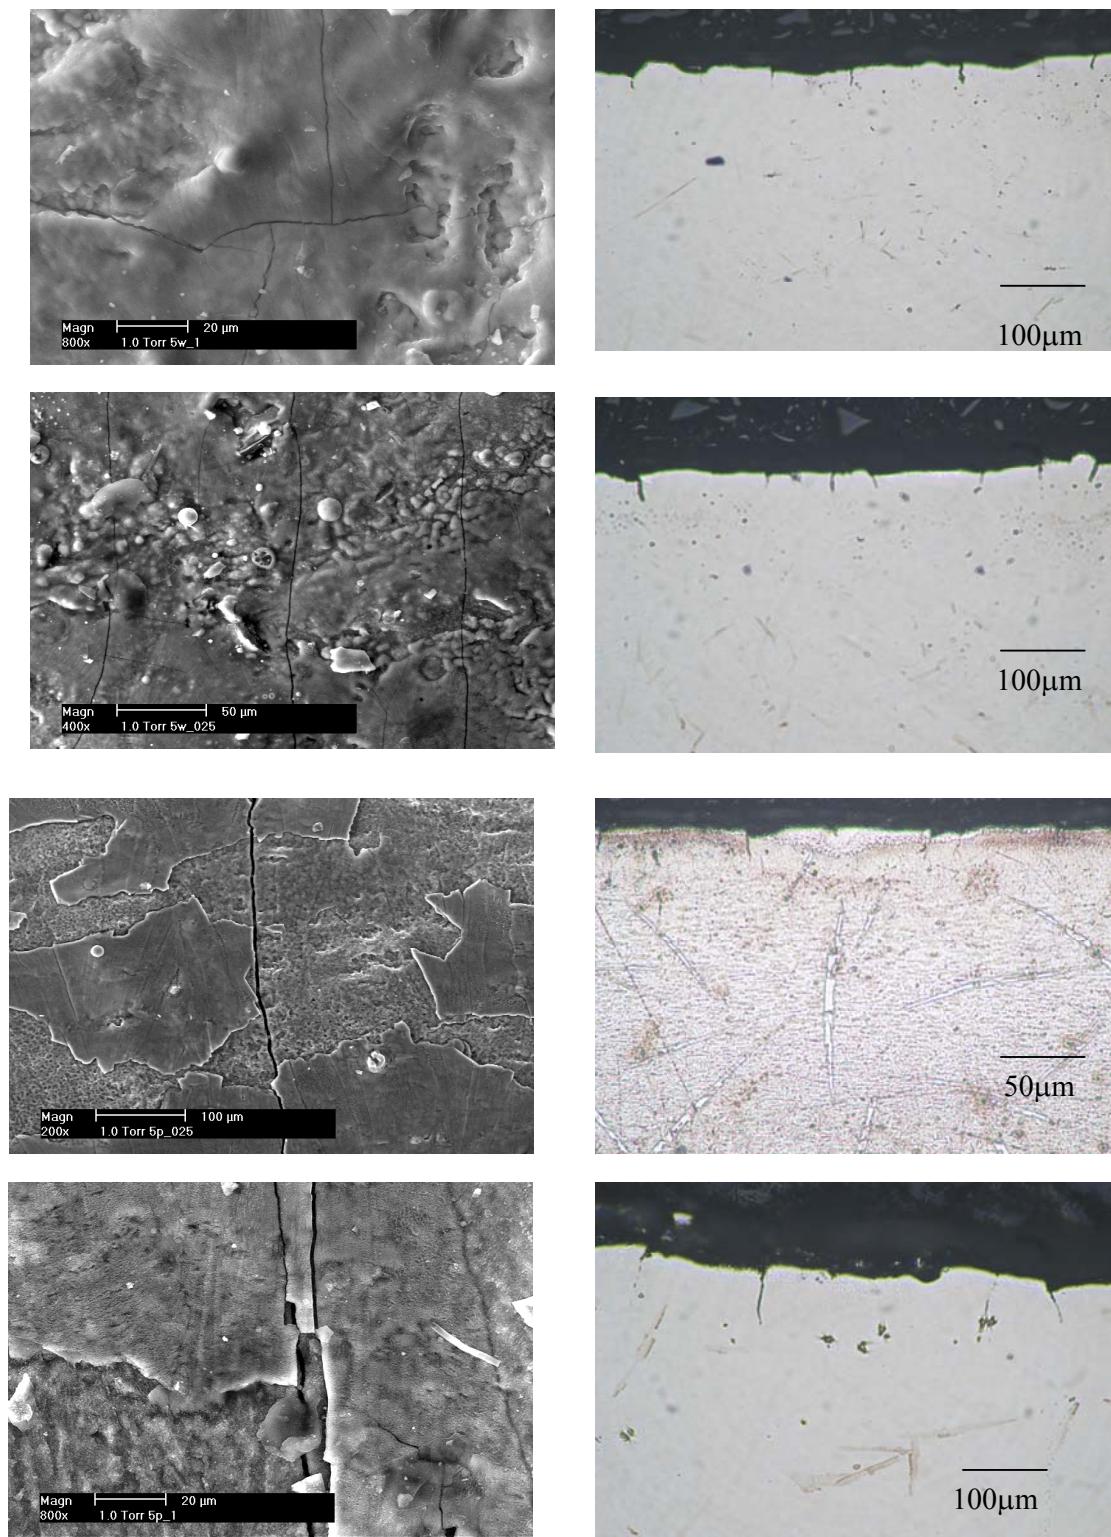
Fig. 2. Cracking of surface layers for specimens laser melted with CO₂ laser at 5 kW (from top to the bottom): in water at scan rate 1 m/min.; in water at scan rate 0.25 m/min.; in air at scan rate 1 m/min.; in air at scan rate 0.25 m/min

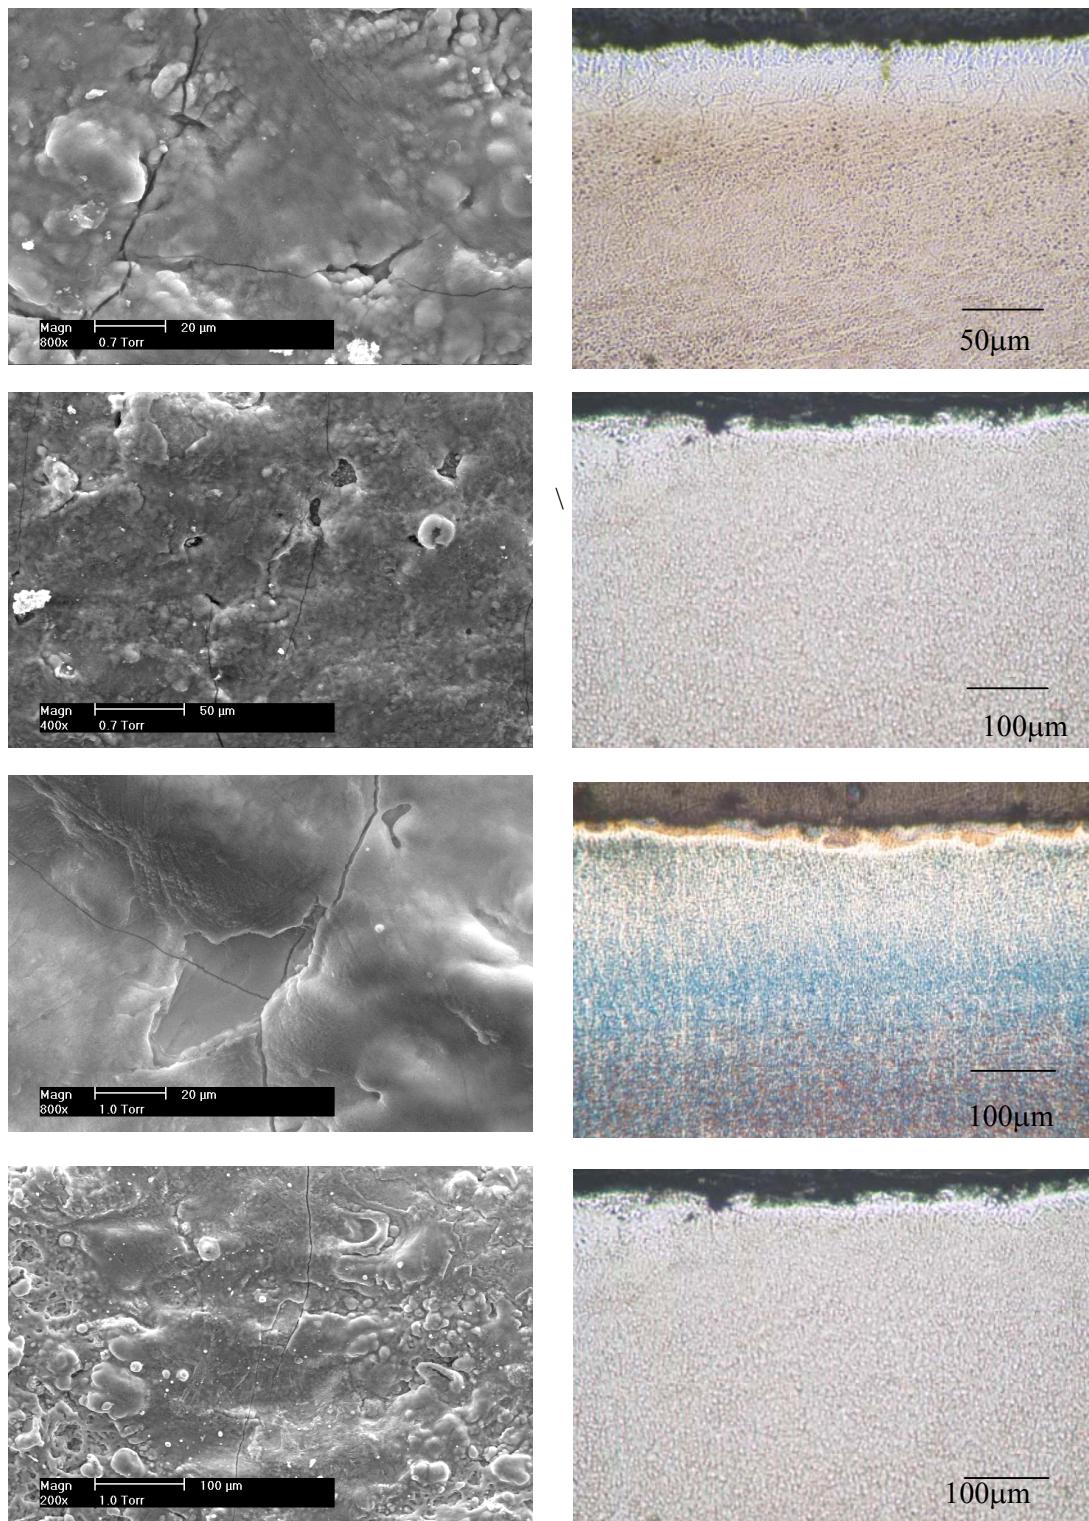
Fig. 3. Cracking of surface layers for specimens laser melted with CO₂ laser in air at 5 kW, at 1 m/min. scan rate and after pre-heating at temperature (from top to the bottom): 200, 300, 450 and 550 °C

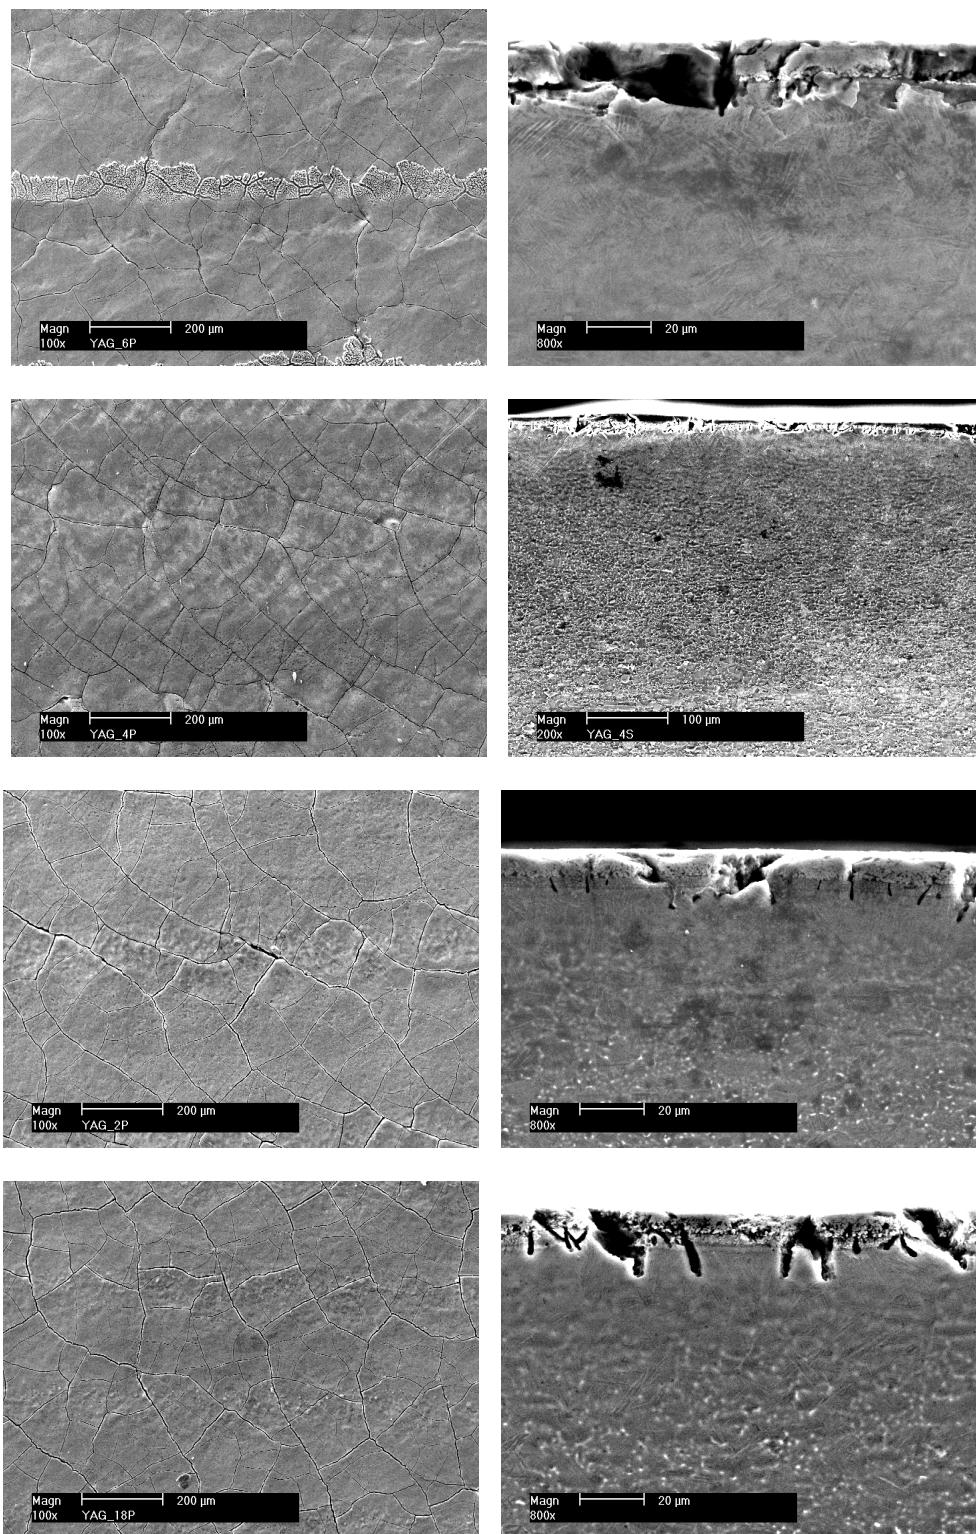
Fig. 4. Cracking of surface layers for specimens laser melted with Nd-YAG laser at 150 W and 50 Hz, with overlapping (from top to the bottom): 50%, scan rate 0.25 m/min.; 50%, scan rate 0.45 m/min.; 50%, scan rate 0.65 m/min.; 30%, scan rate 1 m/min

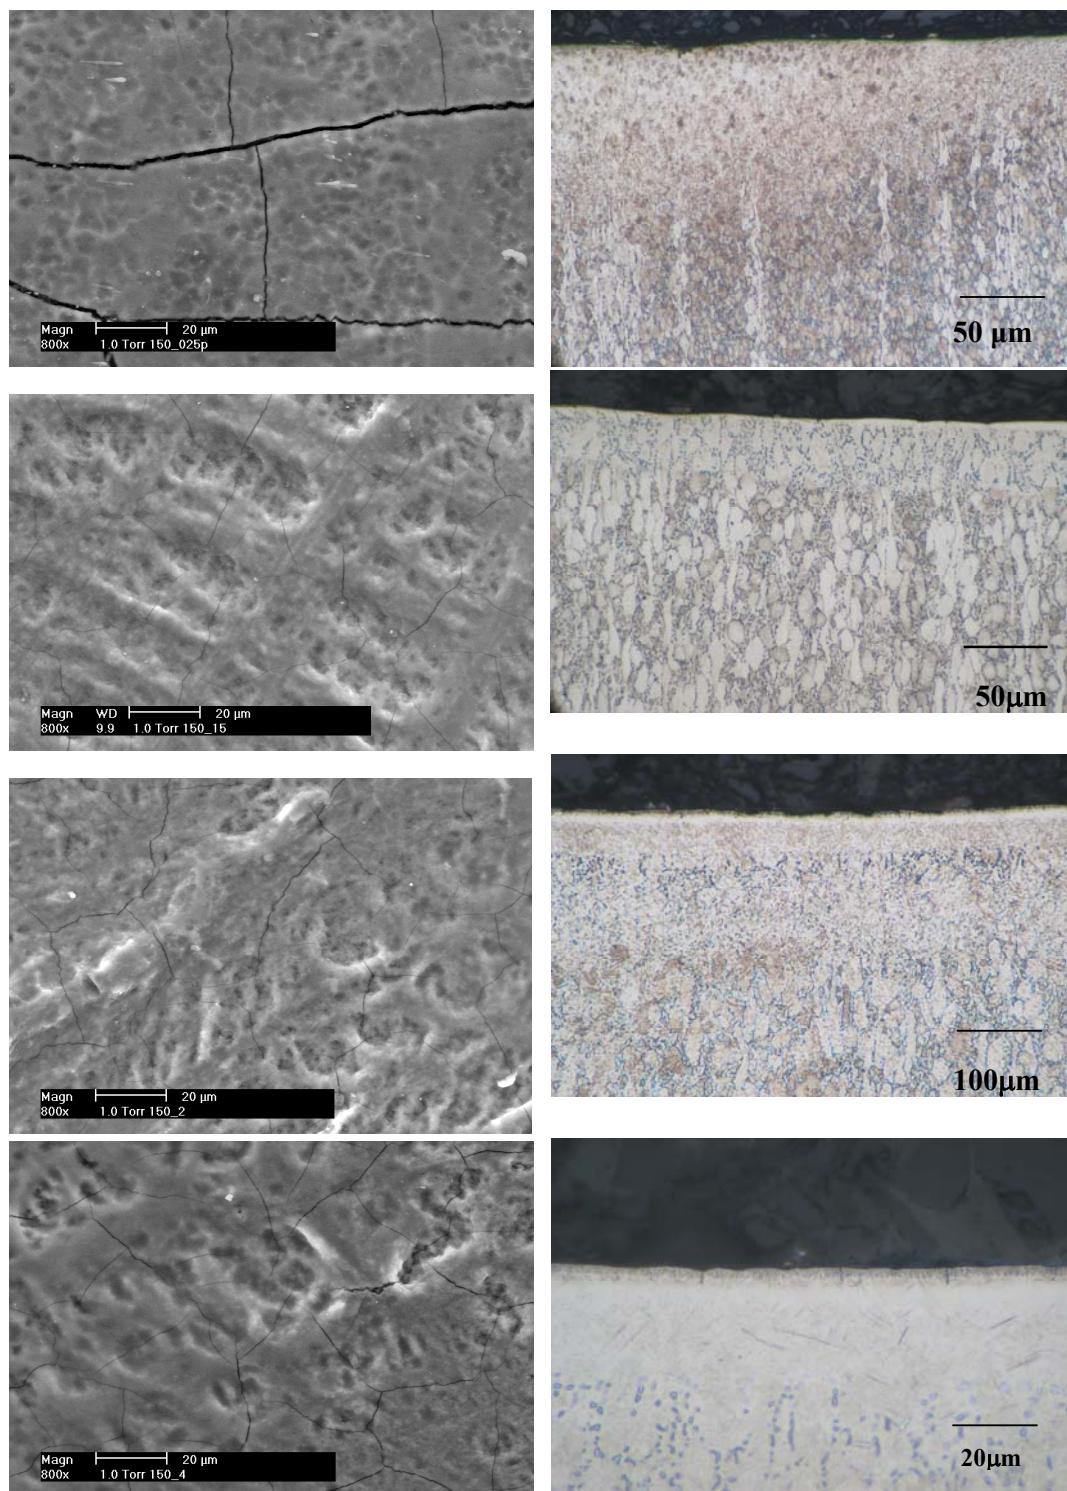
Fig. 5. Cracking of surface layers for specimens laser melted with Nd-YAG laser at 150 W and 50 Hz, without overlapping (from top to the bottom) at scan rate: 0.25 m/min., 1.5 m/min., 2 m/min, 4 m/min
