B. Świczko-Żurek¹, A. Szumlański², J. Zorn¹

ALLERGY TO IMPLANT COMPONENTS: CHROMIUM, NICKEL, COBALT AND TITANIUM

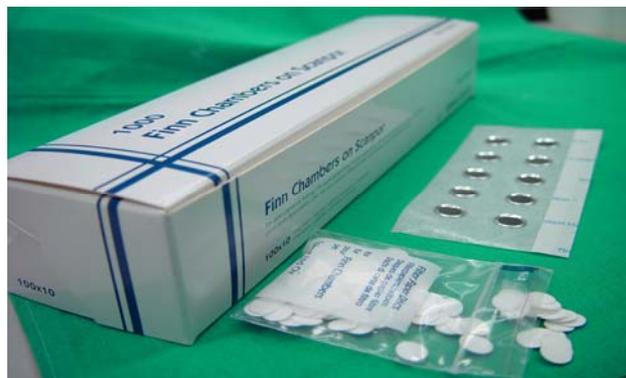
The patch tests (Fig.1) were used for the research, which was carried on 6 selected patients, before and after surgical intervention.

Fig.1. The patch tests were used for the research

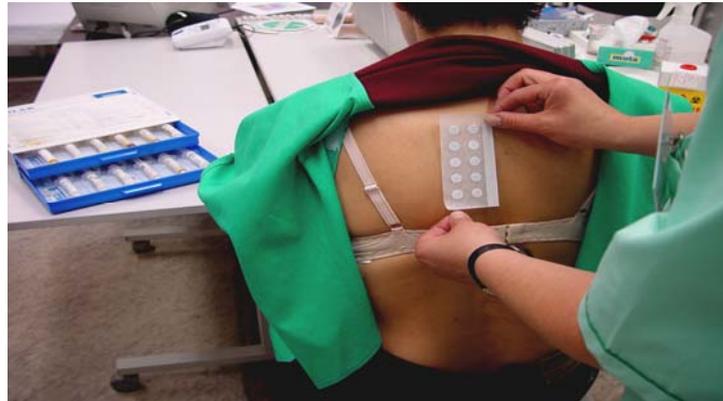
The way of making the tests is shown in the Fig.2

Fig.2. The way of attaching patch tests with the chosen allergic compounds to the body (Ni,Cr,Co,V,Ti)

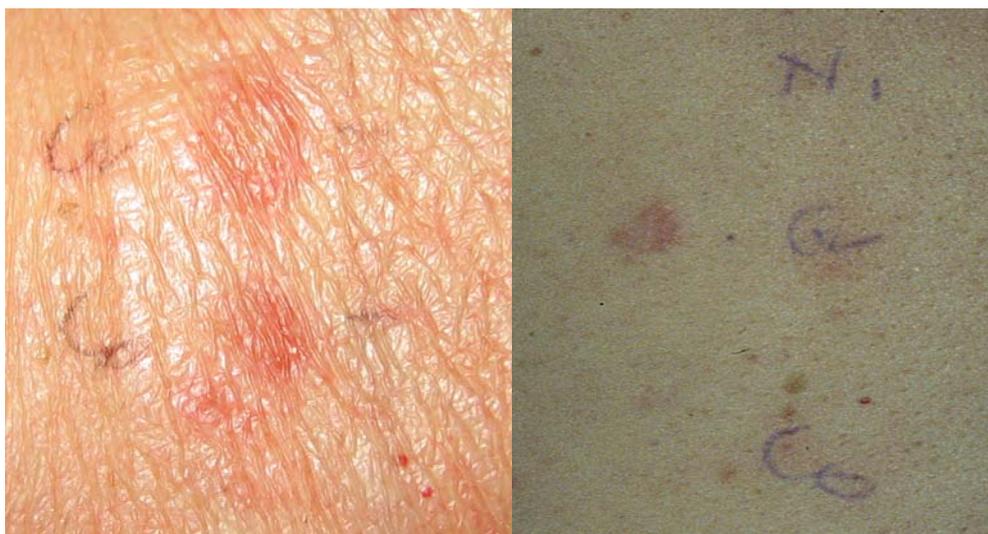
The patients (6) were subjected to the tests on the Ni, Cr, Co allergens (Fig.3).

Fig.3. Skin changes after performing the tests

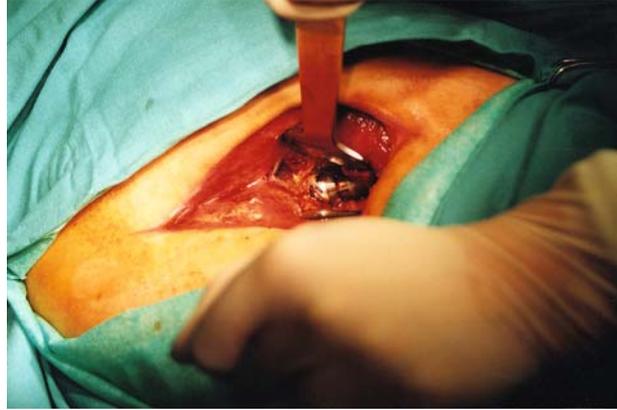
Two of them (1,2) had their implants removed due to aseptic loosening and intolerance of endoprosthesis. It resulted in pain, fistula serosa and edema. There were found to have oversensitiveness to Cr and Co. The allergic were not diminished by using antihistaminic drugs (Fig.4).

Fig.4. The hip implant removing caused by aseptic loosening

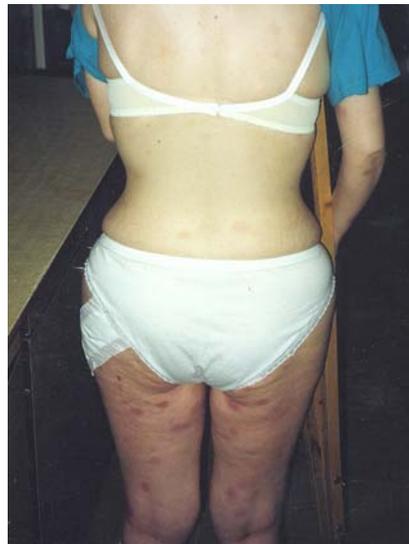
The patient (3) with Ni allergy suffered from skin imperfections after introducing hip implant (Fig.5). The symptoms decreased after applying antihistaminic drugs.

Fig.5. The patient with Ni sensitiveness after applying hip prothesis

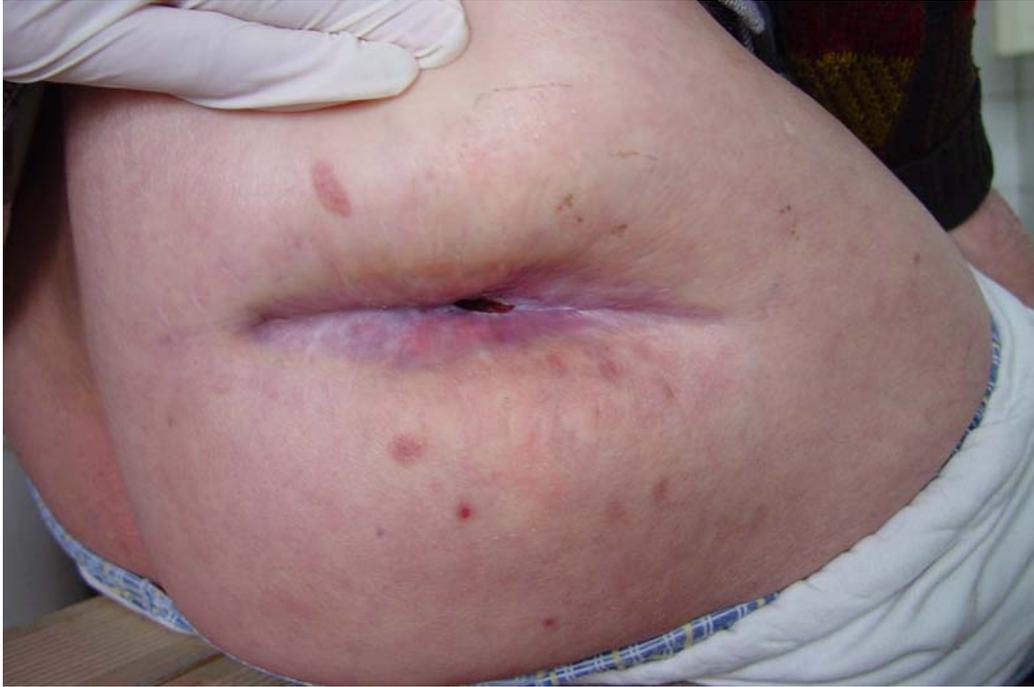
Another is the case with the patient (4) allergic to Ni and Co, who had no symptom of oversensitiveness up to 2 weeks. Then fistula serosa aseptica occurred in the hip (Fig.6). Patch tests were repeated. They showed allergy to Ti. The histaminic drugs decreased the symptoms.

Fig.6. The fistula serosa in hip after implantation

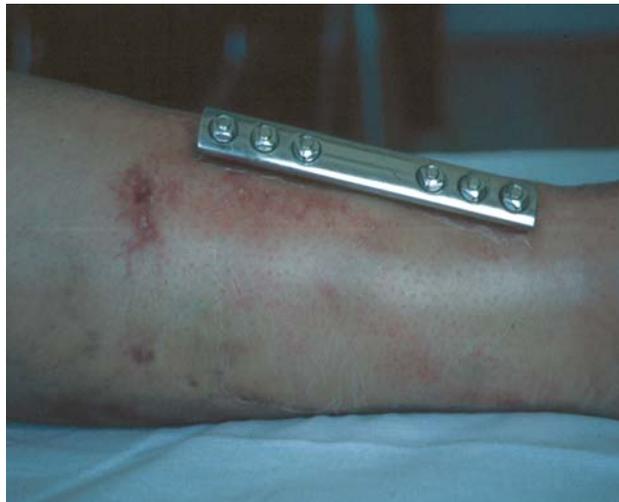
The patients (5,6) whose bones were joint with ZESPOL method, positive reaction to Cr and Ni was found. It appeared as contact dermatitis covering a large area of the skin , not only in the implant-tissue area (Fig.7). Some disturbances in the bone growth was observed. Treatment with antyallergic drugs was ineffective. After 4 weeks the implants were removed and the patients were treated in cast.

Fig.7. The contact dermatitis on the skin surface
