K. Szymlek, C. Kania

Ship Design and Research Centre S.A., Research and Development Department,
Ship Materials, Corrosion and Environment Protection Division Gdansk, Poland

FOULING OF TITANIUM AND STAINLESS STEEL IN SEA WATER

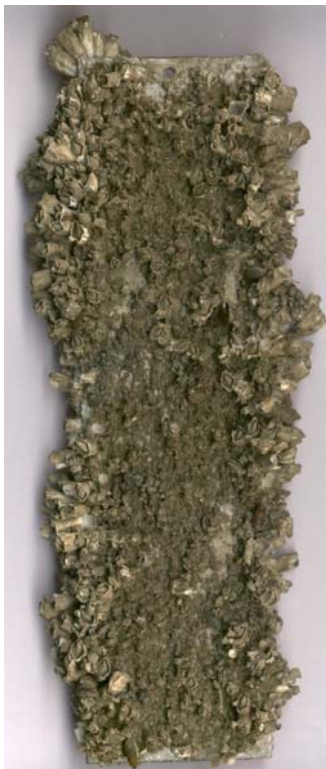
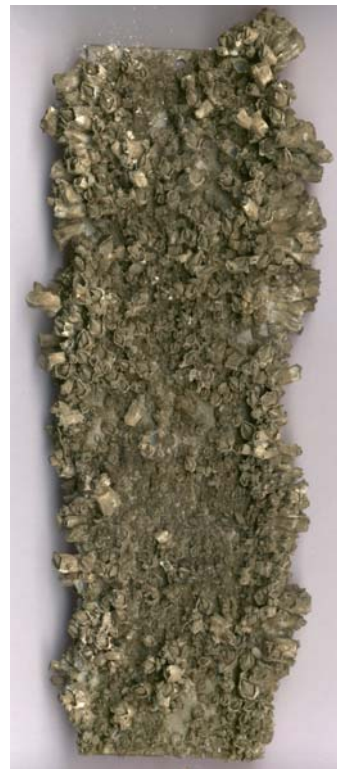
Fig. 2. Fouling of titanium specimen (depth of immersion 4 m - mark T1)

When water temperature in Gdynia Shipyard basin reached approximately 14°C fouling of all tested specimens was observed. After 102 days of immersion in 2006 all investigated specimens were fouled by barnacles (Fig. 1) and after 224 days in 2007 – too (Fig. 2-7).

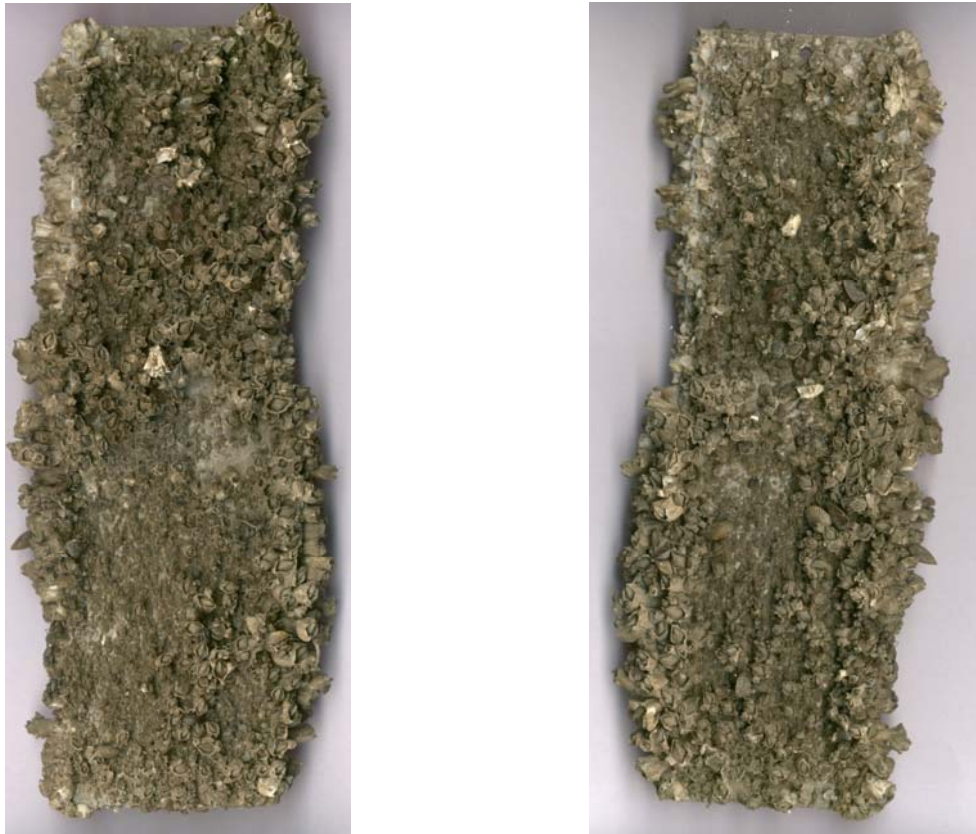
Fig. 3. Fouling of titanium specimen (depth of immersion 4 m - mark RR1)

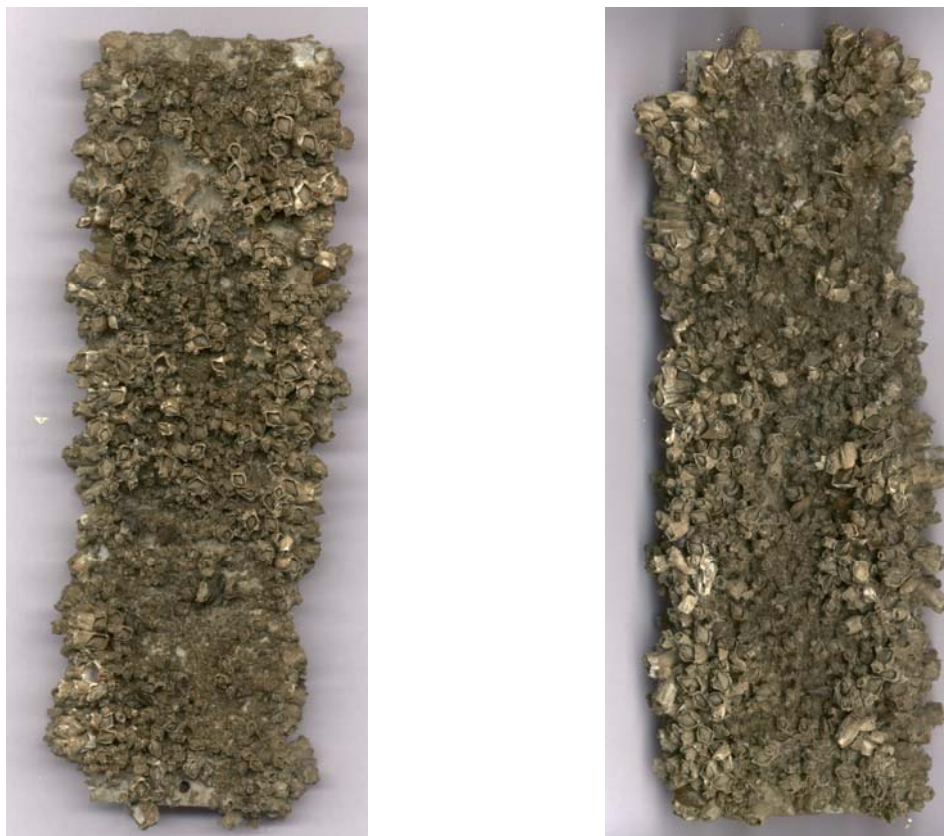
Fig. 4. Fouling of titanium specimen (depth of immersion 4 m - mark RR2)

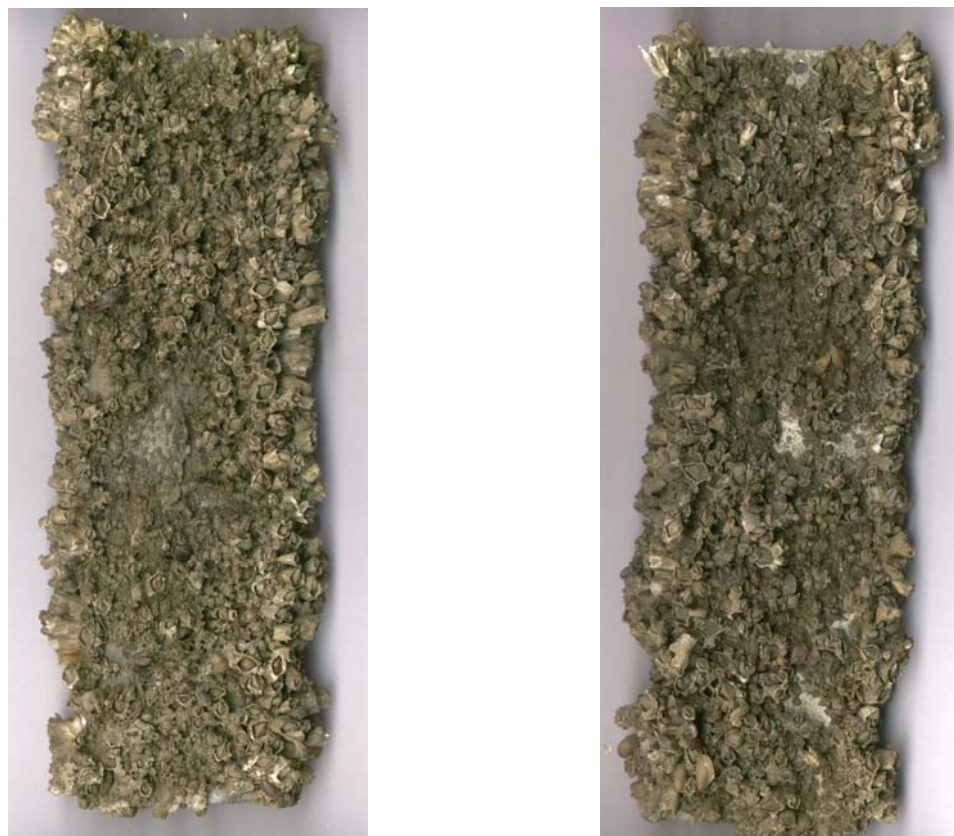
Fig 5. Fouling of stainless steel specimen (depth of immersion 4 m - mark S1)

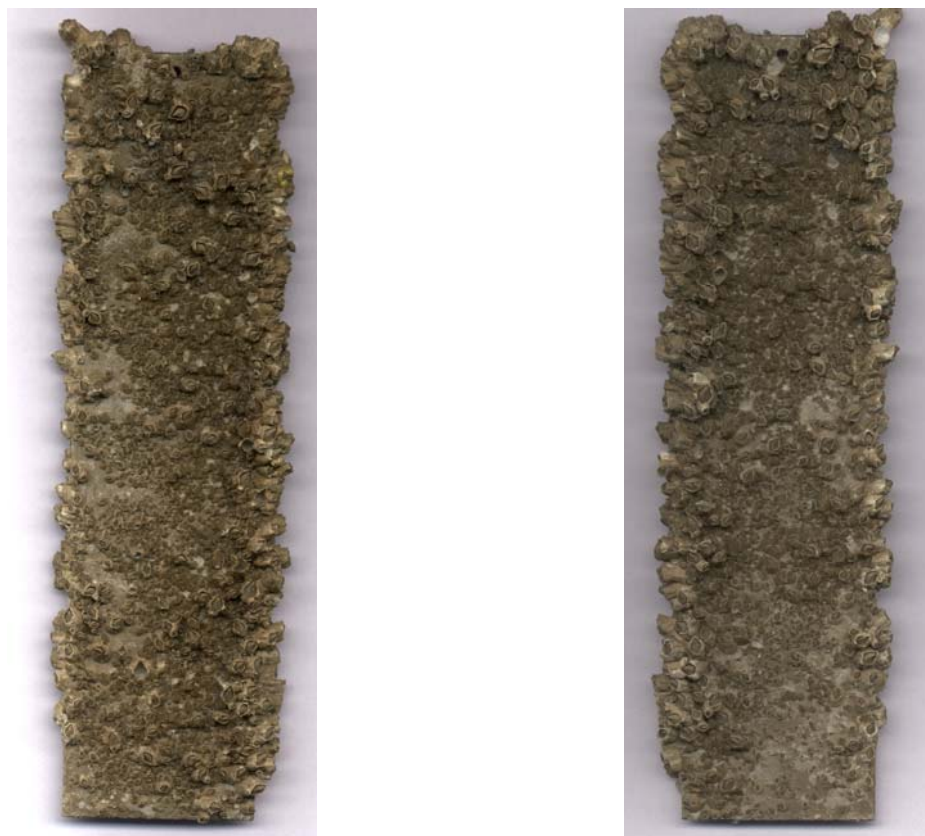
Fig. 6. Fouling of titanium specimen (depth of immersion 8 m - mark T2)

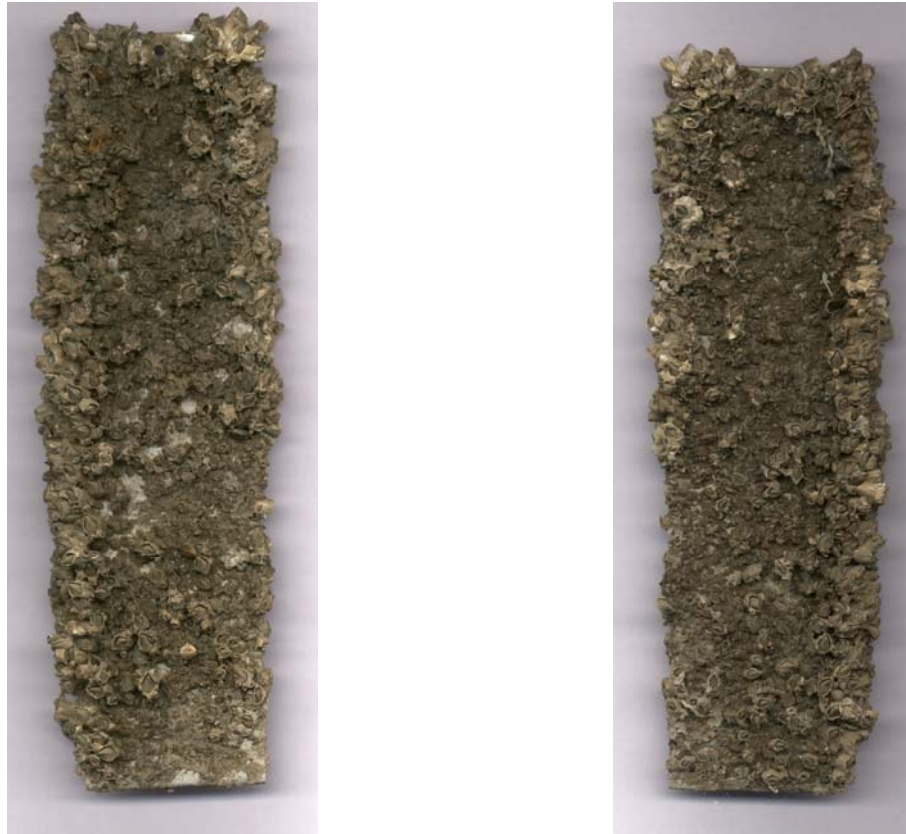
Fig. 7. Fouling of stainless steel specimen (depth of immersion 8 m - mark S2)

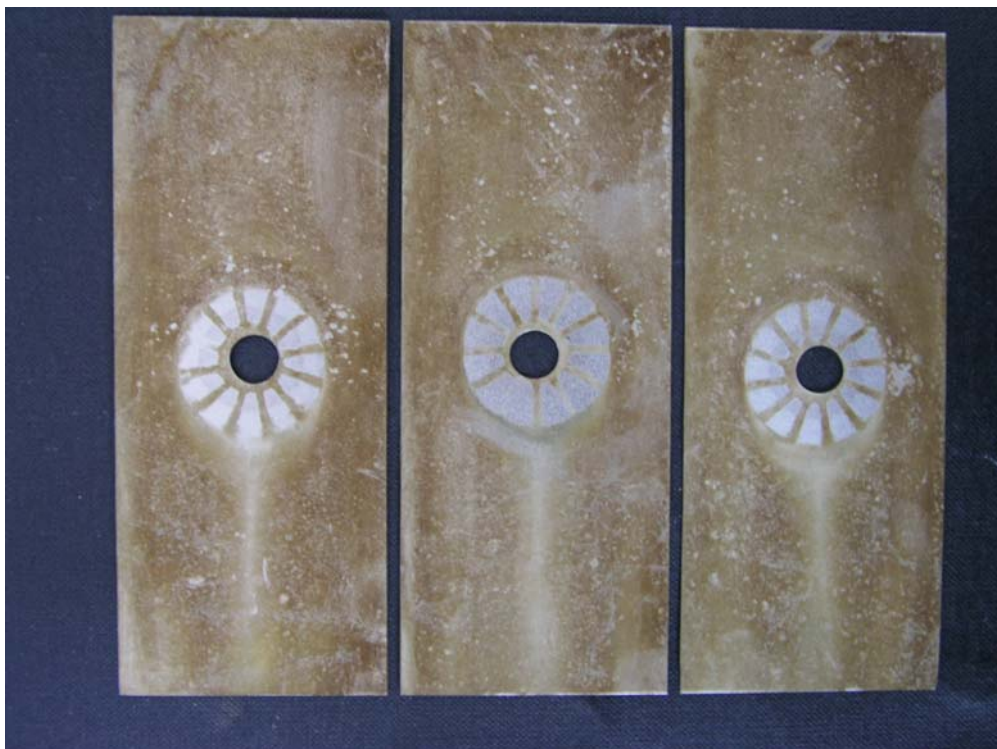
Fig. 9. Fouling of titanium specimen (chlorine concentration of 1 mg/l - mark 1,2,3)

After 1920 hours of test in pipelines all specimens were checked. On specimens without chlorine dosing barnacles and marks of barnacles were found. On the rest of specimens barnacles and other fouling organisms were not observed (Fig. 8 – 9).

Chlorine dosing to natural sea water even on the low level (1 mg/l) prevents fouling of titanium. Without chlorine dosage fouling of titanium is like that of every other material susceptible to this process. Less intensive fouling in the case of dynamic flow of sea water was observed.

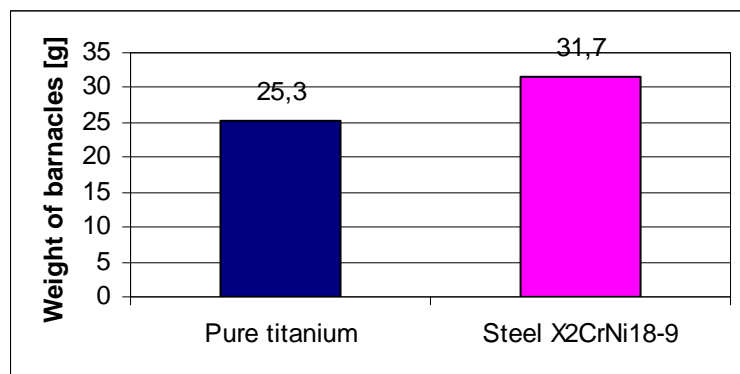
Fig. 11. Weight of barnacles on specimens immersed at 8 m depth

All specimens after drying for two days in ambient temperature were weighed. Mass of barnacles was calculated as the difference between mass of the specimens before and after exposition. Weight of barnacles on the specimens was calculated as average value for three specimens. The results are presented in Fig. 10 - 12.
