Acta Horticulturae et Regiotecturae 1
Nitra, Slovaca Universitas Agriculturae Nitriae, 2019, pp. 29–36

SMALL SACRAL ARCHITECTURE AND ITS GREENERY IN LOWER SPIŠ REGION IN SLOVAKIA

Small sacral structures are significant elements of Spiš cultural landscapes (North-East Slovakia). This paper presents results of the field mapping of small roadside sacral objects and their greenery along a 66-kilometre long road section connecting North and South of Lower Spiš and the municipalities of Levoča, Spišská Nová Ves, Hnilčík, Mníšek nad Hnilcom, Smolník, and Úhorná. This road was an old trade route and has an important historical legacy in Lower Spiš – a traditional mining cultural landscape with a characteristic hilly topography, wide forest landscapes and rich mining history. The presented mapping was conducted within the research project VEGA 1/0371/18 “SacralArch: Preservation of the Historical Legacy and Architectural Diversity of Small Sacral Structures in Cultural Landscapes of Slovakia”, based on the methodology elaborated by Tóth (2018), which includes localisation, spatial context, technical or health condition and an overall description of the sacral element and the woody plants

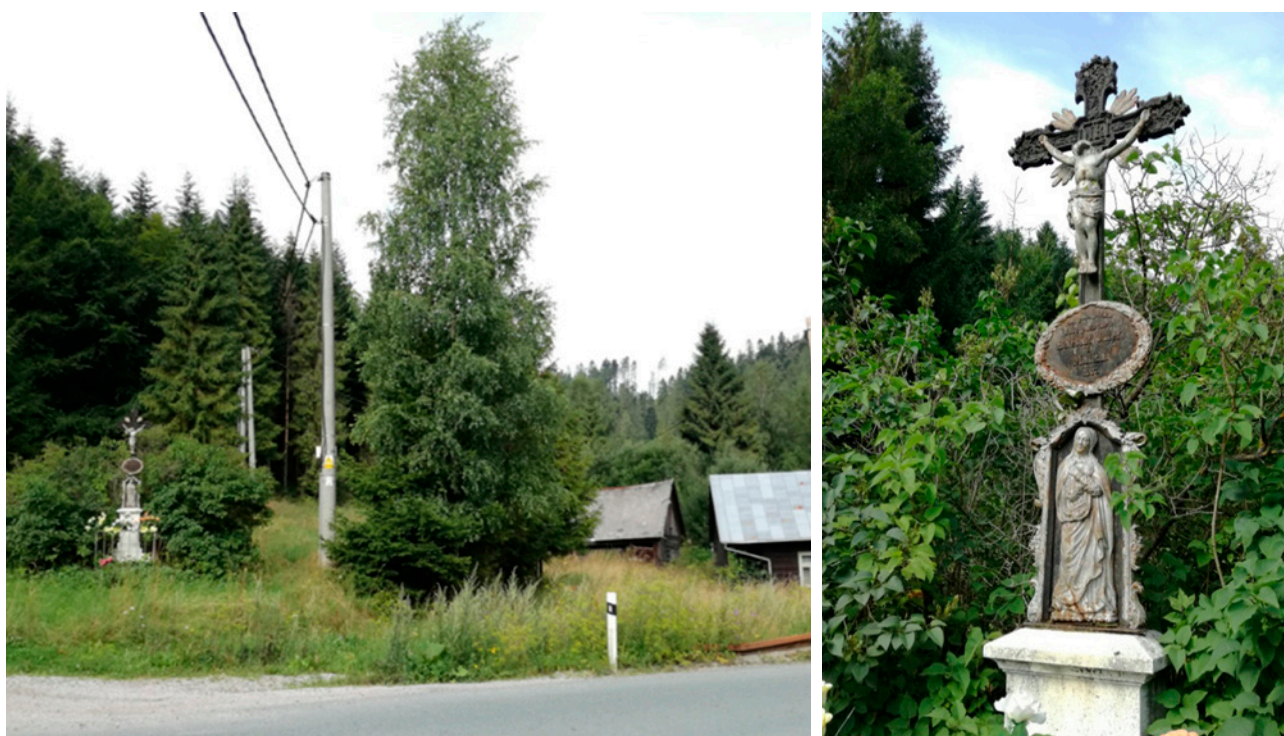
The oldest and aesthetically most valuable cross (No. 4) in the study area is located on the crossroad of II/533 (Levoča – Gemerská Poloma) and II/546 (Hnilčík – Prešov), at the edge of a spruce forest (see Figure 2). This cross dates back to 1907 and it was obviously raised on the site of a previous cross, which is documented in the 3rd military survey (1869–1887).

Figure 2 Black-painted metal-cast cross (No. 4) on a white stone pedestal made of travertine located on the crossroad of B-road II/533 (Levoča – Gemerská Poloma) and B-road II/546 (Hnilčík – Margecany)
Photo: Halajová, 2018

It can be assumed that there was a former wooden cross that was replaced by a then popular and long-lasting black-painted metal-cast cross on a white travertine pedestal. The handcraft detail of the cross is very elaborate and detailed – rays symbolise Resurrection; plant motives like vine, clover and laurel symbolise life after death. The writing INRI (Iesus Nazarenus Rex Iudaeorum) is a biblical reference to Jesus from Nazareth the Nazarene, as King of the Jews. Below the Corpus, there is an inscription medallion (with the date 1907 and a reference to the donors) and a metal-cast relief of Virgin Mary with elaborate plant-motive decoration. The cross is surrounded by a simple metal fence and a group of common lilac (*Syringa vulgaris* L.).

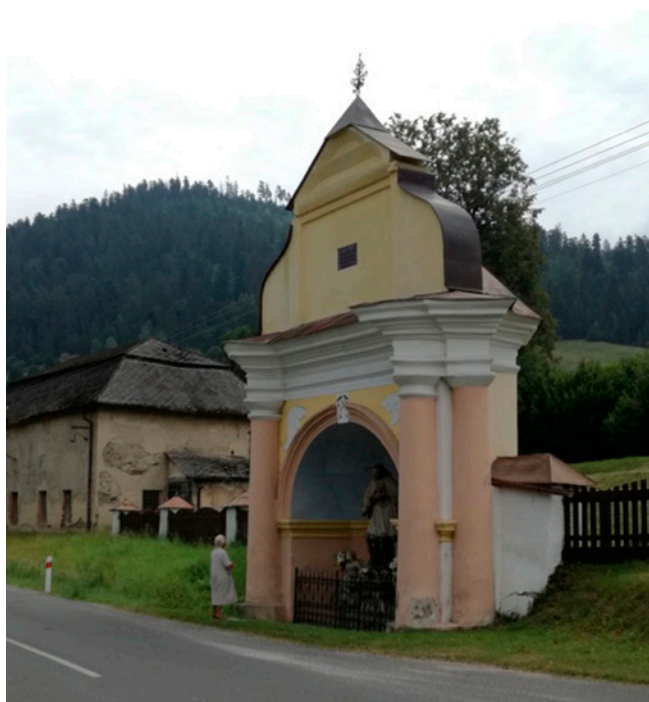
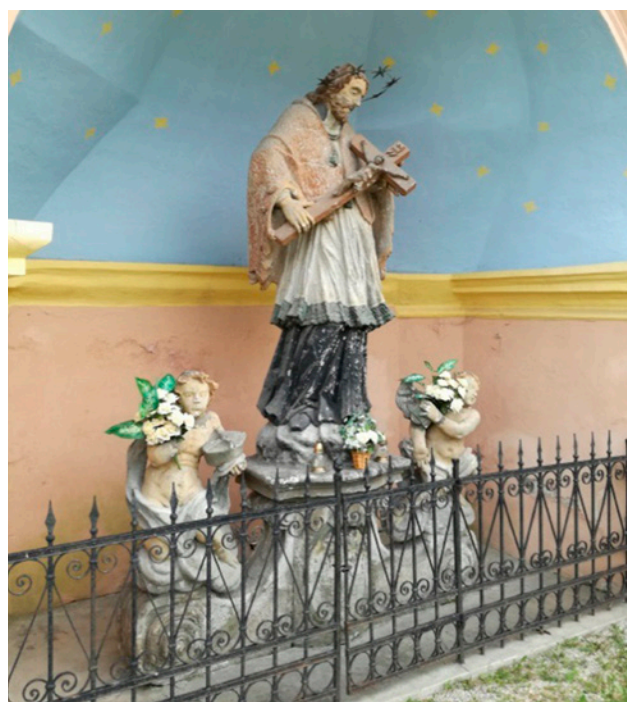
The roadside Baroque chapel of Saint John of Nepomuk from 1726, located at B-road II/549 (Mníšek nad Hnilcom – Krásnohorské Podhradie), at the entrance to village Smolník (Figure 3) is registered as a cultural monument since in 1963. It features a typical mining symbol with two hammers at the dating, which represents a symbolic linkage between everyday life and work of locals with their spiritual values. The chapel was built during the reign (1711–1740) of Charles VI (1685–1740) whose name is linked to some of the most spectacular Baroque buildings in the region, in the period when the cult of Saint John of Nepomuk (canonised in 1729) was rising. The development of Smolník continued under the reign (1740–1780) of Maria Theresia (1717–1780) when one of the three mining schools in the Hungarian Kingdom and a mining inspectorate were established.

Figure 3 A characteristic Baroque chapel in Smolník (No. 10) with a niche featuring a polychrome statue of Saint John of Nepomuk and decorative mining symbols around the dating
Photo: Halajová, 2018

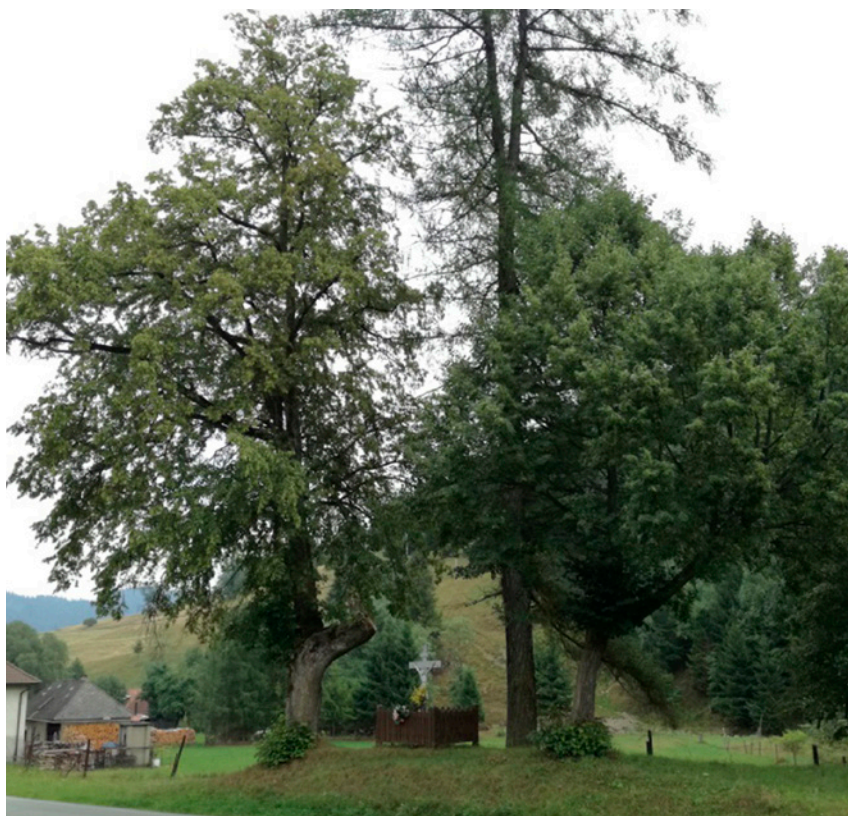
Figure 5 Metal cross in Smolník with two small-leaved linden trees (*Tilia cordata* Mill.) and a European larch (*Larix decidua* Mill.) behind the cross (Object No. 11)
Photo: Halajová, 2018
