Gheorghiu Irina-Maria¹, Mitran Loredana², Mitran M.³, Mironiuc-Cureu Magdalena⁴, Iliescu A. A.⁵, Suci
Ioana⁶

Dental abfraction- case report

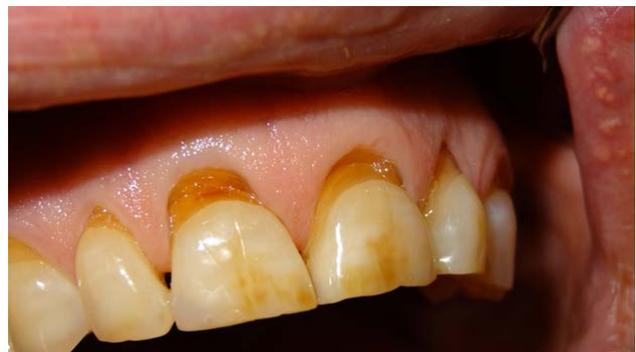
A male patient, 60 years old, presented to our dental practice for dental treatment. We indentified the presence of multiple cervical abfraction lesions, located on the buccal upper anterior teeth, including the upper premolars(Figure no. 1). The patient had complaint of dental hypersensitivity to physical agents, especially cold sensitivity in that area. The examination revealed that the source of sensitivity was the presence of exposed dentin from abfraction lesions.

Figure no. 1. Clinical view showing multiple abfraction lesions on upper front teeth

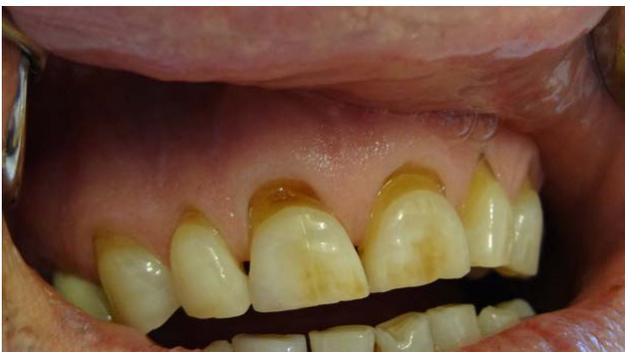
The medical history revealed the existence of the phenomenon of bruxism, confirmed by objective clinical examination. The patient presented areas of occlusal wear and enamel fissures which are specific to hyperoccluded teeth. The abrasion phenomenon was extended both in the upper arch teeth where the abfraction lesions were localized, and in the lower arch, clearly confirming the presence of the parafunction(Figure no. 2). The clinical examination revealed class IV restorations at central upper incisors previously made with composite materials, also suggesting the presence of excessive occlusal forces.

Figure no. 2. Abrasion phenomenon in both dental arches, specific to bruxism, which led also to abfraction lesions

The patient was instructed to wear a night mouth guard in order to control the parafunction which led to the abfraction lesions.

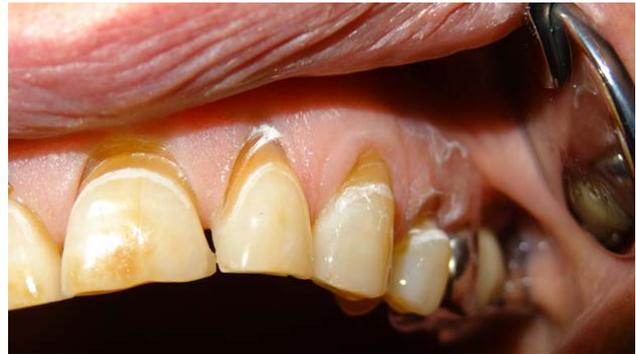
Cavities were prepared by rounding the internal angles in order to reduce internal stress and all sharp line angles were smoothed and beveled with a fine bur. Removing these line angles as well as the V-shaped pattern of the cervical lesion relieved concentrated stress at the apical area of the lesion. The edges are beveled to increase the contact surface, and subsequently adhesion, as well as for aesthetic reasons (Figure no. 3). Proper isolation was put in place and then the cavities were acid-etched with

Figure no. 3. Prepared cavities by rounding the internal angles and beveling the edges for better adhesion of composite resins

3 M Scotchbond 35% phosphoric acid for 15 seconds and rinsed thoroughly. When the acid-etching was complete, two layers of bonding agent 3M Single Bond Dental Adhesive were placed, thinned, dried for 2-5 seconds and light-curing for 10 seconds. Then the composites resin was applied in successive layers inside the cavity and light-cured for 20 seconds.

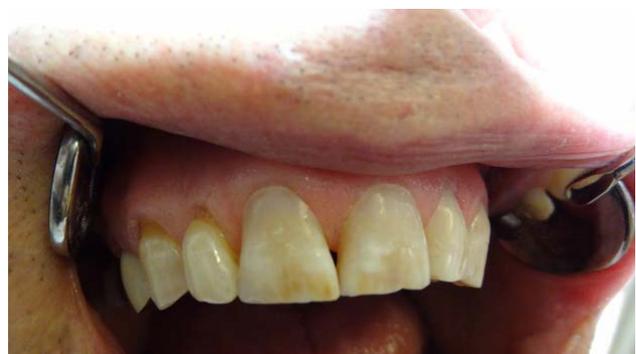
Figure no. 4. The restorative treatment of abfraction lesions with composite resins

The technique used in restorative treatment of these abfraction lesions is the technique of direct placement of composite materials using a light-curing universal microhybrid composite, with a low modulus of elasticity: Filtek Z 250 (3M ESPE). The adhesive used was 3M Single Bond Dental Adhesive. The operative visit began with brushing teeth surfaces in order to remove extrinsic stain, followed by careful choice of shade of the restorations, considering its high yellow saturation in the cervical third.

Finishing and polishing restorations were accomplished with 3M Soft Lex finishing discs, with progressively finer grits. A special attention was given when polishing the restoration at the gingival level(Figure no. 4 and Figure no. 5).

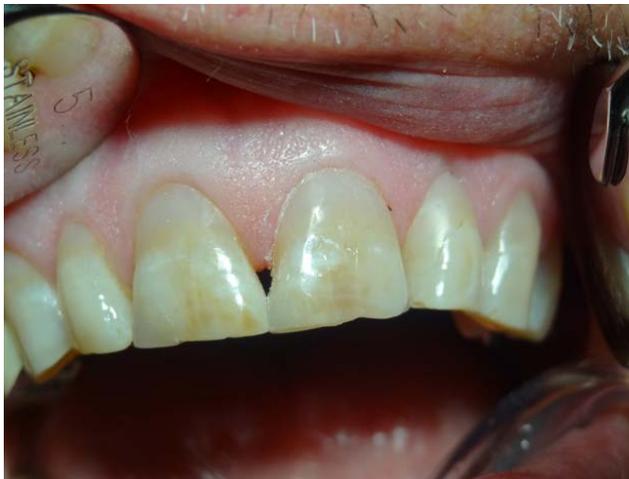
Figure no. 5. The final result of restorative treatment of all existing abfraction lesions

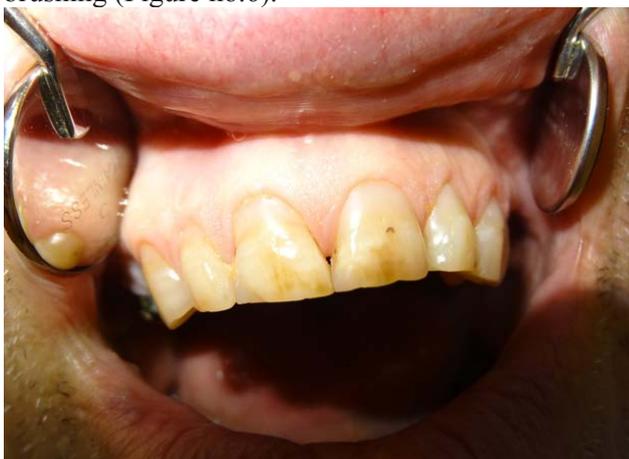
Also, the patient was instructed about proper brushing technique, in order to eliminate horizontal movements and applying excessive force on the toothbrush. The restorations have been observed and followed up during subsequent dental visits at every 6 months. After two years their condition is very good, not only that they are maintained, but no signs of loss of marginal adaptation due to abrasion or tooth brushing (Figure no.6).

Figure no. 6. The aspect of restoration after 2 years
