DEFORMATION OF EXPOSED TOOL PARTS FOR CRUSHING OF UNDESIRABLE ADVANCE GROWTH

Tools for crushing of undesirable advance growth and mulching wood are subjected to heavy wear in operation with the need for their frequent replacement shortly after deployment. It is important to address the problem of their wear due to price of tools, as well as the time necessary for their replacement. Tool life is shortened because of deformation taking place due to the loss of wolfram-carbide (WC) tips, what is an undesirable phenomenon. Solutions for increasing the tool lifetimes were designed on the basis of analysis of wear mechanisms that cause this deformation. Furthermore, effect of deformed layer was evaluated by measuring hardness and microhardness. It was found that there was a strain hardening the surface due to cyclic loading. Size and extent of deformation of the entire tool with the loss of material on the functional part were documented using an optical scanning sensor system. Effect of the deformation on the material structure change, as well as topography and extent of surface area affected by abrasive wear under impact loads, were assessed by means of light and electron scanning mic

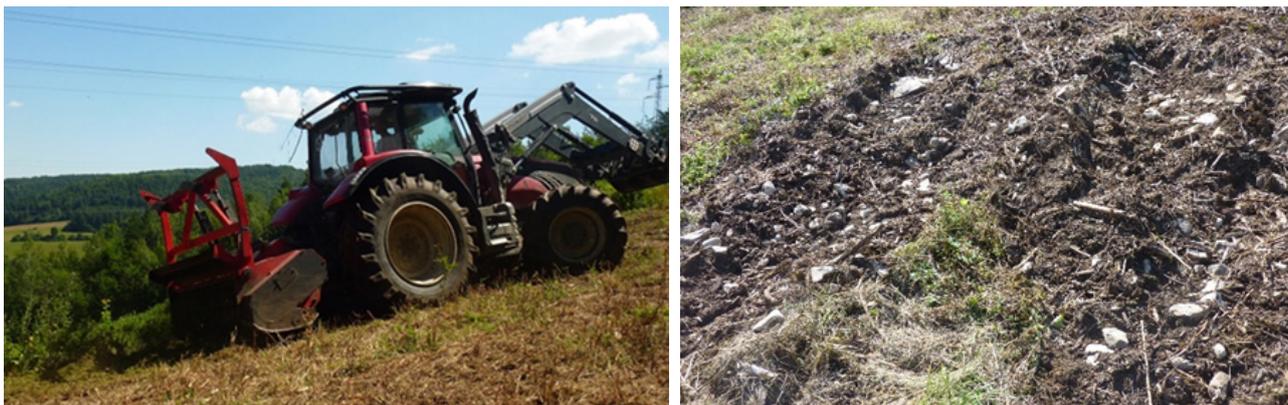
For treatment of forest areas, a crusher of undesirable advance growth is used as additional equipment carried on the three-point support base-machine with forest wheeled skidder. Crusher tools for treatment of undesirable advance growth are located at the back of this adapter and work approx. 0.25 m above the ground level. Firstly, the machine beats down the growth by moving backwards approx. 20 metres with the help of a roller and, subsequently, it moves 20 metres forward and crushes and mulches the beaten growth. Working width of the rotor is 2,750 mm and the working width is 2,300 mm. Number of tools per cylinder (rotor) is 54 pieces (1,000 RPM) (Fig. 1).

Fig. 1 Basic machine with adapter and treated forest stand with increased incidence of rocks

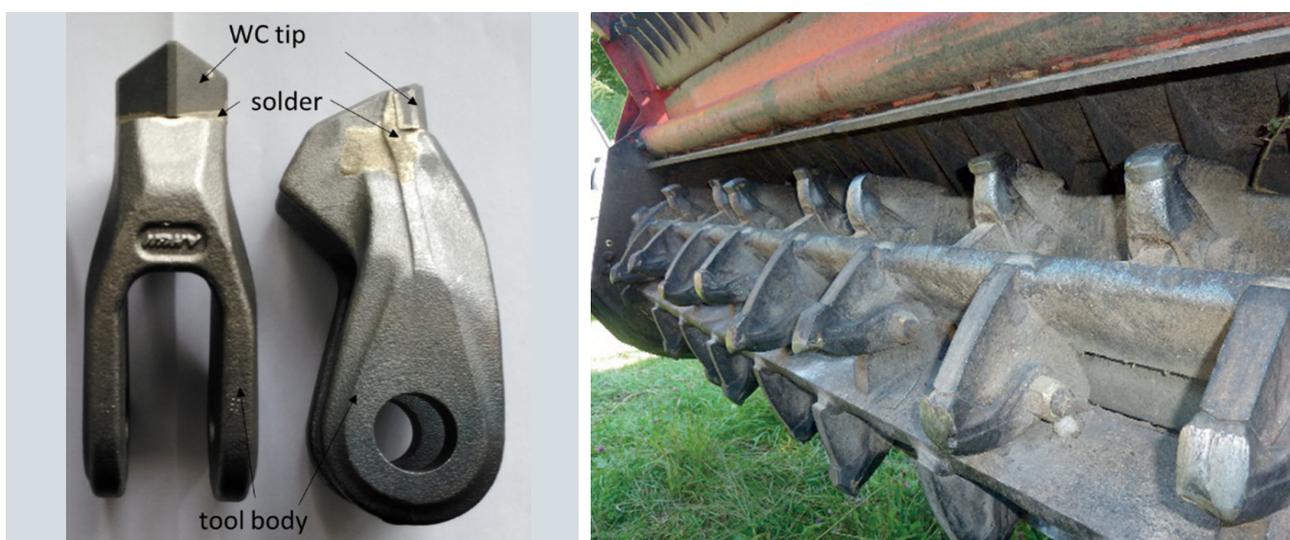
Fig. 2 shows a tool for crushing of undesirable advance growth and an adapter rotor with tools at various stages of wear.

Fig. 2 Tools and roller with working tools

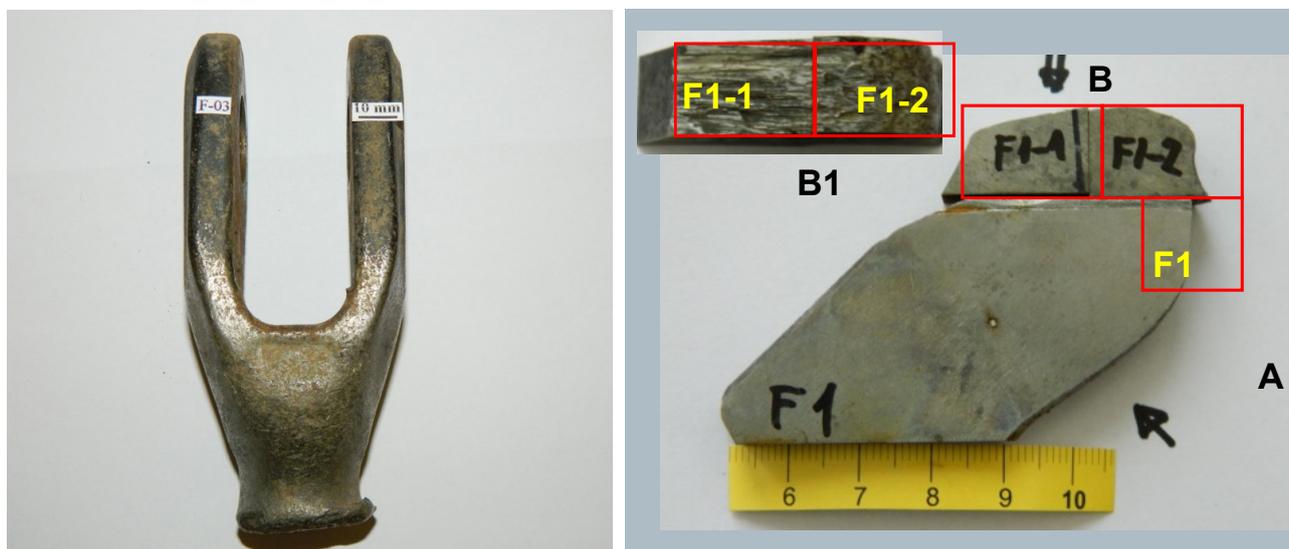
Sample was taken from a worn instrument for microscopic analysis, which was prepared by a standard procedure and etched in 2% NITAL. Fig. 6 shows worn tool, sampling scheme and morphology of tool wear surface (B1).

Fig. 6 Preparation of samples for metallographic analysis

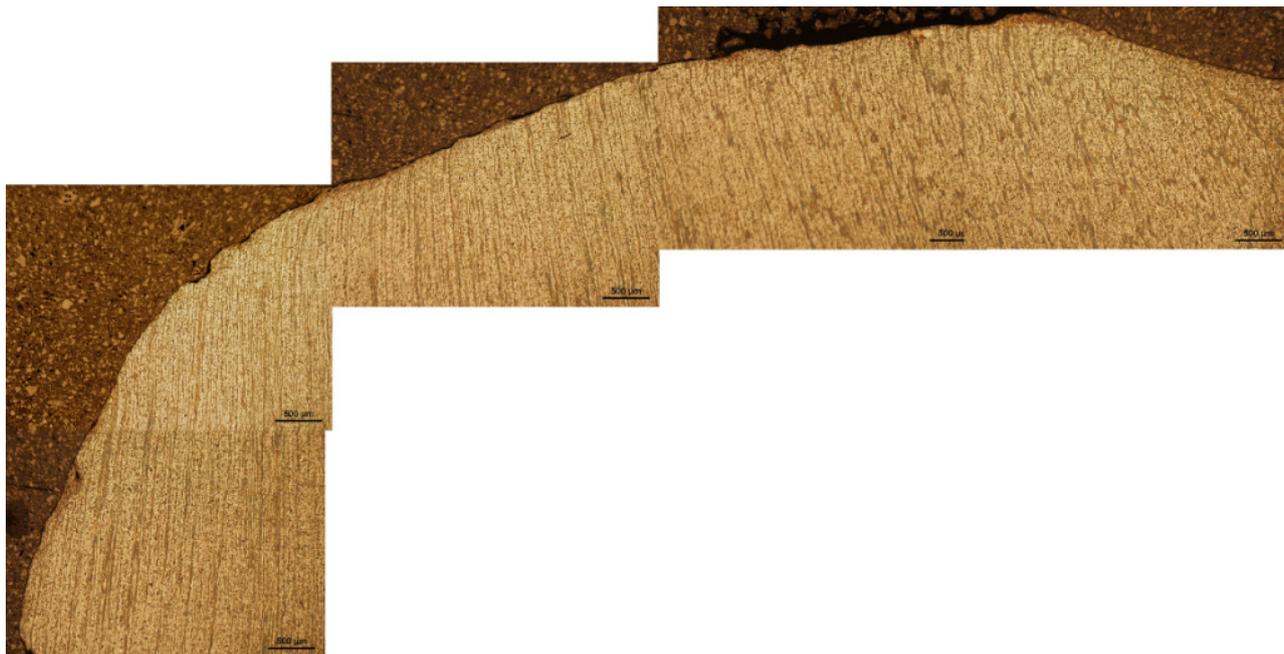
Overall profile of the reference tool face after wear is shown in Fig. 11.

Fig. 11 Profile of the worn tool face

is at least resistant to abrasion wear. This confirms that the forgings were not heat-treated. Figs. 8 to 11 show that there is an intense plastic deformation caused by pressing the foreign hard particles into the tool surface. Figs. 10b, 12c and 13 demonstrate that material is milling, i.e. is abrasively worn due to the contact with hard particles, such as rocks and minerals, occurring in heterogeneous working environment. Significant deformation of the soft ferrite-pearlite structure is visible in the cross-section. After hardening the material surface causing the repeated dynamic loading, plasticity is depleted. Tool surface integrity is disturbed by the action of further loading. Further separation of material particles is the final phase of deformation (Fig. 9a). Plastic deformation as a result of hardening on the face of the tool was identified at a depth of approx. 0.2 mm. Hardening of the material surface is confirmed by higher values of microhardness HV0.025 in the observed surface (Table 4). Tool is deformed and worn as these cycles repeat. This gradual loss of material surface is seen in Fig. 5. Original structure of the tool material is not sufficiently resistant to workload, what is also documented by the overall profile of observed tool face (Fig. 11).
