PROPORTIONS - DISPOSITION RELATIONSHIP ANALYSIS OF A HISTORICAL TRUSS IN A RURAL HOUSE IN VÁPENNÁ VILLAGE, CZECH REPUBLIC

2. Building-historical development

3. Truss construction

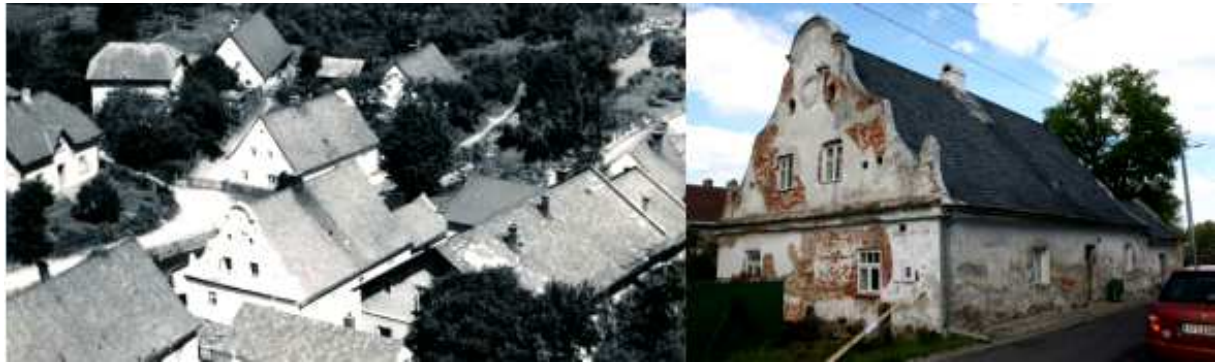
Fig. 1: The researched object – a rural house No. 98 in Vápenná.

House No. 98 in Vápenná, Jeseník region, Czech Republic (Fig. 1) was built in the 2nd half of the 18th century as a reflection of establishment's aims to raise the numbers of tax-paying subjects [3]. The first written note originates in 1786, when Michal Hauke sold the house to his son, Michal [1]. Dendrochronological analysis of the ceiling - after 1775 is also an evidence for the house being built in the 2nd half of the 18th century 70s. The building is a typologically common rural house with a central room and a hood kitchen, but has been richly designed to contain decorations in form of painted red frames, which have been preserved in the western attic area. Despite the ceiling parts being largely preserved above the ground floor, the truss was newly built (1974/75 according to dendrochronological dating) with an inclusion near the southern gable. The living room was partitioned in the southern section on the verge of the 19th and 20th century, which relates to the muring of the window in the southern wall. The kitchen hood in the central tract was under-arched and a stove was set up in the south-eastern room.

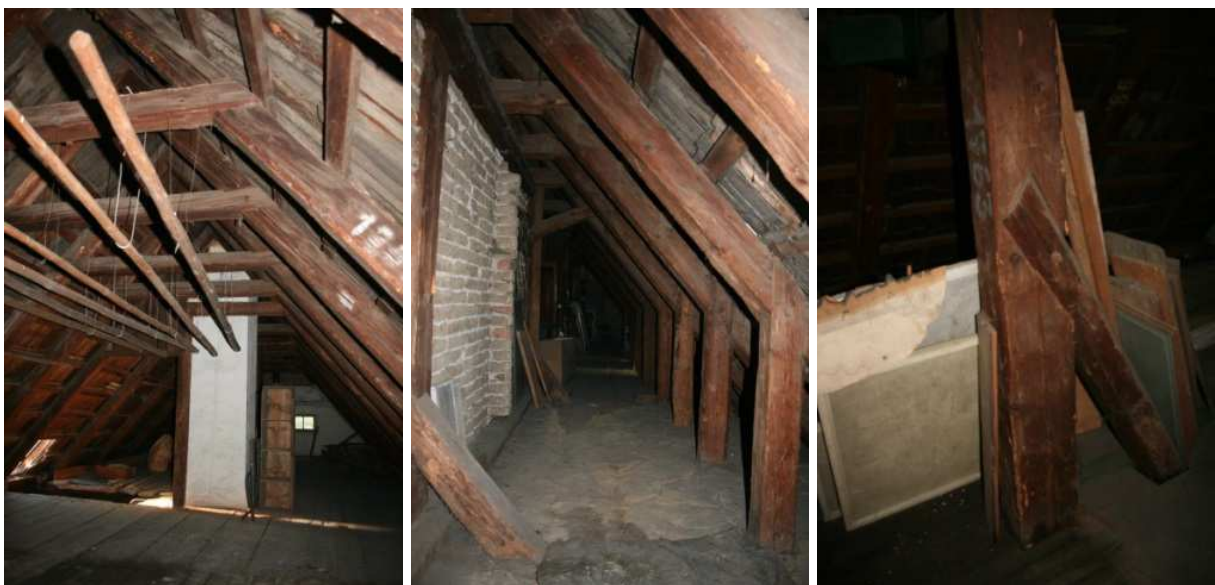
Fig. 2: The inner view of the truss.

The truss over the southern part has a rafter – collar tie structure and consists of two collar tie levels and base struts located at the base of the rafters. Lateral stools, whose posts are placed on the threshold beams, were later incorporated into the design. Central binding rafters bearing the collar beams are tenoned to the posts. The posts are also stabilized using single-sided outer bracing structures clad together into binding beams. The posts in the marginal joints are longitudinally wind-braced by struts (three views of the truss are on the Fig. 2).

The truss over the northern part is also of a rafter - collar beam structure with two collar beam levels, positioned at the same height as in the southern part. Unlike the southern roof its central posts are located in the marginal joints, which are placed on the threshold beam. The posts are stabilized by base struts. The truss itself is longitudinally secured by inclined bracing structures passing through the anchor post into the columns and the anchor posts below the lower collar beams.

Most of the joints used are dovetail joints fixed by wooden stakes. Tenon joints are used in case of the anchor posts and rafters with binding beams.

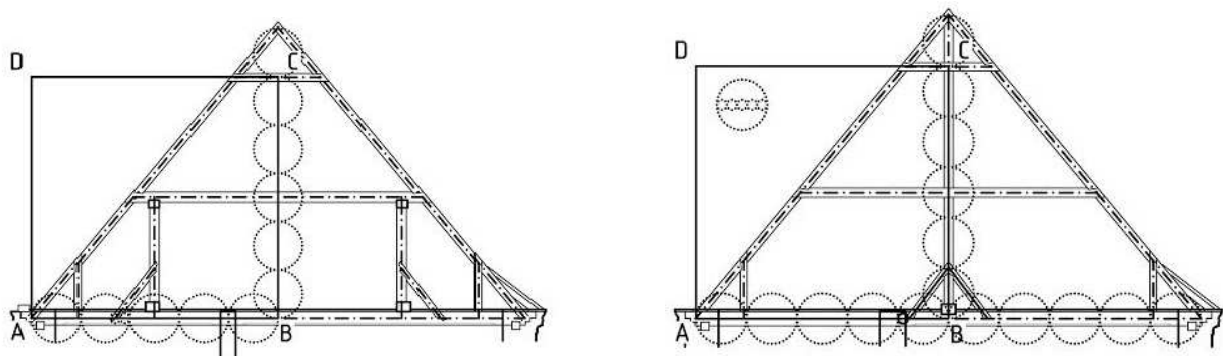
Fig .3: (a) Section of the south truss; (b) Section of the north truss.

After previous examinations of historical trusses of primarily sacral buildings it was found that one of the most commonly used principles for determining the essentials truss dimensions is a principle we dubbed “ n plus one” [4]. It is a principle determining the height of a truss based on its width as follows: the width is divided into $2n$ units and the height is then $(n + 1)$ units. The same principle was applied in case of the rural truss in Vápenná, with $n = 5$ and the ratio between the width and height of the truss being $10 : 6 (= 5 : 3)$. A basic square ABCD dimensions are 5×5 units was obtained (Fig. 3a, b). The unit used for determining the truss height based on its width is also five times the measure of length corresponding to the span (contemporary measure), in this case 19.3 cm [8]. The used measure (span) was found on the top side of the ceiling beam in the form of an engraved circle (Fig. 4b). (The cut of the beam with the engraved circle was included in the depository construction details Technical University of Ostrava under inventory number 176. A, [2].)

For the design of the remaining important elements of buildings and trusses were formerly used a simple integer ratio, in the literature often named as “music” ratios [6, 7]. In the researched truss were used these ratios: the main collar tie is located at half of the height of the base square; upper collar tie is located at the height of the basic square; struts and rafters are placed on the tie beam in one tenth of the total width of the truss. The floor plan of the rural house (Fig. 4a) in relation to the truss is designed in such a way that the relationship between its length and width is $3 : 2$, this relationship expressed by a span is $75 : 50$. The original big front room on the South side of the house has internal dimensions in the same proportion as the entire floor plan of the house, hence the $3 : 2$ ($45 : 30$).

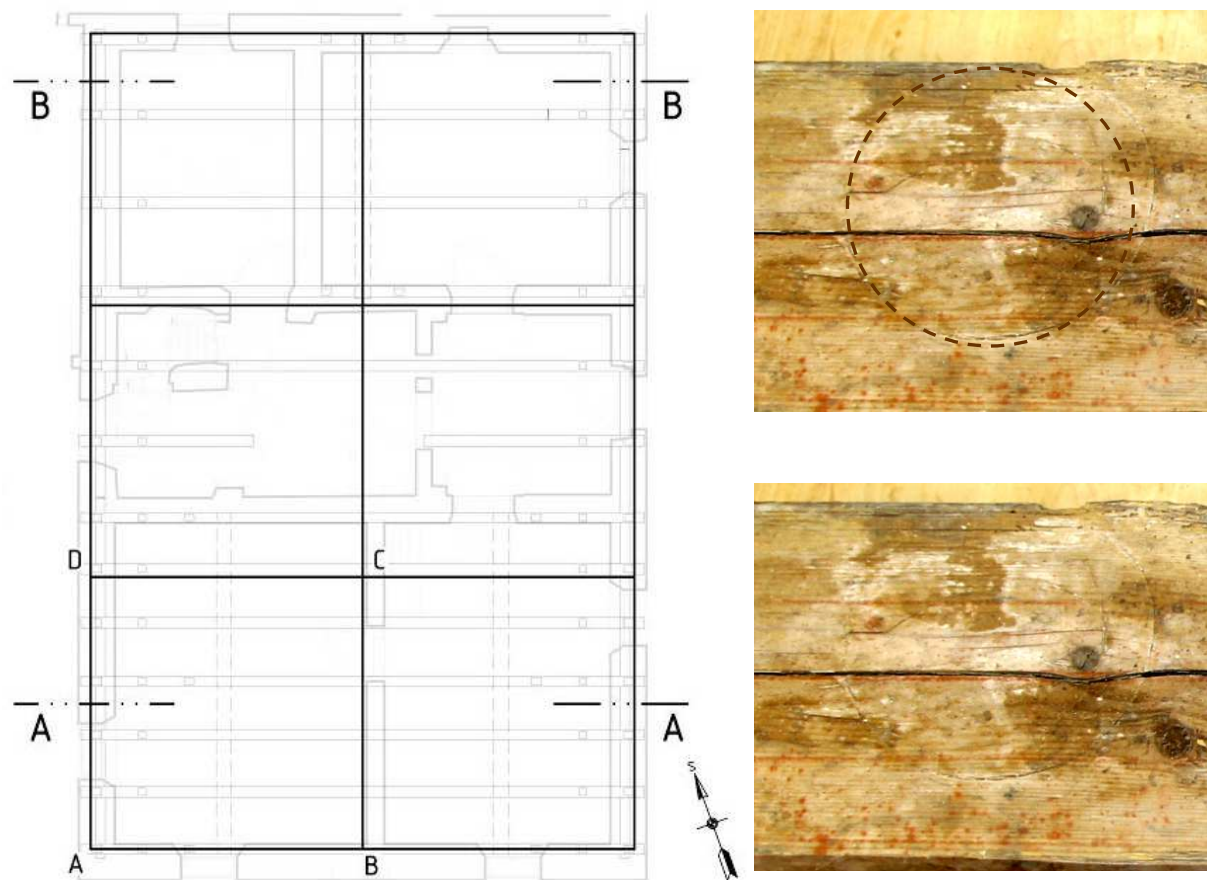
Fig. 4: (a) Floor plan; (b) Engraved circle.
