# OBJECTIFICATION OF PUBLIC BUS STOP'S PAVEMENT SURFACE MORPHOLOGY

The article deals with the road pavement surface morphology objectification in term of the surface unevenness degradation during the life cycle of bus stop pavements. The article presents the results of long-term rut depth measurements performed during 25 years on selected bus stops which were intended to determine correlation dependences of pavement rut depth on a number of design axles. The article also presents different methods for rut depth measurements including the straightedge test, Profilograph GE, TRIMBLE CX, and dynamic Road Scanner.

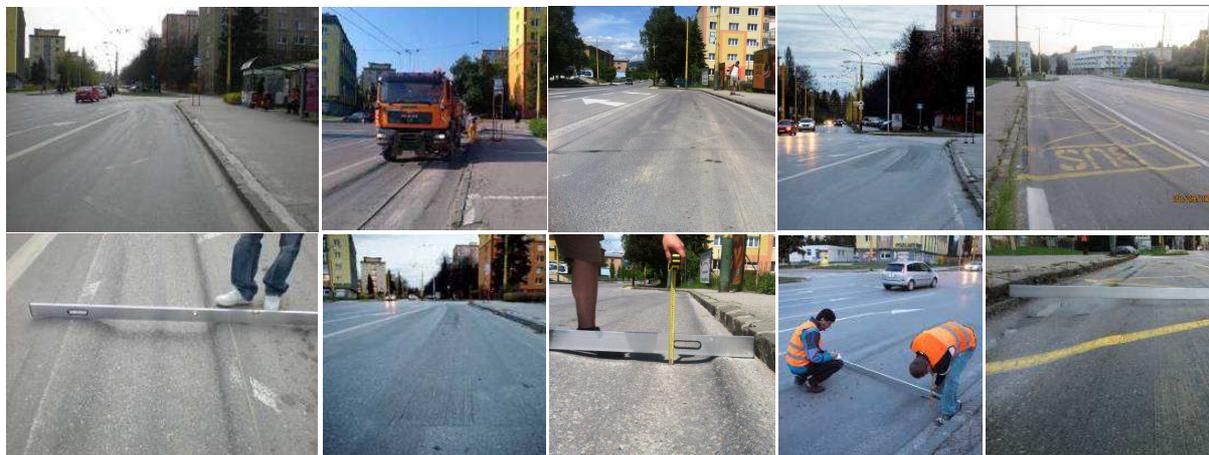
Fig. 1: Transverse unevenness of a road surface of the public bus stop "Mostná" in Žilina on 21 April 2010, 12 August 2013, 21 June 2016, and 29 August 2017 (left to right).

The pavements of local communications are the most common constructed to asphalt and, however, when you use them on bus lanes the longitudinal ruts are created after some time, which undermine the operational characteristics of the road (water in ruts, etc.), but also its aesthetic appearance (Fig. 1 and Fig. 2).

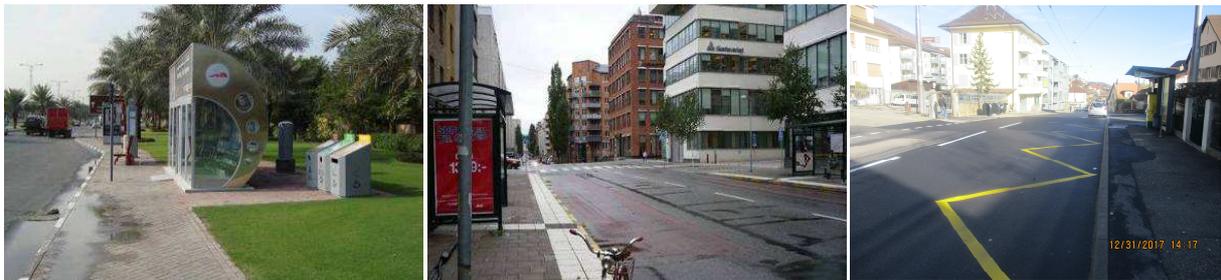
Fig. 2: Permanent deformation of Dubai, Stockholm, Neuchatel asphalt pavements of bus stops.

Permanent deformation in asphalt roads with heavy truck and bus services are related to the thermoplastic properties of the asphalt, and in our conditions, they cannot be fully avoided. There is the frequent presence of the permanent deformations of asphalt and paved roadways of public transport bus stop, and also the ruts are more common and deeper (Fig. 1 and Fig. 2).

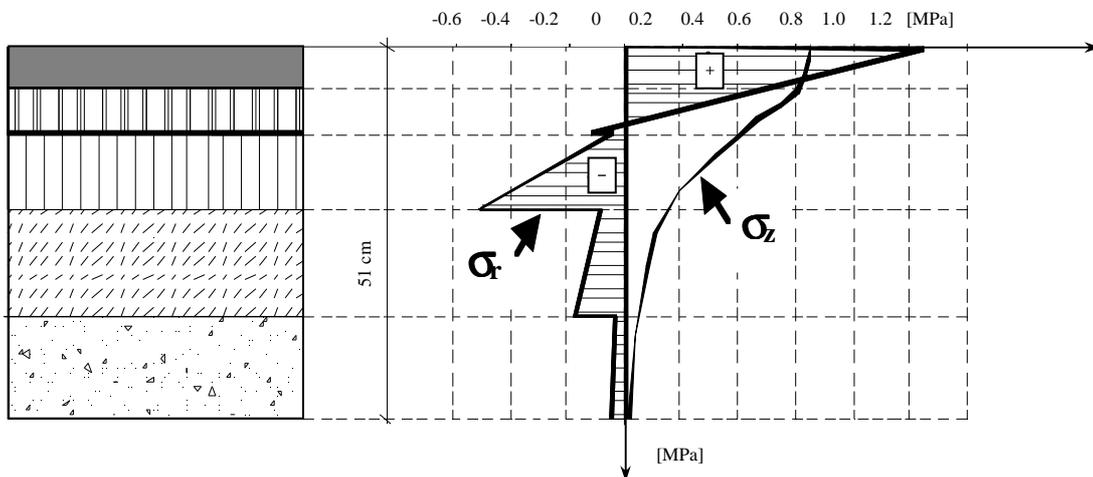
Fig. 3: The graphical view of vertical and radial stresses in the structure of asphalt pavement.

The cause of the increased formation of permanent deformations on the surfaces of public transport bus stops roads is the combined effect of vertical and horizontal forces acting on the roadway with intensive effect at temperatures above 20 °C. The effect of vertical forces is shown as the formation of vertical and radial stresses in the road structure. The stress curve inside the road structure is schematically shown in Fig. 3.

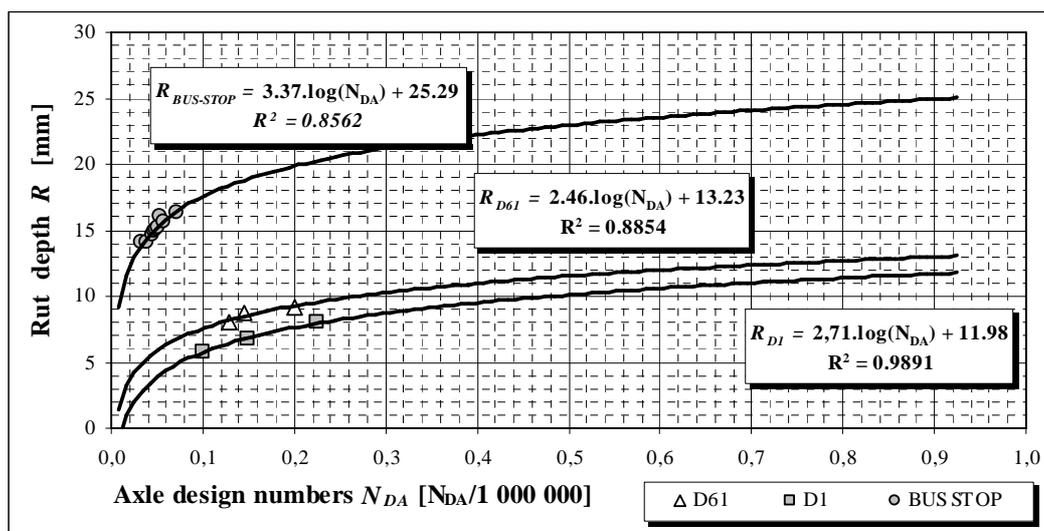
Fig. 4: Comparison of the permanent deformation of the road surface of public bus stops in Žilina and highway roads D1 and D61 from the '80s and '90s of the 20th century.

As shown by measurements of the permanent deformations, carried out for more than 30 years in the workplace of authors, where the road bus stops and highways were monitored over the long term, the permanent deformation under the same number of axle run is more than double times the larger. For a comparison of the results, the measurements from the '80s and '90s of the 20th century are shown in Fig. 4.

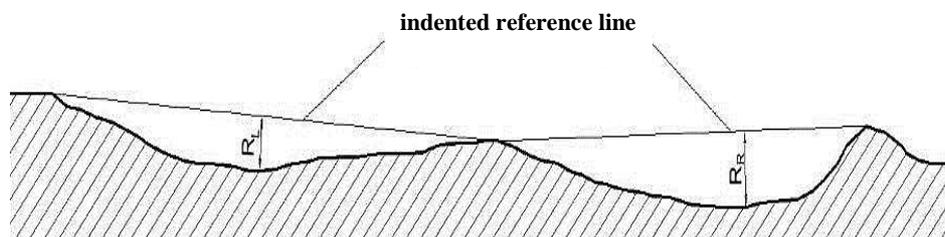
Fig. 5: Left and right rut depth of pavement surface according to technical regulation TP 056.

This standard describes the instrument and method for the measurement of the various unevenness that reflects the deficiencies in the quality of the new road surface layers, airports, and transport surfaces, as well as other surfaces in use. By TP 056 [8] is a rut depth  $R$  [mm] defined as the perpendicular distance between the lowest point of wave and a line connecting the wave peaks (Fig. 5). A five-level classification system of road crosswise unevenness according to technical regulation TP 056 [8] is given in Table 1.

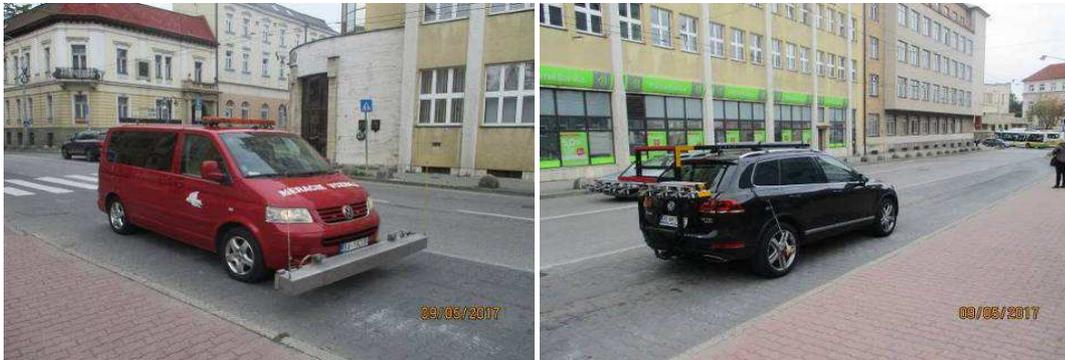
Fig. 6: View of measuring instrument Profilograph GE and Dynamic Road Scanner in measuring road surface morphology at the public bus stop “Hurbanova” in Žilina on 9 May 2017.

In the Slovak Republic, for the mass collection of data on the roadway longitudinal roughness, the instrument PROFILOGRAPH GE (Fig. 6 left) produced by the Danish company Greenwood Engineering Aps., is used. The instrument is owned by Road Databank of the Slovak Road Administration. Website of Road Databank of Slovak Road Administration describes that the Profilograph instrument consists of VW Multivan vehicle, measuring beam containing 16 laser sensors,

3 accelerometers, 2 gyroscopes + control unit, length measuring instrument in the left rear wheel, the operational units (for the control of the system and the immediate presentation of data), software for calibration equipment and analysis of measured data, GPS.

In the present, the Research Centre and the Faculty of Civil Engineering UNIZA in cooperation with the company KVANT are developing the brand-new device Dynamic Road Scanner (Fig. 6 right), which is an instrument for measuring the transverse and longitudinal unevenness. To scan the surface of the road, the instrument uses 8 devices Geocator 2375, scanning width in a single pass is 4 m, scanning frequency is 2000 Hertz (Hz) with 9600 measuring points to the width of 4 m. Possibility to scan the road is up to the speed of 110 km/h.

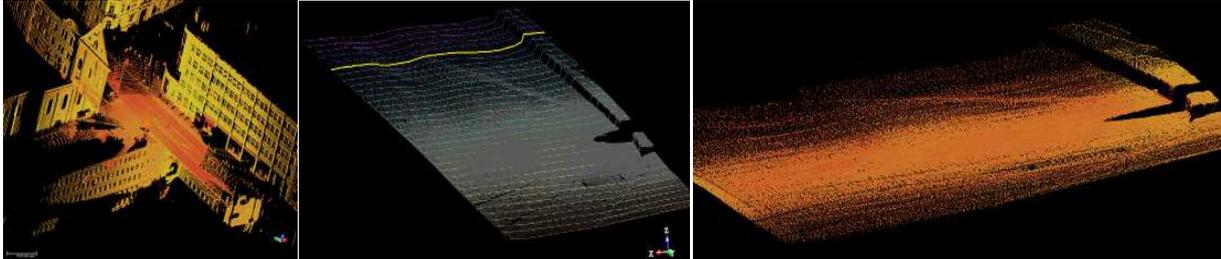
Fig. 8: Perspective view on the raw point cloud with the capture of the surrounding buildings (left), a point cloud for the processing of cross profiles (centre), and the point cloud with generated transverse profiles of the road surface (right).

The first measurement of a road surface unevenness of the public bus stop "Hurbanova" in Žilina using instrument Trimble CX was carried out by J. Mužík and A. Villim in the year 2013 and point cloud data processed using Trimble Realworks 6.0 (Fig. 8). The outputs of the Trimble Realworks 6.0 programme can be imported into AutoCAD in.dwg or.ptc file format.

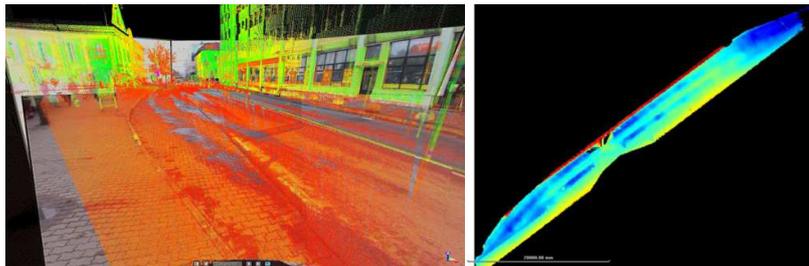
Fig. 9: Perspective view from standpoint No. 2, together with the underlying images (left), height map of the surface obtained from the point cloud (right).

On a height map of the surface, the distortions of the surface in the form of a rut, are very clearly visible. The height map is the basis for more detailed quantification of deformations. Subsequently, the profiles, showing the shape of the road surface, were generated, creating the possibility for the general expression of the status of the road and assessment of general condition, along with the determination of the limits of deformations.

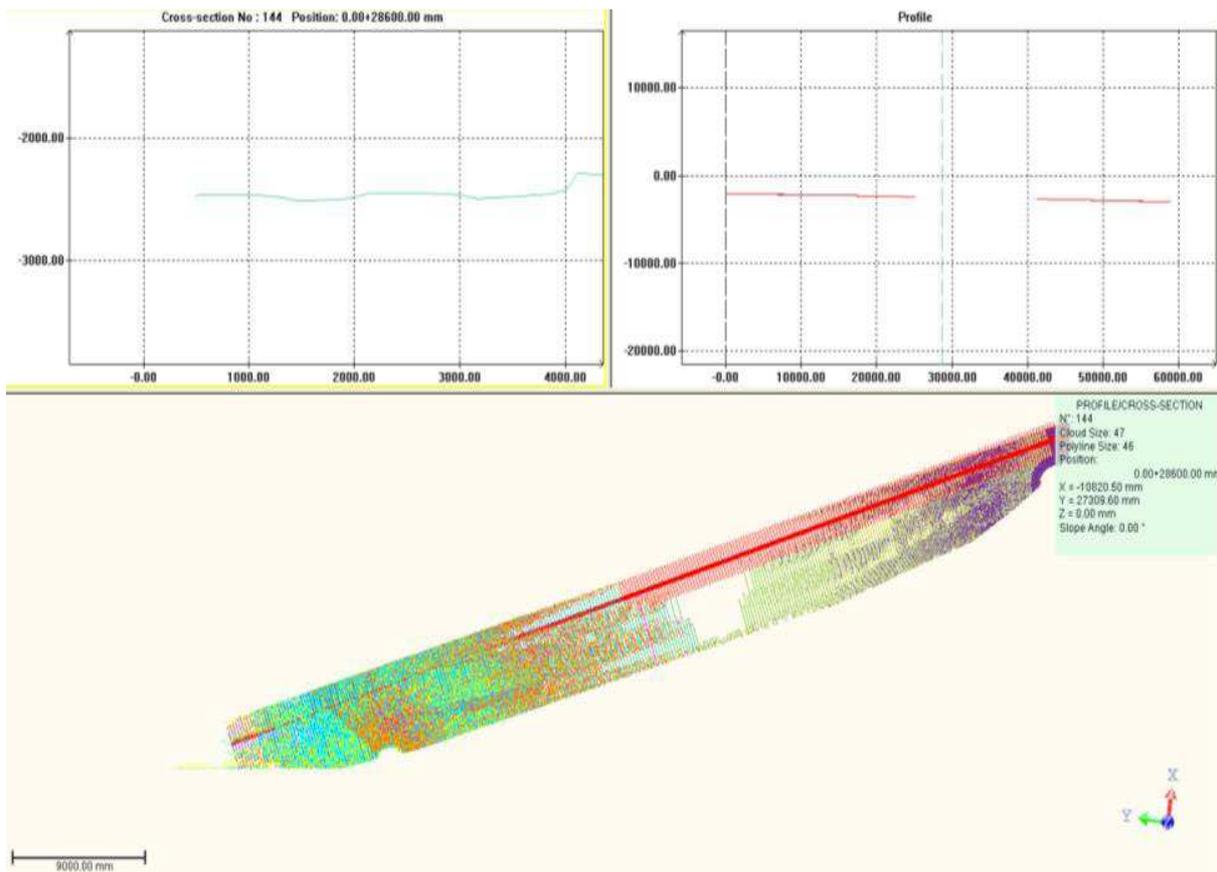
Fig. 10: Profile 83 (right upper section) in the first part of the road and the profile 144 (left upper section) in the second part of the road.

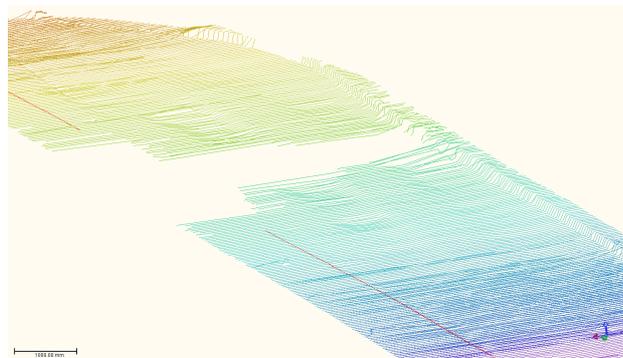
Fig. 11: Generated profiles and visible unevenness on the surface of the bus stop "Hurbanova" in Žilina on 22 October 2015.

Using the generated profiles a comparison with the traditional methods of measuring of unevenness can be carried out. While it was determined that the maximum value of right rut depth  $R_{Rmax} = 76$  mm and left value  $R_{Lmax} = 36$  mm, which is quite an exact match with the data obtained by measurement using a measuring staff (Fig. 11).

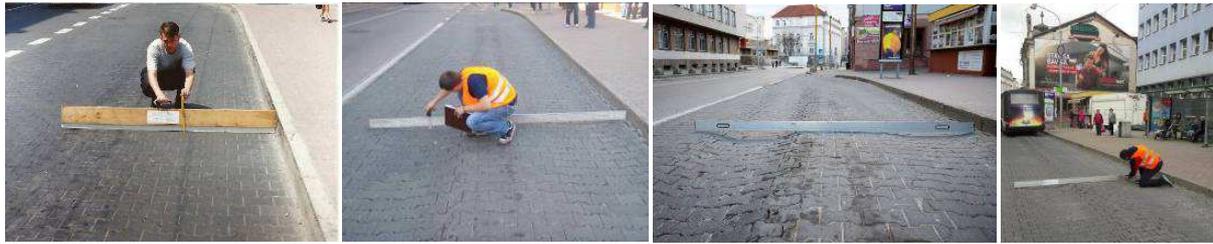
Fig. 12: Views of measurement process for determination of rut depth after the run of 160 000 design axles (DA) – on 27 August 1994, in the year 2012 after  $N_{AD} = 3.4 \cdot 10^6$ , 2012, 2015 after  $N_{DA} = 4 \cdot 10^6$  (Centre) and after  $N_{DA} = 4.5 \cdot 10^6$ .

The behavior of the pavement during the operation was constitutionally monitored by measuring the transverse unevenness of the bus stop "Hurbanova" in Žilina (Fig. 12) and measurements were made at least once a year using UNIZA's profilograph [3].

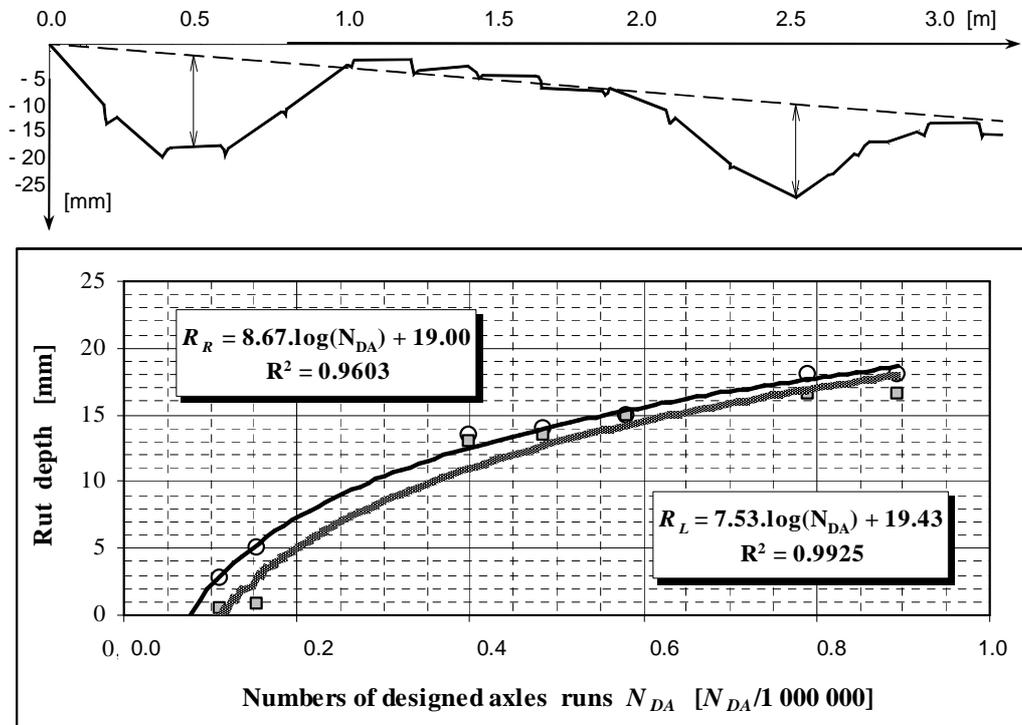
Fig. 13: View of evaluated transverse unevenness of the surface of the bus stop “Hurbanova” and correlation dependence of rut depth on axle numbers.

Possible monitored characteristics of pavement transverse unevenness in our case was a depth of ruts. The characteristic graph of surface unevenness after a run of 400 000 axles is shown in Fig. 13 and results of measurements in the years 1993 - 1998 are in graphical interpretation presented in Fig. 13.

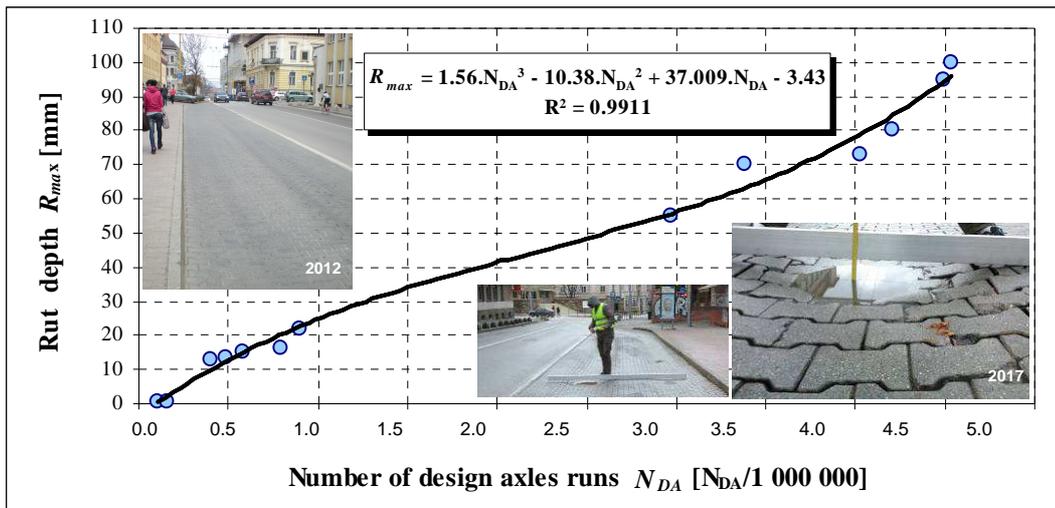
Fig. 14: Development of the rut depth, depending on the number of crossings of design axles for the public bus stops “Hurbanova” in Žilina.

On the basis of the long-term relevant results obtained was created by degradation model for maximum rut depth, where it was measured throughout the reporting period (Fig. 14).

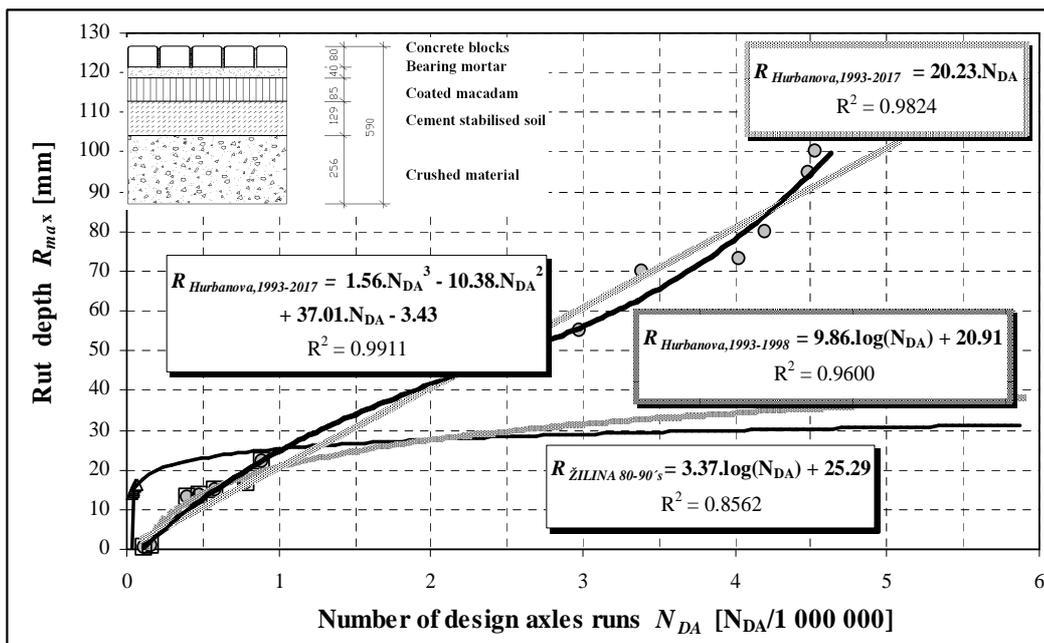
Fig. 15: Comparison of correlation dependences of the pavement bus stop rut depth on the design axle number obtained after the  $N_{DA} = 0.1 \cdot 10^6$ ,  $N_{DA} = 0.9 \cdot 10^6$ , and  $N_{DA} = 4.5 \cdot 10^6$ .

In the article were presented the results of long-term rut depth measurements performed during 25 years on selected bus stops which were intended to determine correlation dependences of pavement rut depth on a number of design axles. However, the found dependencies of rut depth on number of design axles seem to be logarithmic at first (up to 1 million of design axles runs), it was shown that after 3 millions of design axle runs the dependencies confirmed the theoretical 3rd degree polynomial correlation function, which is typical for pavements with asphalt layers.

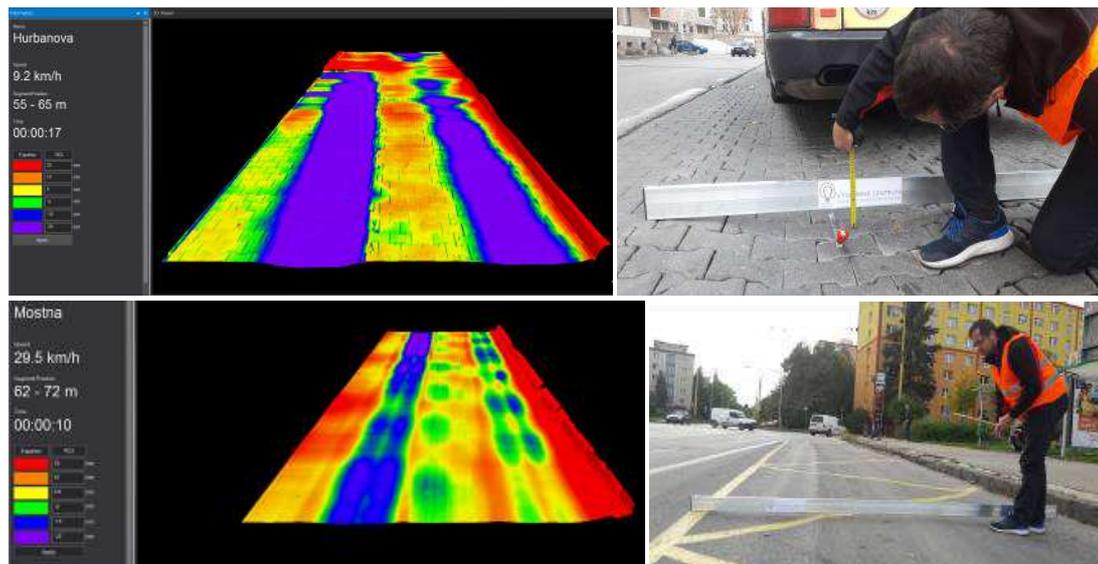
Fig. 16: Results of Dynamic Road Scanner measurements of the bus stops "Hurbanova" and "Mostná" in Žilina on 17 October 2017 and standardized measurements according to STN EN 13036-7.

In the present, the Research Centre and the Faculty of Civil Engineering UNIZA in cooperation with the company KVANT are developing the brand-new device Dynamic Road Scanner for measuring the transverse and longitudinal unevenness. The example of the output of the device is shown in Fig. 16.
