# THE ABILITY OF TOURIST NATURAL TRAILS TO RESIST TOURISM LOAD AND POSSIBILITIES FOR REDUCING THE ENVIRONMENTAL IMPACTS: CASE STUDY OF THE SLOVAK PARADISE NATIONAL PARK (SLOVAKIA)

Janočková J., Koščová M., Jablonská J.: The ability of tourist natural trails to resist tourism load and possibilities for reducing the environmental impacts: case study of the Slovak Paradise National Park (Slovakia). *Ekológia (Bratislava)*, Vol. 34, No. 3, p. 281–292, 2015.

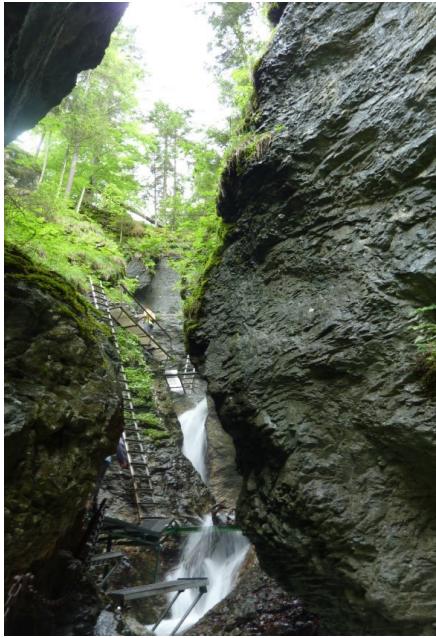
Fig. 2. The access equipment of the path.

The trail leads through a varied terrain and was therefore divided into 13 independently assessed sections, each section constrained by ladders and/or bridges. The selected attributes were evaluated based on terrain observations since July 2012 and by a review of the literature, including geological maps and topographic tourist maps at the scale of 1:25,000.

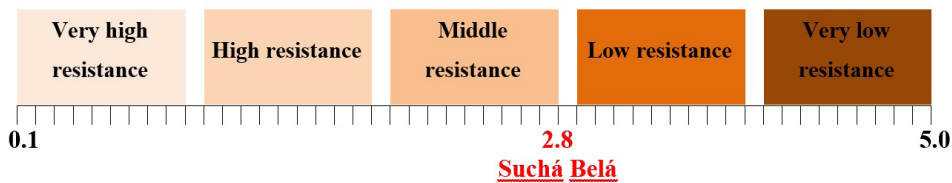
Fig. 3. Categories for site resistance according to geometric parameters, geologic structure, and geomorphologic structure: characteristics of these parameters classify Suchá Belá as a middle resistant site.

On a scale of 0.1 (multiplying the lowest possible weight coefficient with the lowest possible assignment grade) to 5 (multiplying the highest possible weight coefficient with the highest possible assignment grade), the above assessed factors place Suchá Belá in the category of middle resistance (Fig. 3).

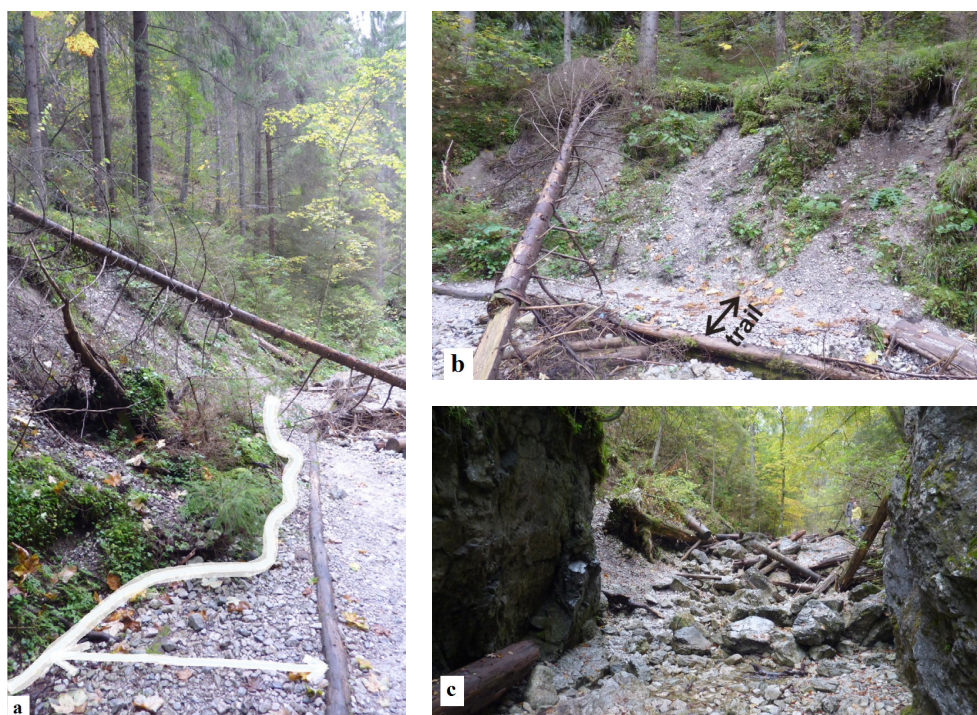
Fig. 4. Examples of geohazard activity directly affecting the trail: (a) trail covered by a slide; (b) small slides flanking the trail; (c) trail covered by rocks fallen from adjacent rock walls.

The first and last sections of the analysed trail (numbered 1 and 13) are located on a slightly uphill terrain with a minimal tendency to geohazard. Also, these sections are generally of sufficient width to allow for an appropriate distribution of tourists. These factors make the alterations caused by trampling negligible in these parts, even though they lead on a very low resistant loam and gravelly loam. This is also due to the fact that these sections are rarely flooded, as opposed to the rest of the trail. The trail sections numbered 2–12 are formed in middle resistant (both to chemical and mechanical load) Wetterstein dolomite rock occasionally covered by wood, tree trunks, and stones deposited by water. These trail parts closely fit a steep exposed terrain with high geomorphologic energy, which is generally a typical setting of high geohazard frequency (Fig. 4).

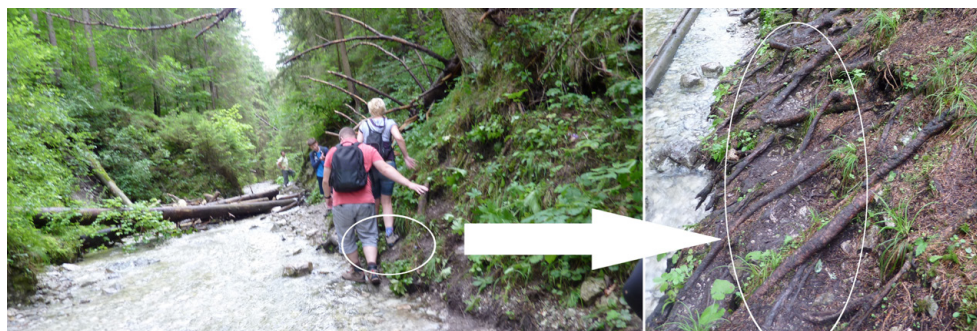
Fig. 5. Alteration of trail surroundings: traces of path widening, break down of vegetation cover, and uncovering of tree roots.

As the trail mostly leads on a stony stream bed resilient to trampling alterations, the overuse from trampling occurs mainly on the trail surroundings. The observation of the trail and its surroundings during the summer months of June and July, with an approximate visitation of 780 tourists daily (Slovak Paradise National Park Administration, 2012), showed no change in the tourist path, and negligible alterations of permanently used alternate paths on the surrounding terrain. Conversely, the increased intensity of tourist visits caused a visibly worsening condition of the narrow terrain belt adjacent to the trail. At the end of July, there were traces of widening of the trail by break down of vegetation cover due to several floods. The uncovered tree roots adjacent to the trail were even more exposed as a result of tourists trying to avoid the stream by walking on the inclined trail side and attaching to them (Fig. 5). The surrounding terrain was marked by newly created paths that could change into permanent paths if an additional number of tourists walk on the same terrain before it recovers.

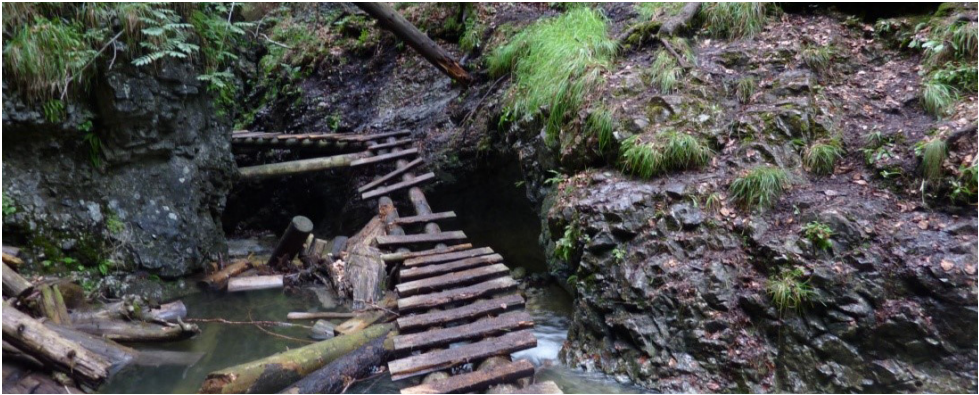
Fig. 6. Damaged wooden ladder after a flood in the gorge Suchá Belá.

The main reason for off-trail movement, and therefore the key issue influencing the path preservation, is the ephemeral stream leading through the gorge. During floods, the stream transports a considerable amount of weathered rock material, which covers the path and finally is deposited at the confluence of the gorge with axial river Biela Voda. The water often floods the tourist path and damages the access ladders and steps (Fig. 6).

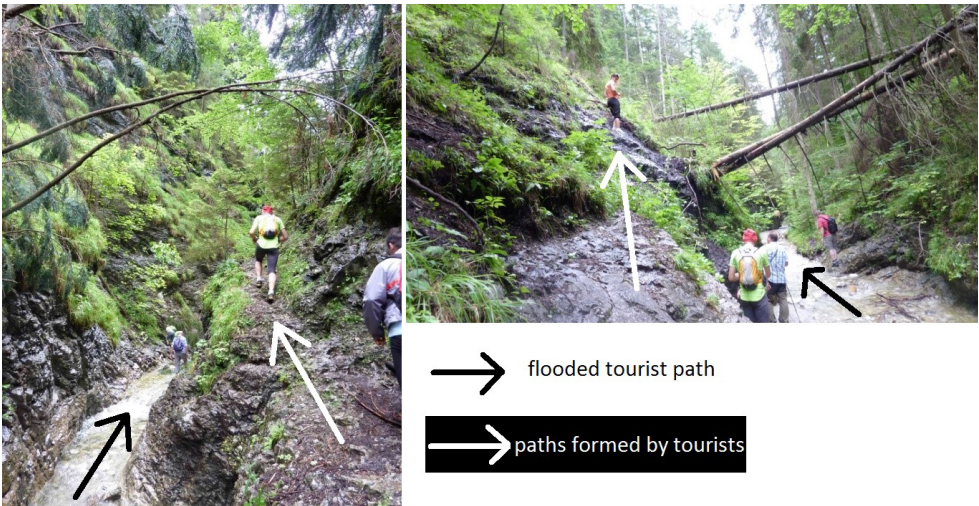
Fig. 7 (a, b). Flooded tourist path causes tourists to form alternative paths on an unstable terrain.

To avoid the flooded trail, tourists develop alternative paths on a terrain that is unstable and susceptible to erosion and sliding, particularly at times when the surface is wet (Fig. 7). Such illegal paths attract additional use by tourists when the water level falls.
