SEDIMENTARY-VEGETATION RESPONSE TO THE CHANNEL BY-PASS: A CASE STUDY OF THE DANUBE RIVER

Horáčeková Š., Lehotský M., Štefanička T., Viczián I.: Sedimentary-vegetation response to the channel by-pass: A case study of the Danube river. *Ekológia (Bratislava)*, Vol. 36, No. 2, p. 172–183, 2017.

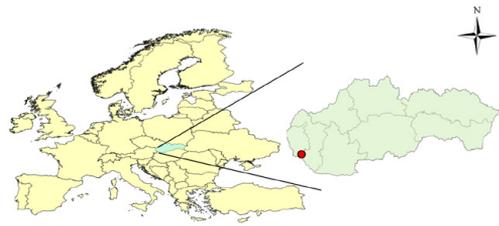
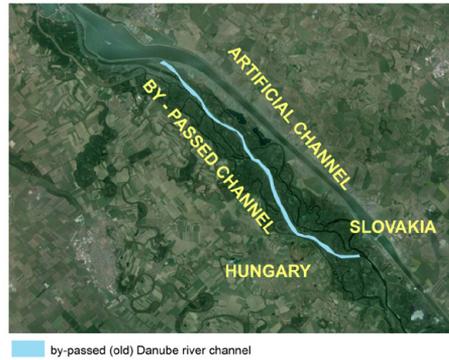
Fig. 1. Study area of the by-passed Danube river channel.

The Danube river and its floodplain were subject to increased urbanisation, channel regulation and its modification for shipping during the past three centuries. Owing to the construction of several dams upstream Bratislava in Germany and Austria, the character of the bed load and its regime has changed substantially too. Only suspended load comes from upstream and forms a new sandy levee downstream Bratislava (Globevnik, Mikoš, 2009; Lehotský et al., 2010). Furthermore, the construction of Gabčíkovo–Nagymaros waterworks (1992) because of the decrease in discharges in the by-passed channel contributed, on one hand, to its narrowing and degradation and, on the other hand, to the development of new floodplain along its banks (Fig. 1).

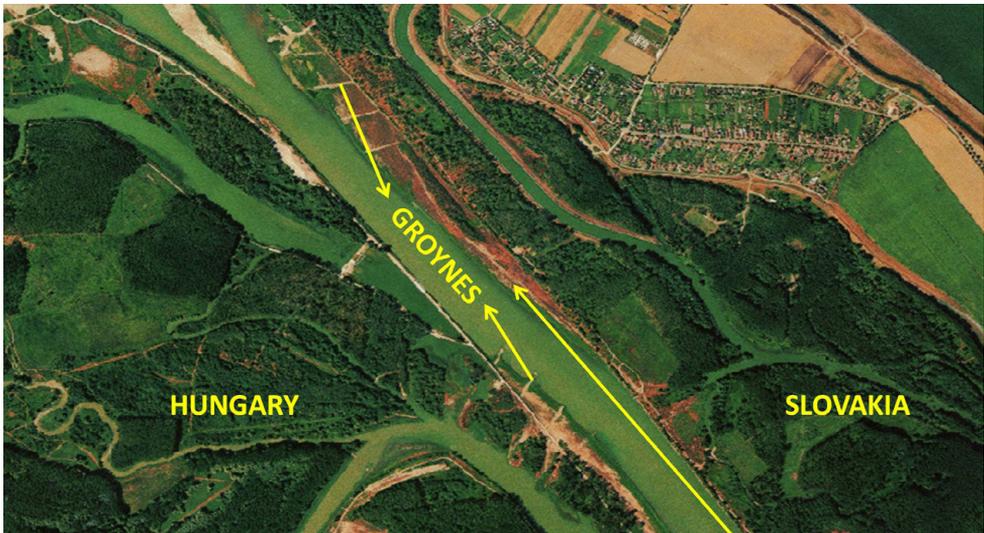
Fig. 2. Groynes structures in the by-passed Danube river channel in 1996.

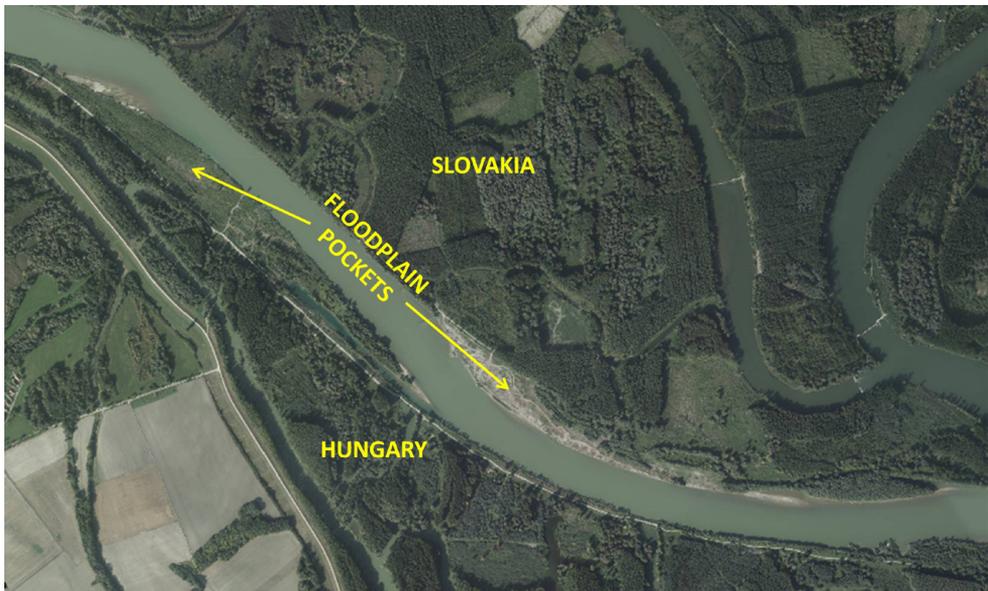
Fig. 3. Sedimentation (floodplain pockets) in the Danube river channel in 2013 caused by anthropogenic landforms groynes near Vojka village.

In case of the vertical accretion, the floodplain pockets are the major landform structures as shown in Fig. 3 (Liébault, Piégay, 2002). After the commissioning of the waterworks, new floodplain pockets began to developing the by-passed, old Danube channel. Owing to several problems (economical, social, ecological or political), Slovakia begun to build water scheme without the support of Hungary (Jansky et al., 2004). The main disadvantages of this decision were major ecological consequences in surrounding areas (Lehotský et al., 2013; Illyová, Matečný, 2014; Otaheľová et al., 2007; Jansky et al., 2004).

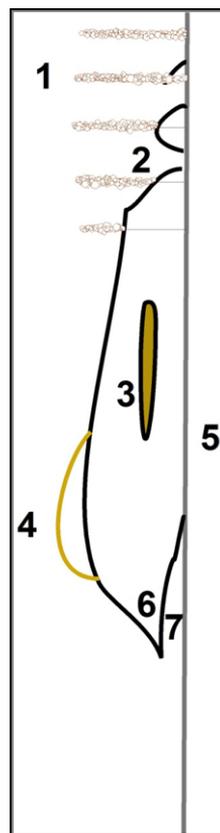
Fig. 4. Scheme of fluvial landforms on the sedimented floodplain pocket in the by-passed Danube river channel (1 – groynes; 2 – accumulation bank; 3 – crest of the pocket - previous scroll bar; 4 – island/peninsula; 5 – original artificial dyke; 6 – tail; 7 – cove).

Each floodplain pocket in the channel has its typical shape and system of landforms (Fig. 4). Each of these landforms rose after building of anthropogenic landforms – groynes. Below these landforms, river flow begins swirling, what is encouraging the sediments to accumulate on these places.

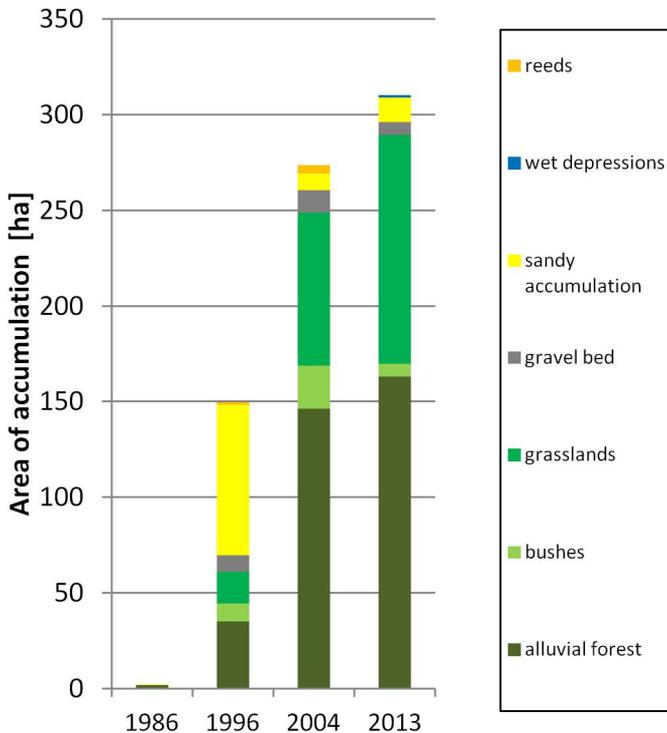
Fig. 5. Change in the in-channel accumulation over the water level and land cover changes from 1986 to 2013.

First vegetation in the channel was visible on the oldest orthophotomaps from the 1986, even before the by-passed channel formation begun. Next orthophotomaps (1996) are pointing on the increased area of scrollbars (Fig. 5) that consequently created a new area of the floodplain in the channel. Afterwards, vegetation succession took place on these sandy sediments. Water Management Institute in cooperation with Forest Management in Slovakia and Hungary cuts this initial forest regularly on both sides of the river. This intervention increases the amount of woody debris accumulated by the flood sand that might cause blockage during the major floods, because some of the fallen wood is not transported away. On the other hand, some in-channel parts were left out of deforestation and, therefore, accumulate greater amount of sediments. Vegetation is nearly impenetrable and might cause higher friction on these scrollbars in the river channel.

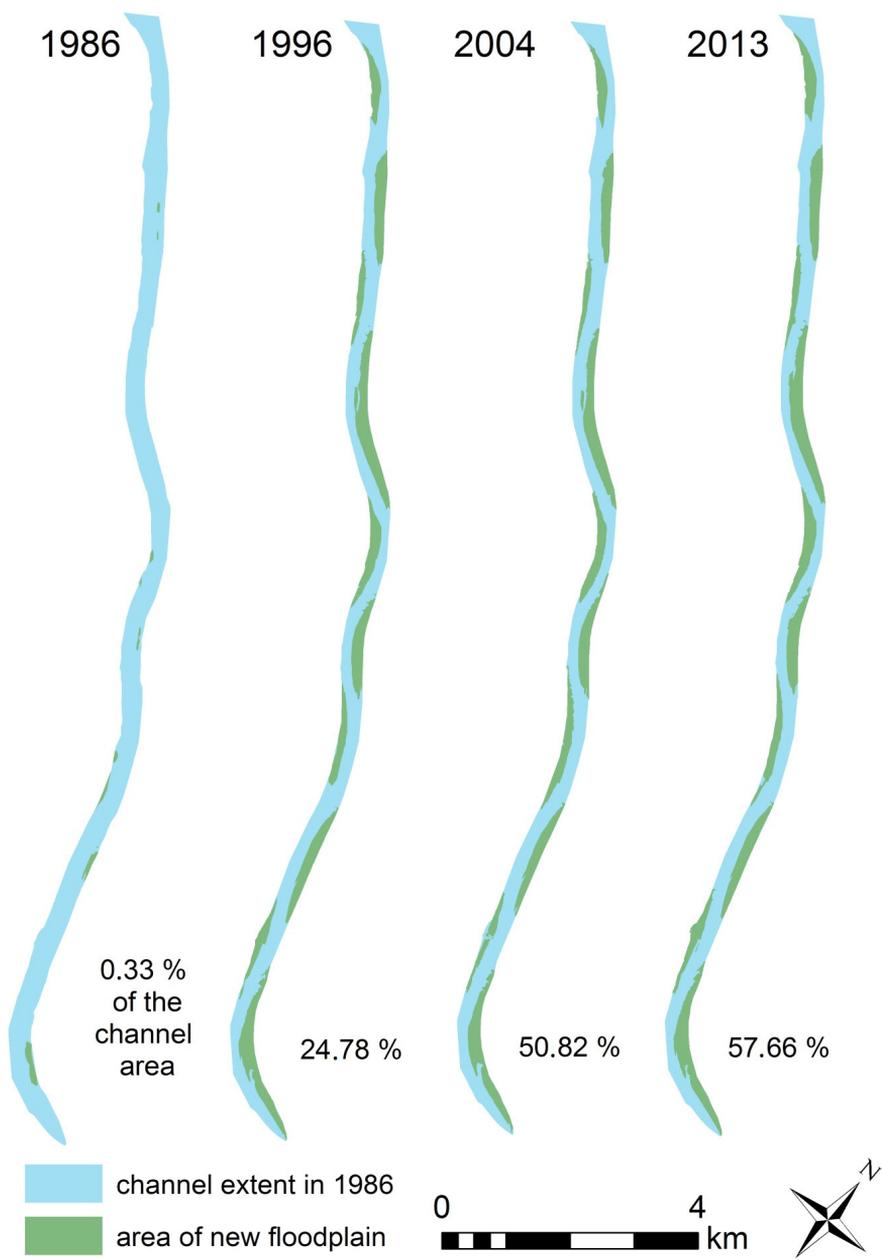
Fig. 6. Area of in-channel sedimentation over the water level in the by-passed Danube river channel.

The major change in the channel is formed by floodplain pockets formation that originated from the scrollbars. Their area increased from 1.79 ha in 1986 to 310 ha in 2013, what represents 57% of the channel. Every landform developed its own vegetation succession (Figs 6–8) ranging from initial vegetation stage to the developed alluvial forest. Human impact is noticeable in this area. The trees are regularly cut down and the succession is often disrupted. Most of the sandy scrollbars were colonised by grasslands and later with initial alluvial forest

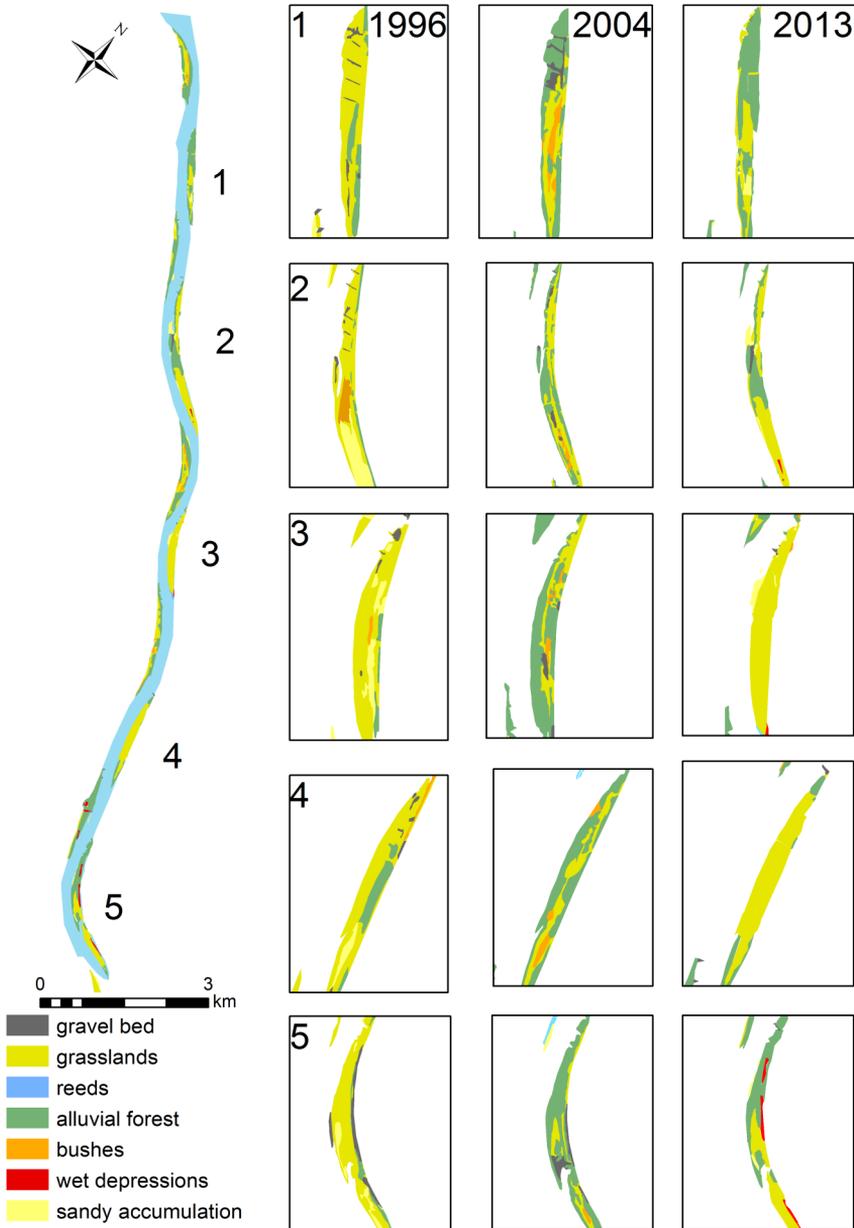
Fig. 7. Land cover changes of the channel (Slovakia).

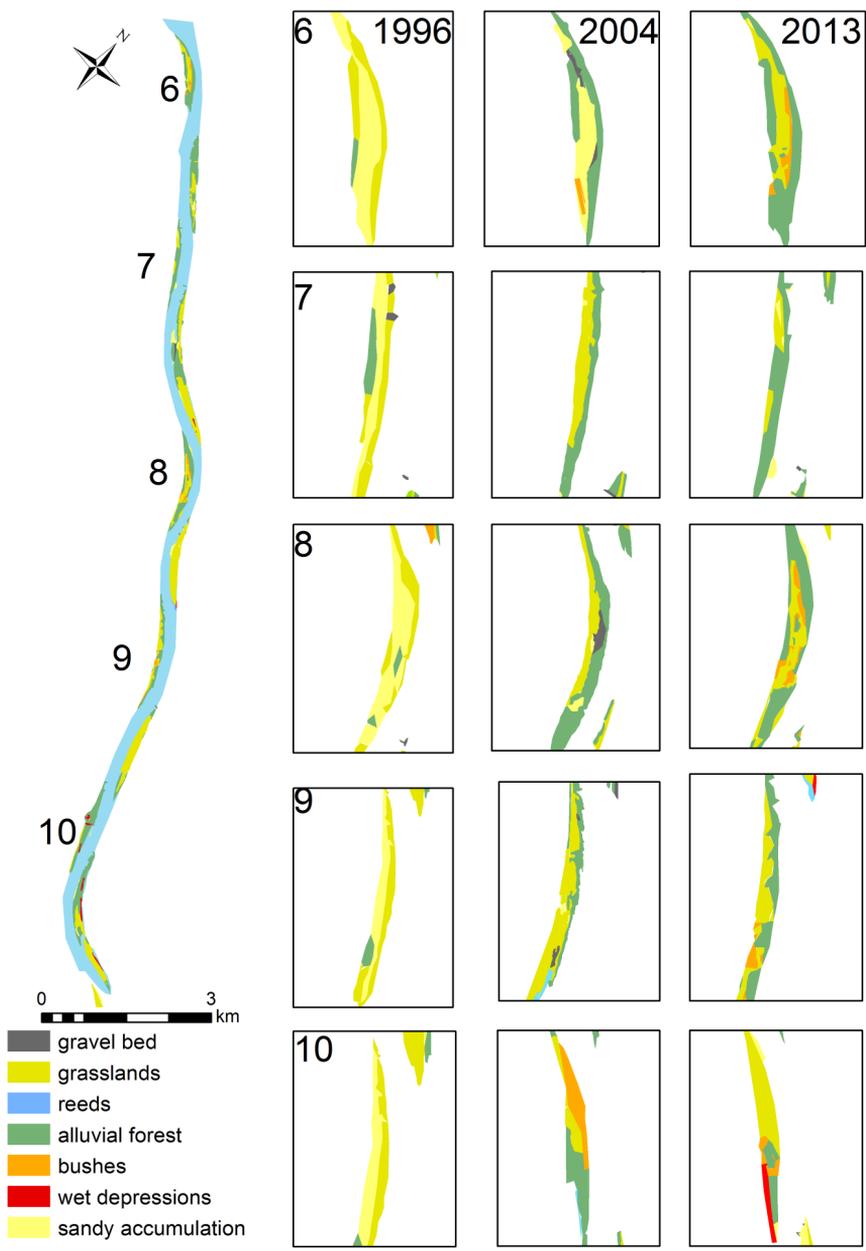
Fig. 8. Land cover changes of the channel (Hungary).
