RECENT PROGRESS IN FULL SCALE FATIGUE TEST OF PZL-130 "ORLIK" TC-II STRUCTURE

Air Force Institute of Technology, Warsaw, Poland

Abstract

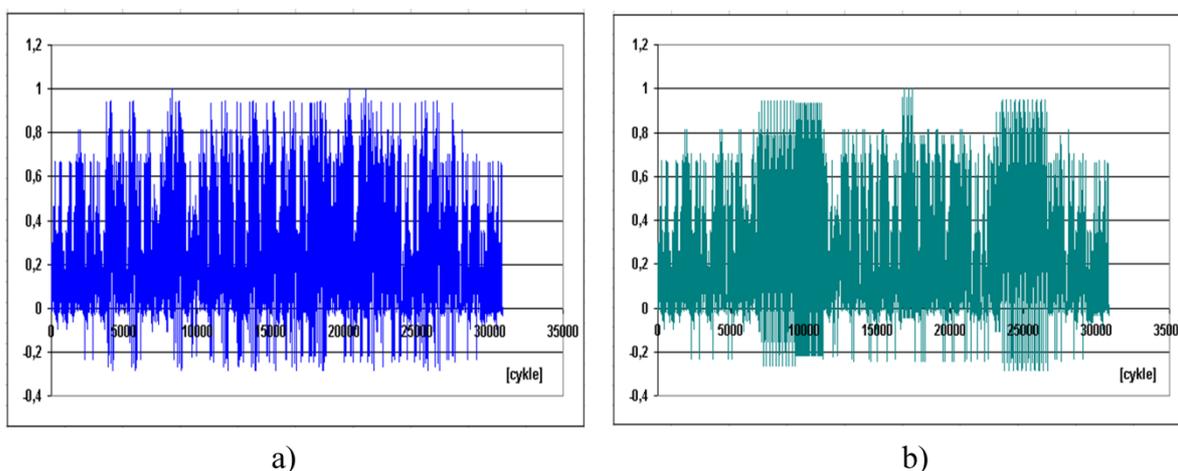
Fig. 1. Tested load blocks: a) before reordering, b) after reordering

The prepared load block, shown in Fig. 1a, exhibits local maxima due to significantly different severity of individual flights, which is consistent with the actual flight profile where aircraft is used both in training and display flying. Hence individual flights could be rearranged in such a manner that highly maneuverable flights were gathered in several groups of different lengths (Fig.1b) resulting in distinguishable markers on the crack surface (Fig.2).

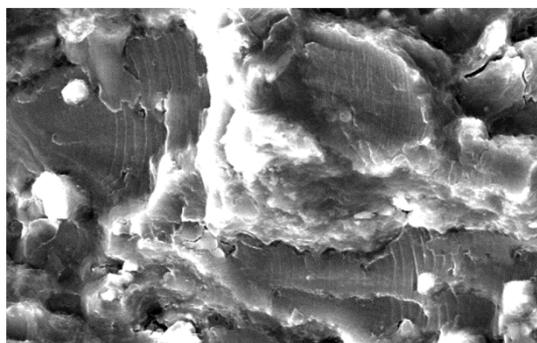
Fig. 2. Visible markers on the crack surface

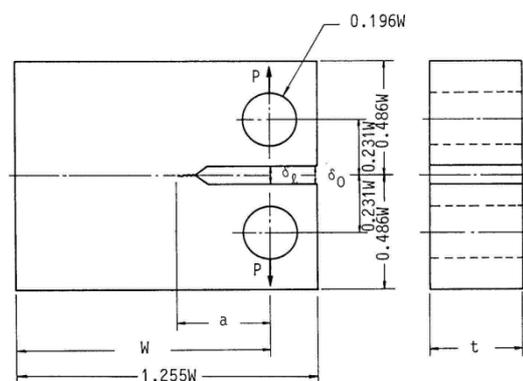
Fig. 3. Wedge Opening Load sample used in tests

The influence of original and modified load blocks were tested using specially prepared Wedge Opening Load samples Fig. 3, manufactured from 2024-T3 aluminum alloy identical with the material used in PZL-130 "Orlik" TC-II.

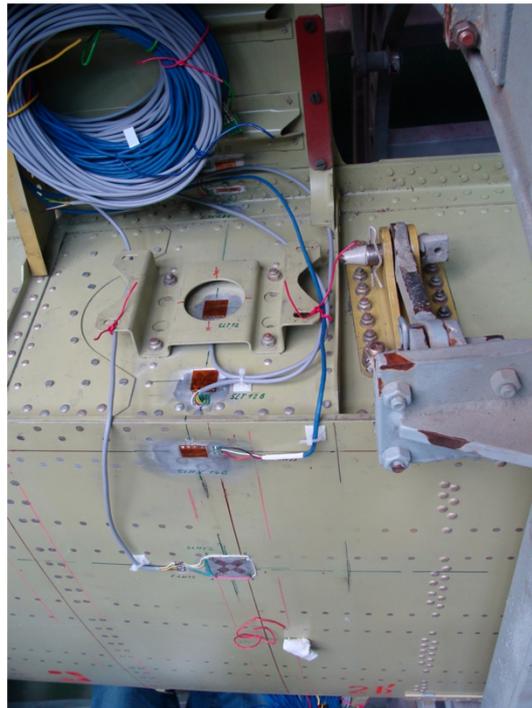
Fig. 4. Strain gauges installed on the test specimen

Prior to the commencement of the test the strain gauge array was calibrated in a two-stage process. Firstly, loads used during the pre-flight calibration were used in order to verify the correlation between two installations. Secondly, actual load lines taken out from the prepared load block were tested in order to check the strain levels and stability of the specimen when extreme loads are applied.

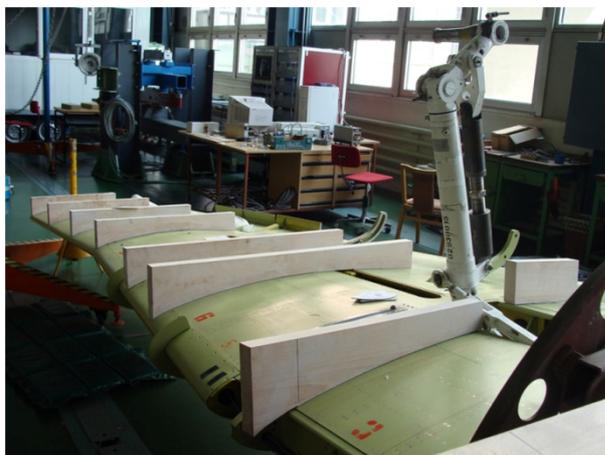
Fig. 5. Completion of loading system

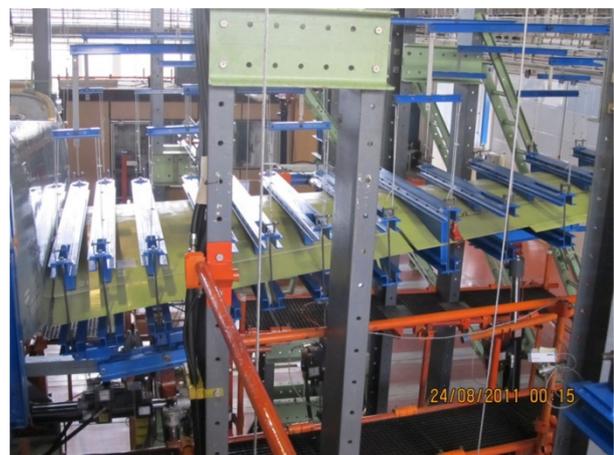
Fig. 6. Test specimen mounted in test rig

The Full Scale Fatigue Test of PZL-130 "Orlik" TC-II is being conducted at Výzkumný a Zkušební Letecký Ústav. A PZL-130 "Orlik" TC-I aircraft was specially selected for the test purposes and modified according to bulletins to the TC-II version. The modernization consisted of overhauling the fuselage and assembling a new set of wings. The completed specimen consists of the fuselage, wings, landing gear and the engine mount. It was instrumented with the identical set of strain gauges as the specimen used previously by the AFIT during Operational Load Monitoring. The measuring system has two main objectives: validation of loads prepared for the purposes of fatigue testing and monitoring strain levels of crucial structural elements throughout the whole test.

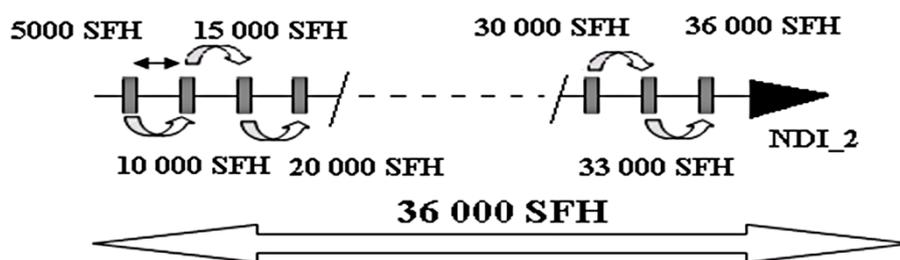
Fig. 7 General schedule of Non Destructive Inspections throughout the test

Level 1 is based on simple NDI techniques and will be carried out every 1000 ± 50 SFH. This inspection will be executed by VZLU in accordance with the NDI instructions delivered by AFIT. Estimated time for inspection is about 2 man-hours. No modifications to the test specimen or the test rig will be necessary.

Level 2 - inspection will require using advanced NDI equipment, so additional access to the structure will be needed. This level will necessitate a removal of clamps to grant access to aircraft structure. The inspection will be conducted every 5000 ± 1500 SFH for between 0 and 30000 SFH and the time interval will be shortened to $3000 \text{ SFH} \pm 1500 \text{ SFH}$ for $30000 \div 36000$ SFH. VZLU will also conduct this level of inspection in accordance with the NDI instructions delivered by the AFIT although first inspections will be conducted in presence of the AFIT qualified personnel. Estimated time for this inspection is 2 working days.

Level 3 – detailed NDI inspection including dismantling the wings and the fuselage. Four major inspections are planned throughout the test every $10\,000 \pm 2500$ SFH:

- 12 000 SFH \pm 2000 SFH;
- 20 000 SFH \pm 2000 SFH;
- 26 000 SFH \pm 2000 SFH;
- 33 000 SFH \pm 2000 SFH.
