## SELECTED ASPECTS RELATED TO THE APPLIED LOADS CONTROL DURING FATIGUE TESTS OF A METALLIC AIRFRAME

*Service life of the PZL M28 is computed based on the results of the full-scale fatigue tests of the structure [1]. As the PZL M28 is a commuter category airplane according to the 14 CFR Part 23 and CS-23 regulations, the test objects are: (1) wing and wing load carry-through structure, (2) empennage and attached fuselage structure. Additionally, there are fatigue tests carried out for the landing gear and other selected elements including control system elements. The aircraft load carry-through structure is metallic and the cabin is unpressurized. The fatigue tests are conducted stage-by-stage. As tests progress, it is possible to extend the aircraft target service life, applying the safe life philosophy with reference to the primary components of the load carry-through structure.*

*The article brings into attention the issue of the applied loads control in conducting fatigue tests of the metallic airframe.*

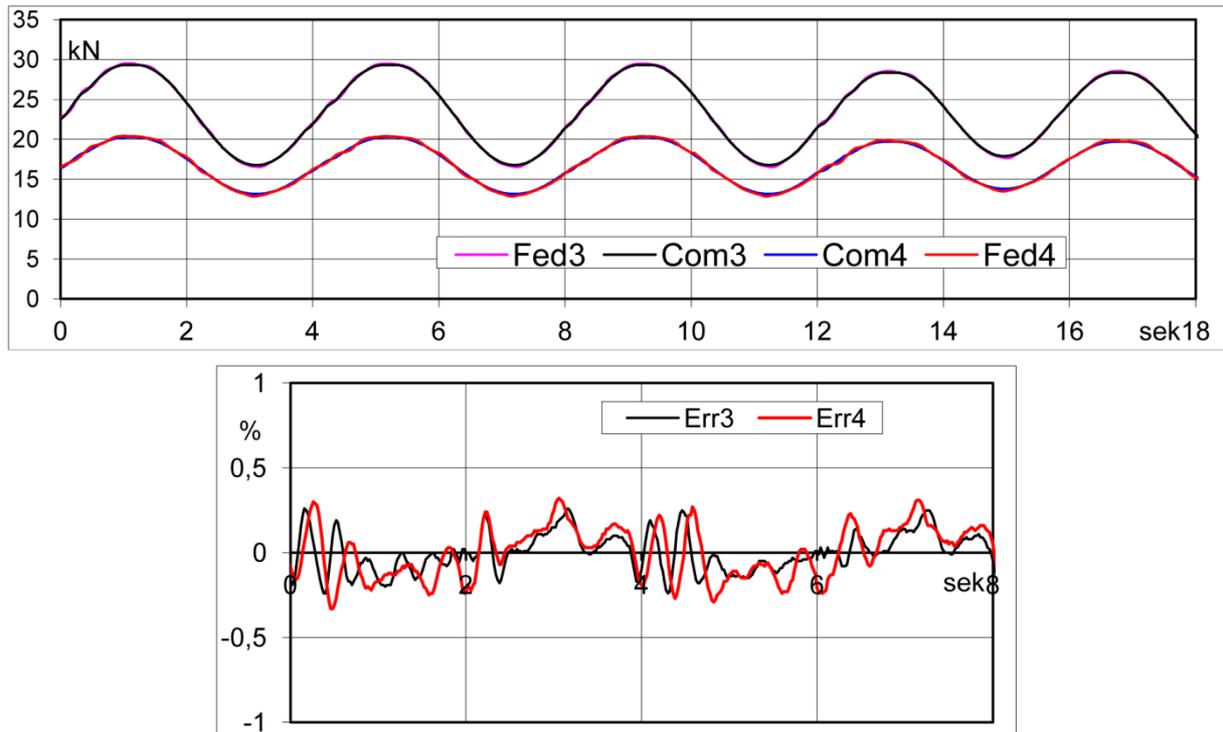
**Fig. 1. Fatigue test of the PZL M28 05's wing and wing load carry-through structure. Illustration of command (in blue) and feedback (in red) forces during several seconds of the test in channels 3 and 4. Force errors in these channels as difference between command and feedback forces, expressed in percentage of maximum force in the load transducers, are also shown.**

As mentioned in [2], during fatigue tests of the wing and wing load carry-through structure the accuracy of applied loads was kept within a 2% margin of error. This margin relates to the maximum force in a given channel in the test. An example of command and feedback force course in the channels is shown in Fig. 1. No significant difference between the forces is visible in the graphs. The error, expressed in percent as a difference between command and feedback forces, is also shown. It can be seen that within the presented time, the error in both channels is not greater than 0,4%, relating maximum allowable force in a load transducer, which is about twice of that maximum in the test.

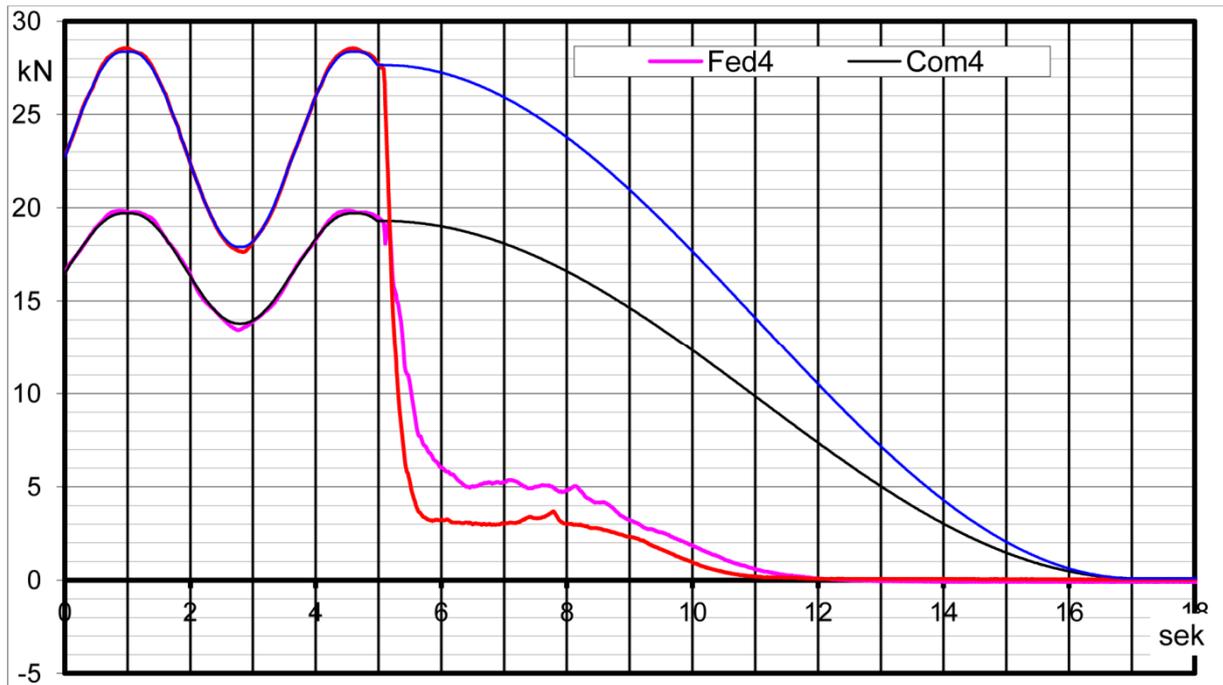
**Fig. 2. Fatigue test of the PZL M28 05's wing and wing load carry-through structure. Automated shutdown following damage of the loading element (test fixture elements are also loaded during test, especially some bolts, lugs, etc.). Command and feedback forces in channels 3 and 4 during shutdown are shown. The effect of multiple provisions is visible: system commanding a slow decrease in forces within about 12 seconds, while another provision was activated – the hydraulic pressure was automatically discharged, resulting in a faster decrease in forces.**

Some goals of the fatigue tests conducted are to find the critical elements in the aerostructure, determine its service life and to develop maintenance activities plan of the aircraft fleet in service. So, the test should be run until a fatigue damage occurs as the sole fatigue analysis is not a reliable tool to predict fatigue life. This aspect imposes great responsibility on the test team who need to watch for early symptoms of developing damage and observe fatigue crack propagation. Of course, many provisions are set to help, e.g. strain gauges in predicted critical areas. Nevertheless the system should be capable of a rapid reaction to the damage occurrence so as not to introduce random loads, which are uncontrolled and likely to be excessive. The system's behavior during one of the test events (damage of one test fixture element) is shown in Fig. 2. The system detected a failure and commanded a slow decrease in forces in the actuators. At the same time another provision was activated – the hydraulic pressure was automatically discharged. All parameters during the event were automatically recorded. In the effect, no damage was introduced to the tested article. Figure 3 shows a fatigue-damaged bolt of the test fixture as an example of a potential source of the tested article damage.

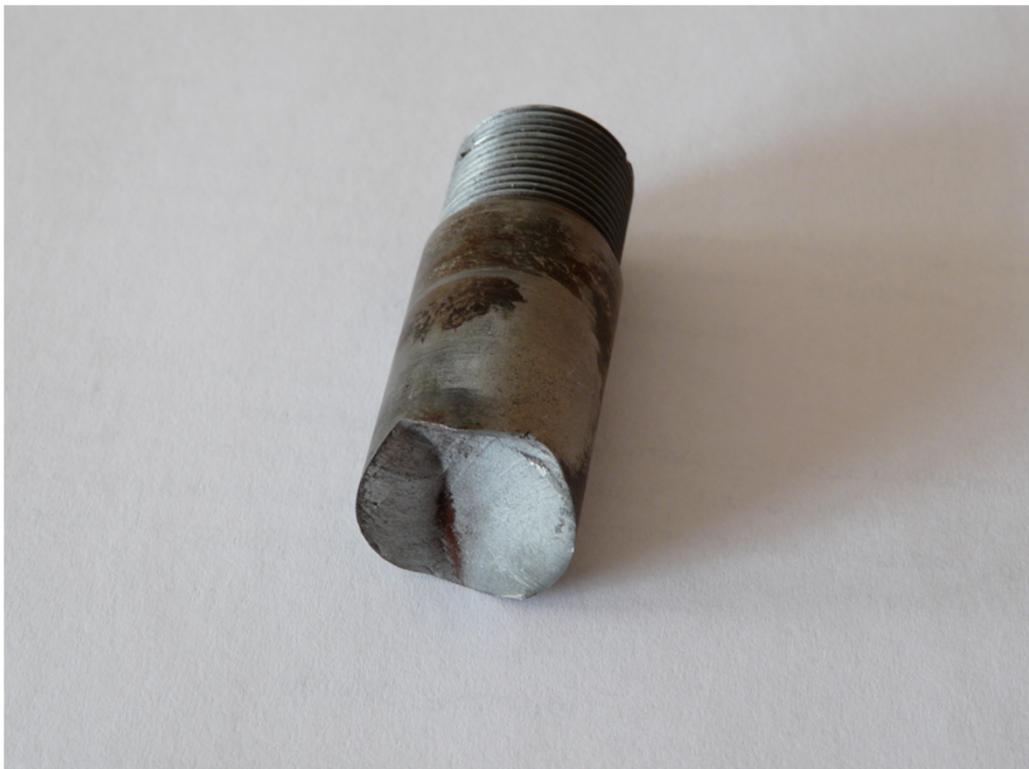
**Fig. 3. Fatigue test of the PZL M28 05's wing and wing load carry-through structure. A fatigue- damaged bolt of the test fixture.**

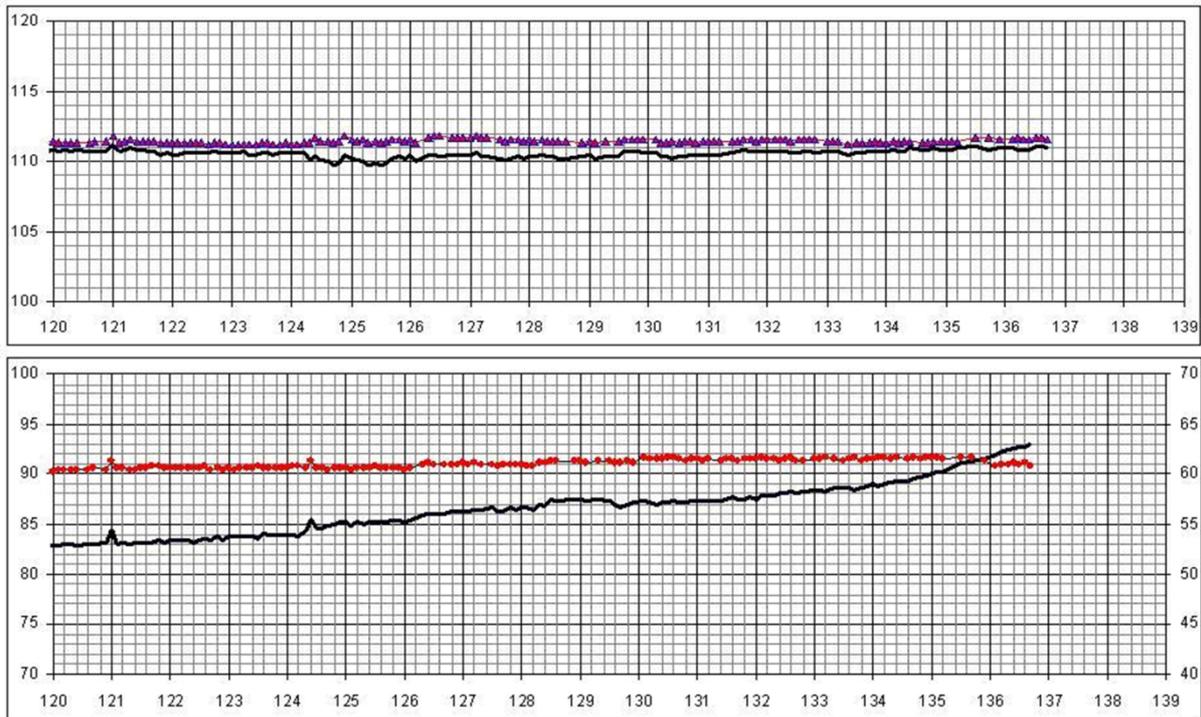
**Fig. 4. Fatigue test of the PZL M28 05's wing and wing load carry-through structure. Strain gauges maximum values recorded at each of 100 flights: (upper) no changes detected within the period shown; (lower) one gauge indicates monotonous change (possibly caused by damage development of the tested article or a strain gauge; in the case of doubts, additional strain gauges were applied).**

*Note some random excesses, but falling within the 2% error limit.*

As mentioned above, strain gauges offer convenient cues to monitor critical areas of a tested article during test. Sample records of strain gauges maximums in each of 100 flights are shown in Fig. 4 and 5. Four strain gauges records are shown in Fig. 4. No actions were initiated due to changes indicated in the bottom part of the figure as no visible damage in the affected area was observed. A different situation is shown in Fig. 5. One of two almost symmetrically located strain gauges (B2-3/P and B2-3/L) indicated a permanent growth. Local damage in its vicinity was detected. Repair was performed and a new strain gauge was installed in approximately the same position. The growth of B2-3/L was a warning signal for the test team who did not introduce any additional damages until the test article was repaired.

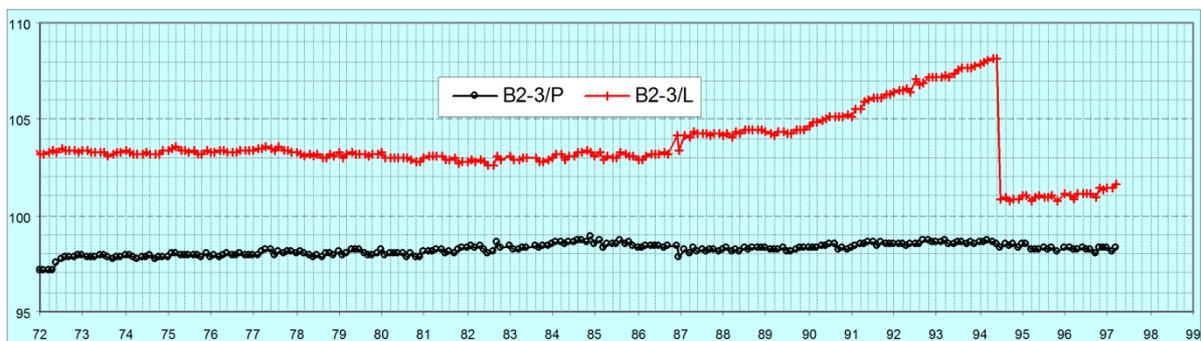
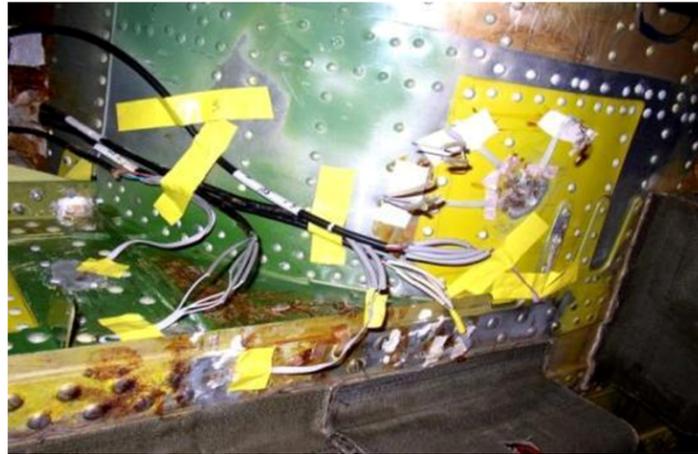
**Fig. 5. Fatigue test of the PZL M28 05's wing and wing load carry-through structure. Two almost symmetrically located strain gauges on the tested article, B2-3/P and B2-3/L maximum values recorded at each of 100 flights are shown. B2-3/L indicated rising up to local damage of the tested article (see the red arrow). Repair was performed and the strain gauge was glued in approximately the same position. B2-3/P is at the undamaged side in this event (its location is shown by the yellow arrow).**
