THE EFFECT OF ENVIRONMENTAL FLIGHT CONDITIONS ON DAMAGE PROPAGATION IN COMPOSITE SANDWICH STRUCTURE

Air Force Institute of Technology, ul. Księcia Bolesława 6, 01-494 Warsaw, Poland

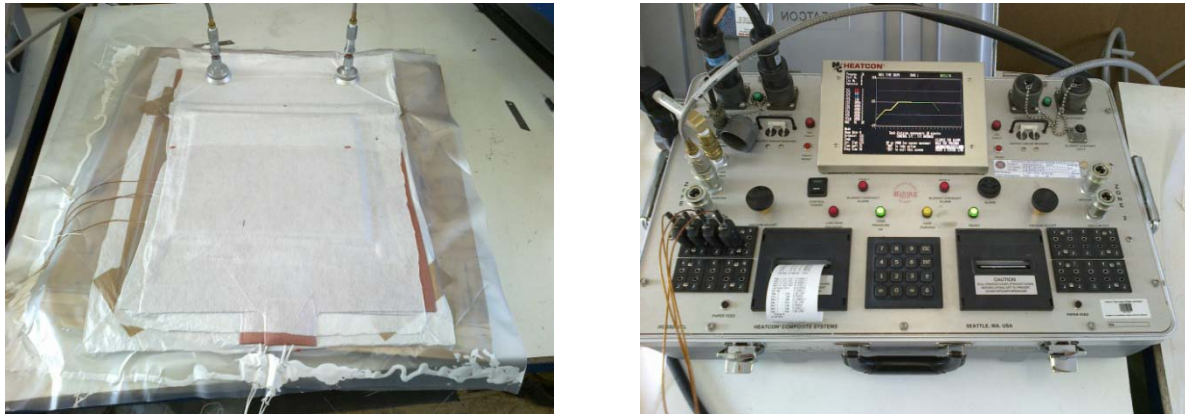
Figure 1. Honeycomb panel during curing cycle

Composite sandwich specimens with the skin made of aramid-epoxy composite and honeycomb core material Nomex® were designed and manufactured. They were made of prepreg using heating blankets (Fig. 1). In center of each Specimen there were made 4 holes having a diameter of 1 mm and spaced at a distance of about 10 mm. Then, water was applied through the holes.

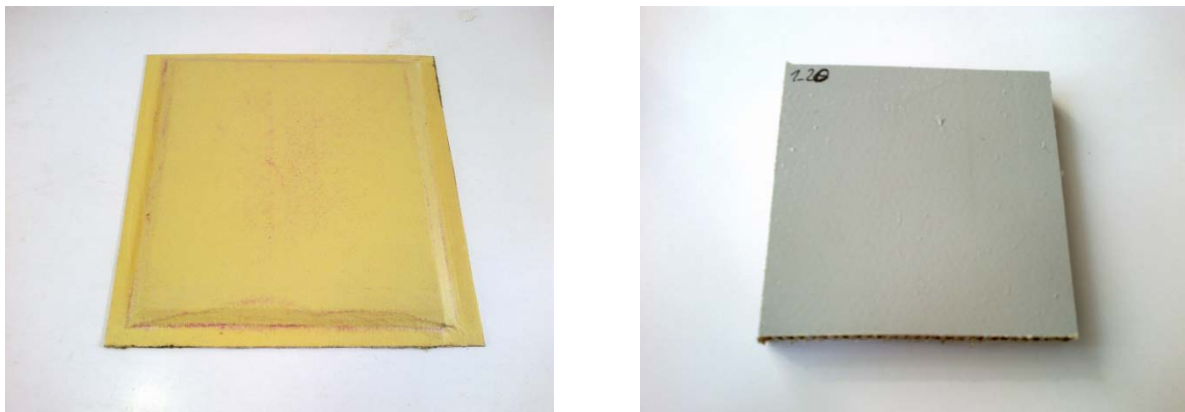
Figure 2. Honeycomb panel after curing (left), one of the specimens (right)

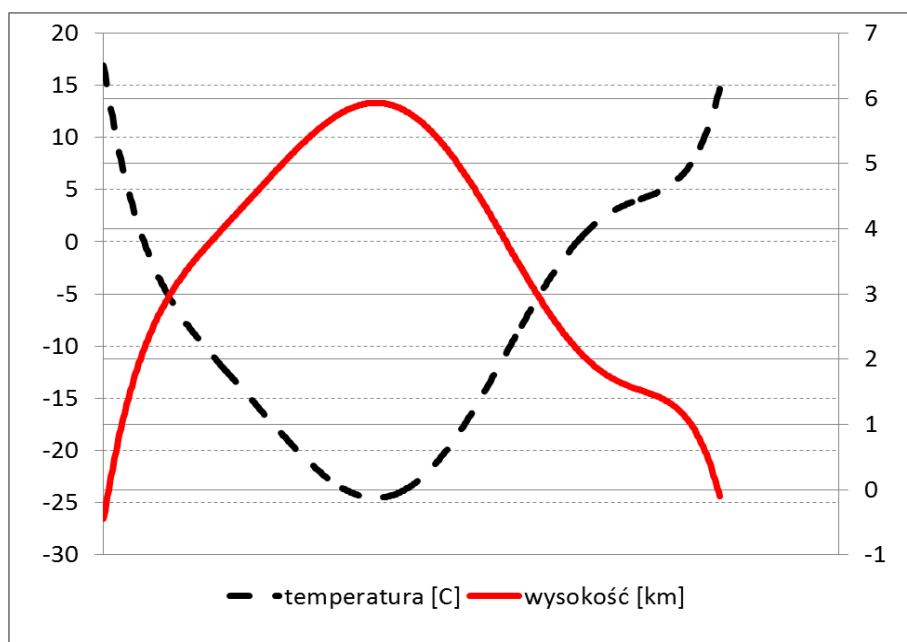
Figure 3. Temperature profile recorded during freeze-thaw cycles. Continuous line represents altitude calculated from standard atmosphere

The simulation involved a 3-hour cycle simulating the aircraft's take-off and climb to the altitude of 6000 [m] and then descent, landing and parking on the apron. The specimens were cooled to a temperature of -25°C and then heated to room temperature in forced convection conditions. During the experiment, temperature was recorded. Thermocouple was located inside

the core cell. The correlation between the altitudes and related temperatures was assumed based on the standard atmosphere [1].

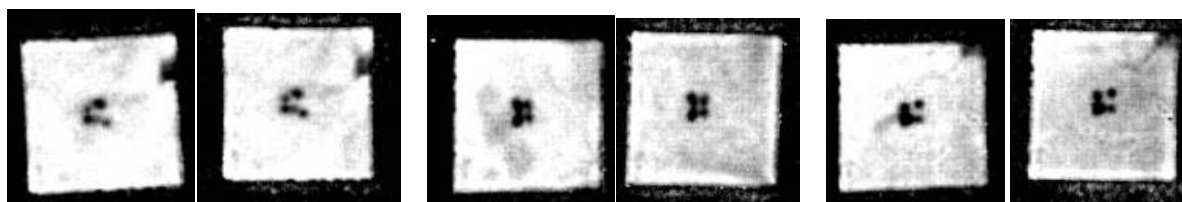
Figure 4. The results of the NDT of three specimens before and after the experiment. The specimens were not subjected to freezing cycles. Initial state on the left side. The final state on the right side

It was observed that the number of cells with water inclusions increased. The area of water inclusions expanded into the adjacent cells. The results of inspections are shown in Figure 4 and Figure 5.

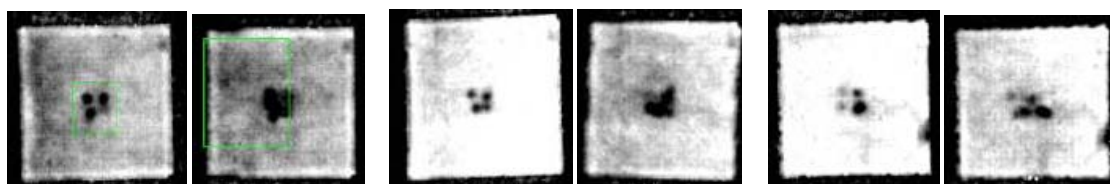
Figure 5. The results of the NDT of three specimens before and after the experiment. The specimens were subjected to freezing cycles. Initial state on the left side. The final state on the right side
