THE VERIFICATION OF THE TECHNICAL CONDITIONS OF A COMBAT-TRAINER JET'S AIRFRAME

Air Force Institute of Technology, ul. Księcia Bolesława 6, 01-494 Warsaw, Poland

Abstract

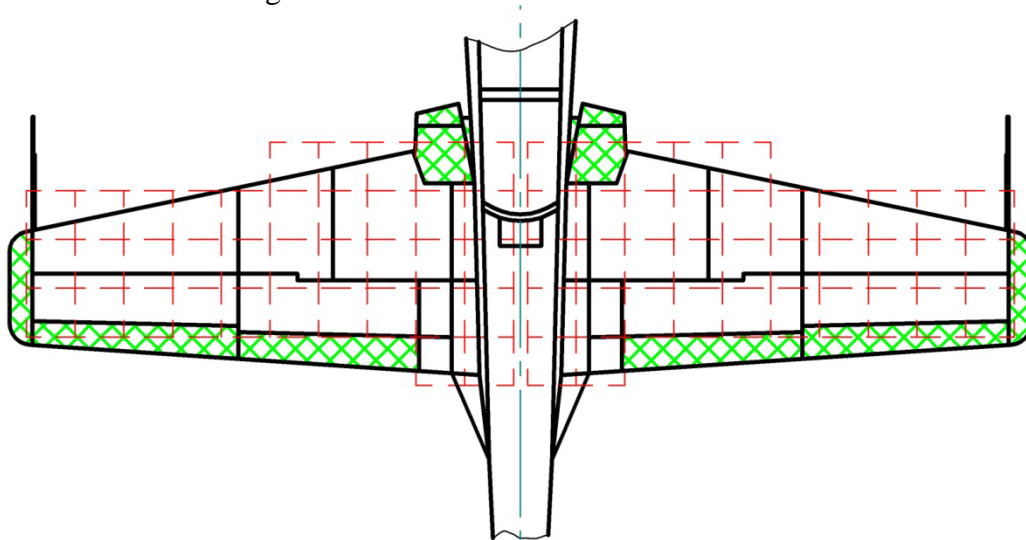
Figure 2. Measurement diagram for the upper side of the wing

The following regions have been selected for inspection:

- Wing, left side, top surface
- Wing, left side, bottom surface
- Wing, right side, top surface
- Wing, right side, bottom surface

The regions were shown in Figures 2 and 3.

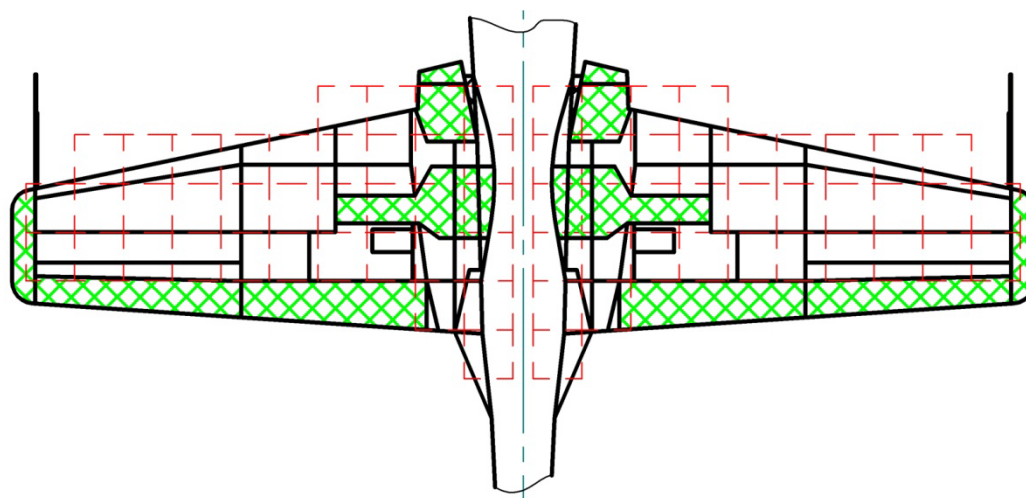
Figure 3. Measurement diagram for the bottom side of the wing

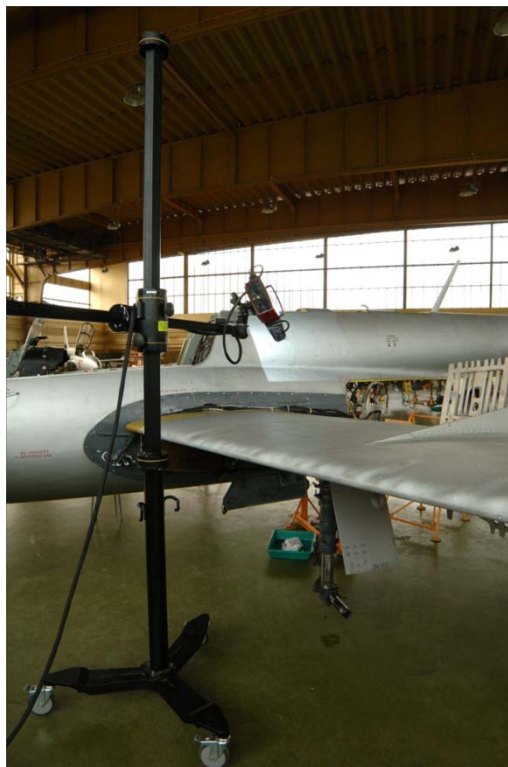
The ATOS III optical scanning system, produced by GOM mbH, was used for the measurements. In the measurements, a series of special line patterns was projected onto the measured surface and the line shapes were analyzed by the system to produce a digital 3D representation of the geometry.

Figure 5. ATOS III is an industrial optical 3D scanner

The measurements involved taking snaps of the measured surface until the complete structure was scanned. The resulting multiple scanned patches were sewn together automatically by the ATOS software with the use of markers randomly placed on the measured surface. Markers were placed randomly because the system relied on the pattern recognition to orient the scans in the reference system so that the marker pattern should be different for each scanned patch.

The scans were taken with the use of a 500x500mm measurement field. This size enabled a sufficient scan resolution, with a low overall number of scans. The surface area of the TS-11 was 17,5 m². The overall scan surface was 34 m², including the fuselage. This area corresponded to

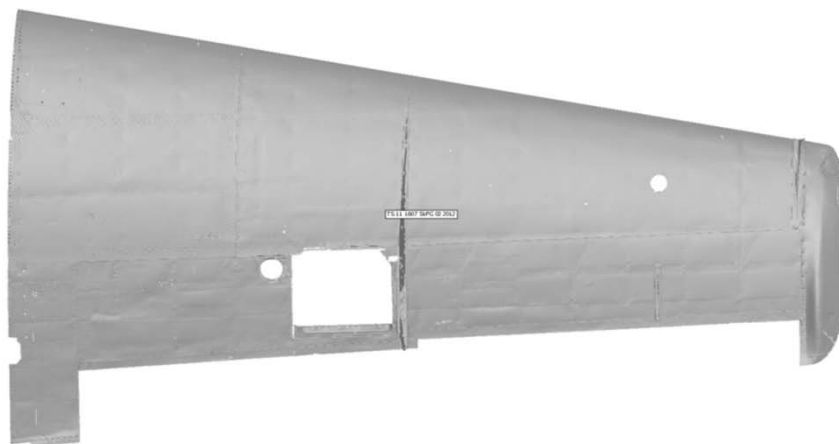
As a result of the described measurement procedure 6 digitized surfaces were obtained, which are subregions of the scanned area. These segments are shown in figs 6 and 7. The digital surfaces are made of triangle meshes. Triangle edge length was approx. 1,5 mm in areas of low curvature and approx. 0,3 mm in the areas of high curvature.

Figure 7. Example scan result – wing, right side, top

- 4,5÷4,7 mln nodes – upper wing surface
- 3,7÷4,1 mln nodes – lower wing surface
- 1 mln nodes – fuselage (single side)
